Letter of Notification for the Shannon-Astor 138 kV Transmission Line Rebuild Project

PUCO Case No. 23- 0040-EL-BLN

Submitted by:
AEP Ohio Transmission Company, Inc.

January 20, 2023

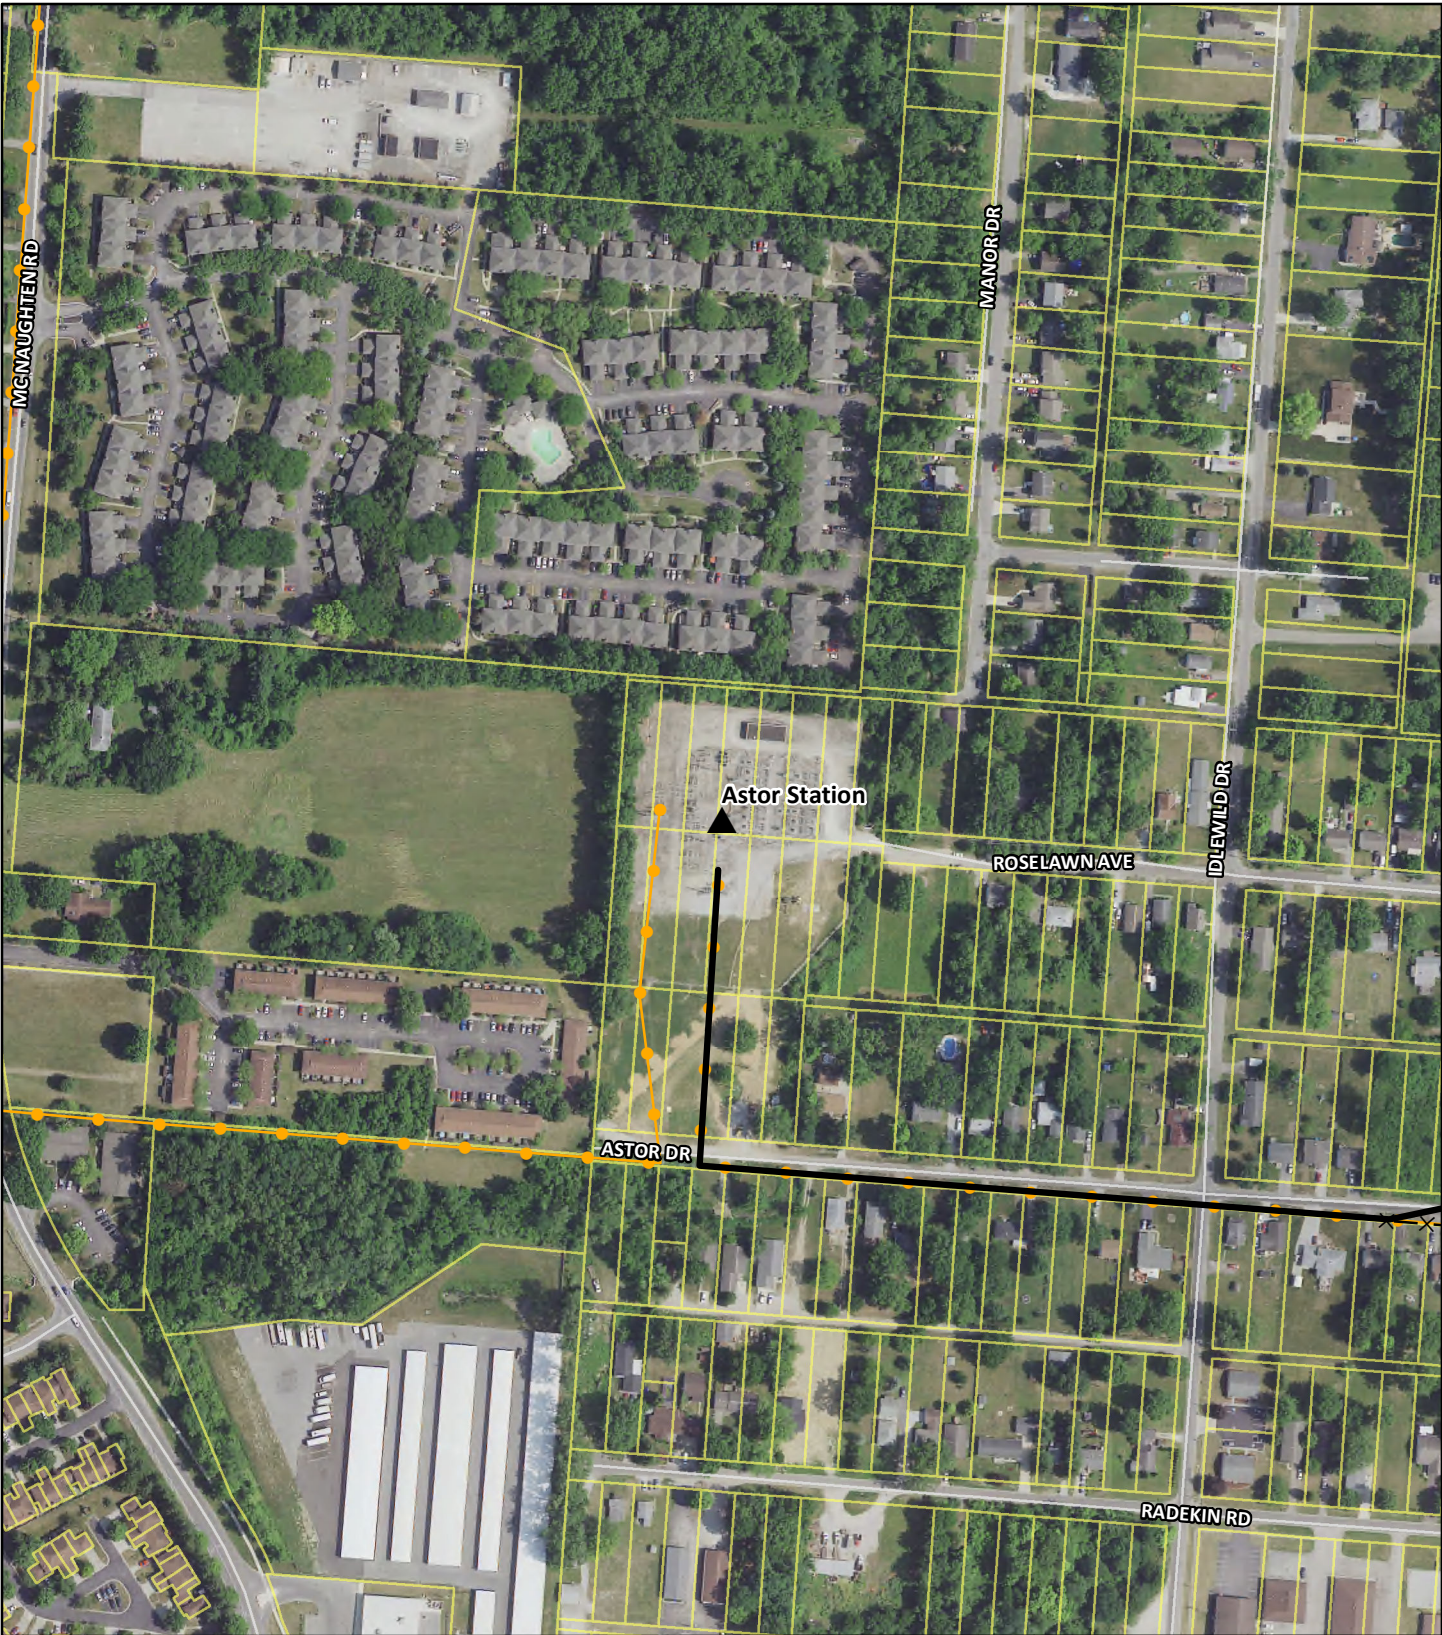
- ▲ Existing Substation
- Proposed Shannon - Astor
138 kV Transmission Line
Rebuild
- Existing 138 kV Transmission
Line
- Parcel Boundary

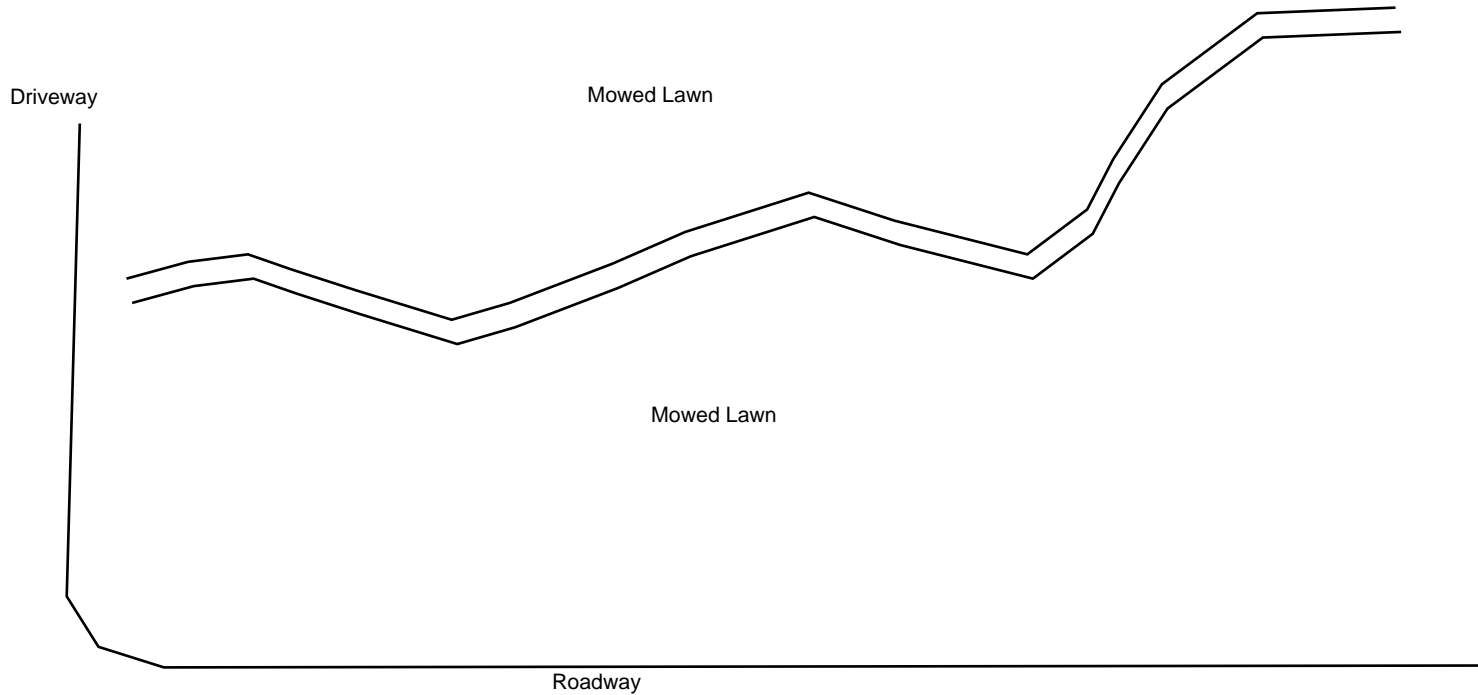
Stream Drawing:

- AREA DEPTH
 POOL: >100ft² >3ft
