CONSTRUCTION NOTICE FOR HARMAR HILL 138- kV SWITCH INSTALL PROJECT

PUCO Case No. 21-0266-EL-BNR

CONSTRUCTION NOTICE
AEP Ohio Transmission Company, Inc. (AEP Ohio Transco)
Harmar Hill 138-kV Switch Install Project

The existing lattice frame switch will be replaced with a steel monopole phase-over-phase switch. The location of the Project is shown on Figure 1 in Appendix A.

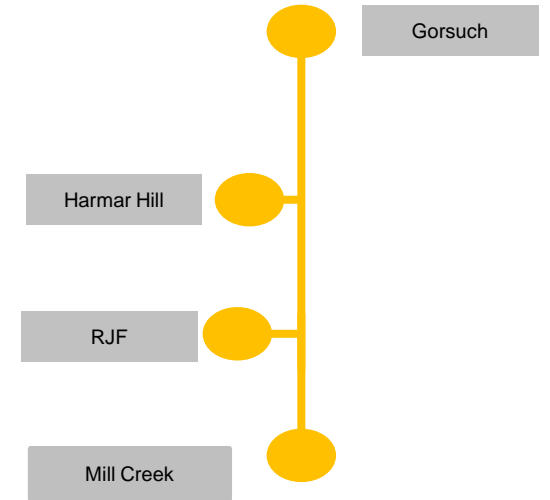
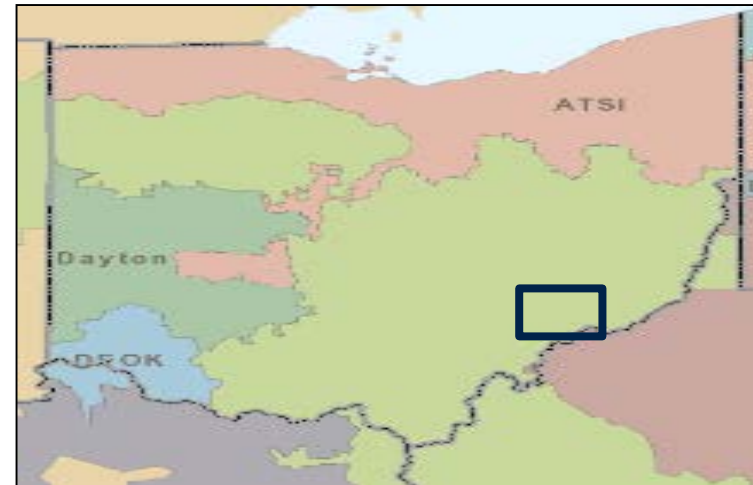
RJF is a customer owned substation that is served off a 138kV hard tap. Harmar Hill is served from a tap with a one way switch. Any line work along between Mill Creek and Gorsuch causes considerable outages to both customer loads. There is limited transfer capability at Harmar Hill and no transfer capability for RJF. AEP's internal guidelines justify sectionalizing on this line (FOI: 10.17).

Mill Creek will be replaced by a new substation Devola as part of an unrelated project (S1125).

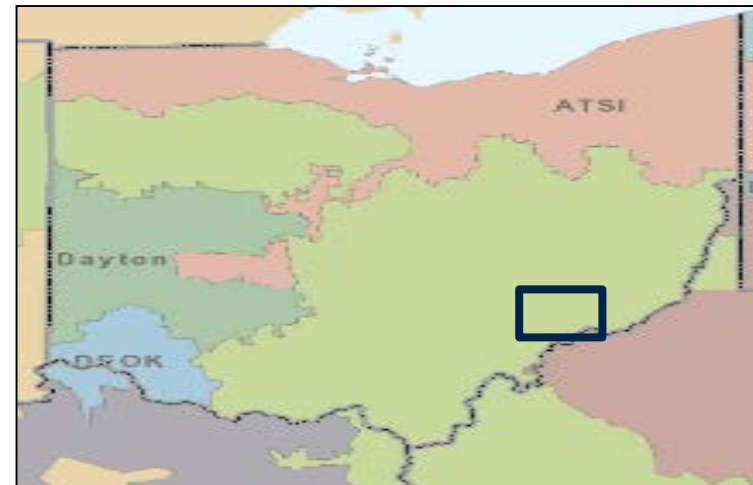
Install a 3-way, SCADA-controlled phase-over-phase switch at Harmar Hill to replace the one-way line switch on the Gorsuch – Mill Creek 138 kV circuit.

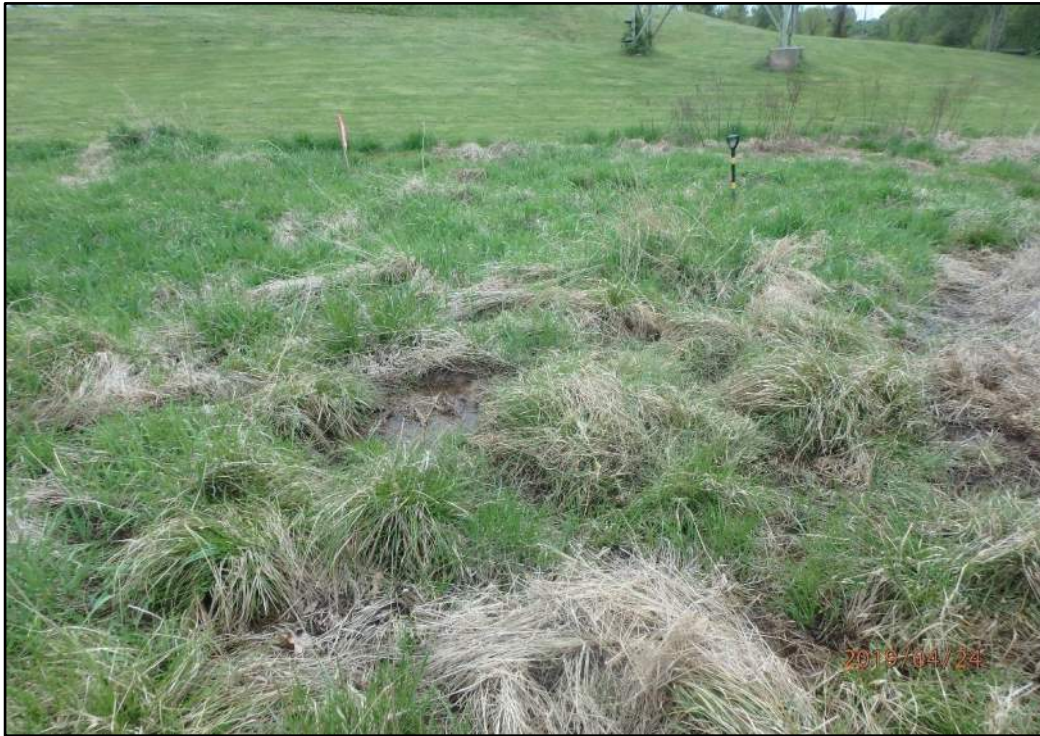
Photograph 1. Wetland W001-PEM-CAT1, Facing North

One (1) PEM wetland was identified and delineated within the Project study. In order to document site conditions, USACE Data Forms were completed for the wetland and upland reference. Information on the delineated wetland can be found in Table 1 and photographs of the wetland is included in Appendix A.

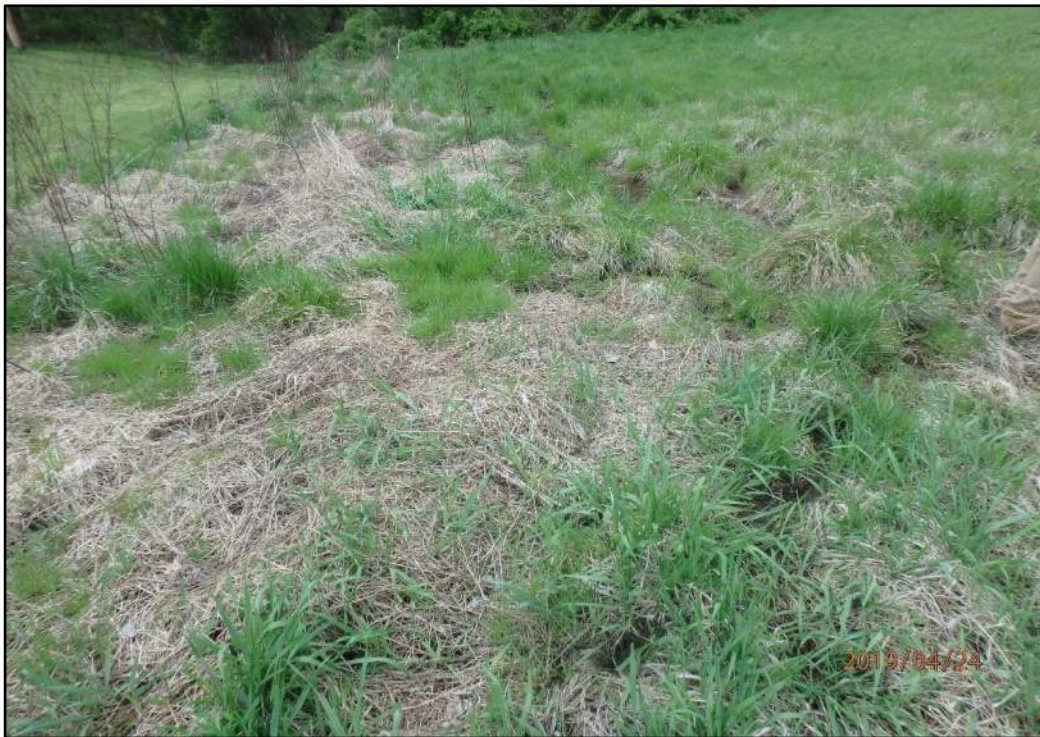
Photograph 2. Wetland W001-PEM-CAT1, Facing West

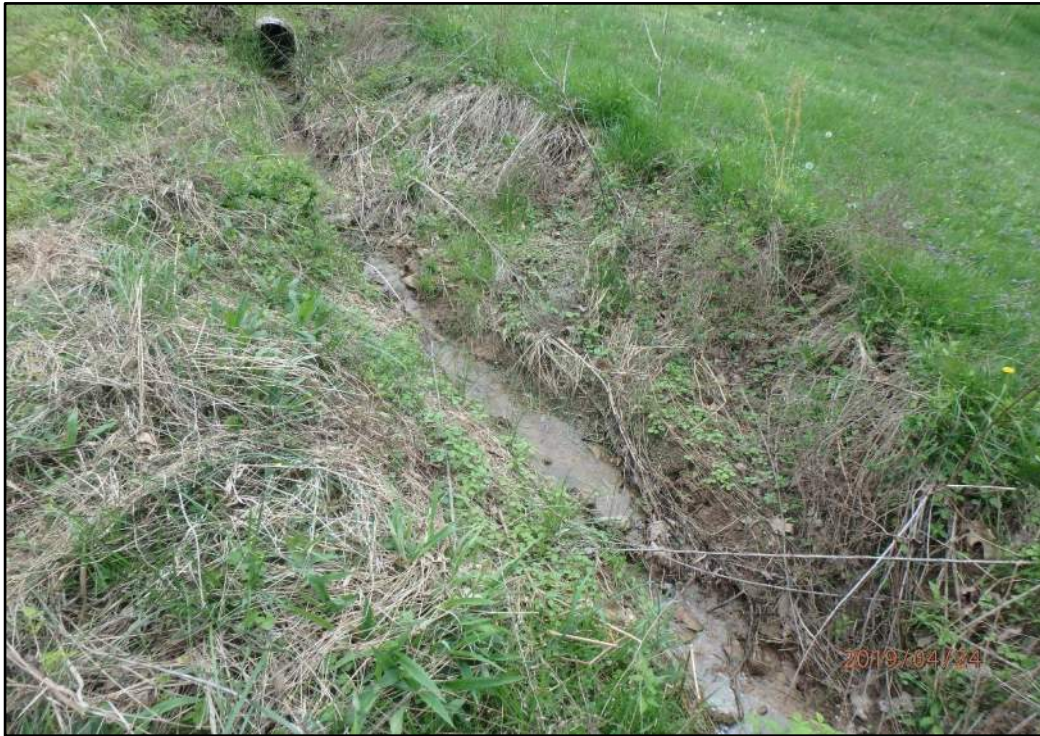
Photograph 3. Stream S001, Upstream, Facing East

Four (4) stream segments were identified and delineated within the Project study area. All four stream segments were classified as having an intermittent flow regime. Information on the delineated waterbodies and their classifications can be found in Table 2, and photographs of the identified streams are included in Appendix A.

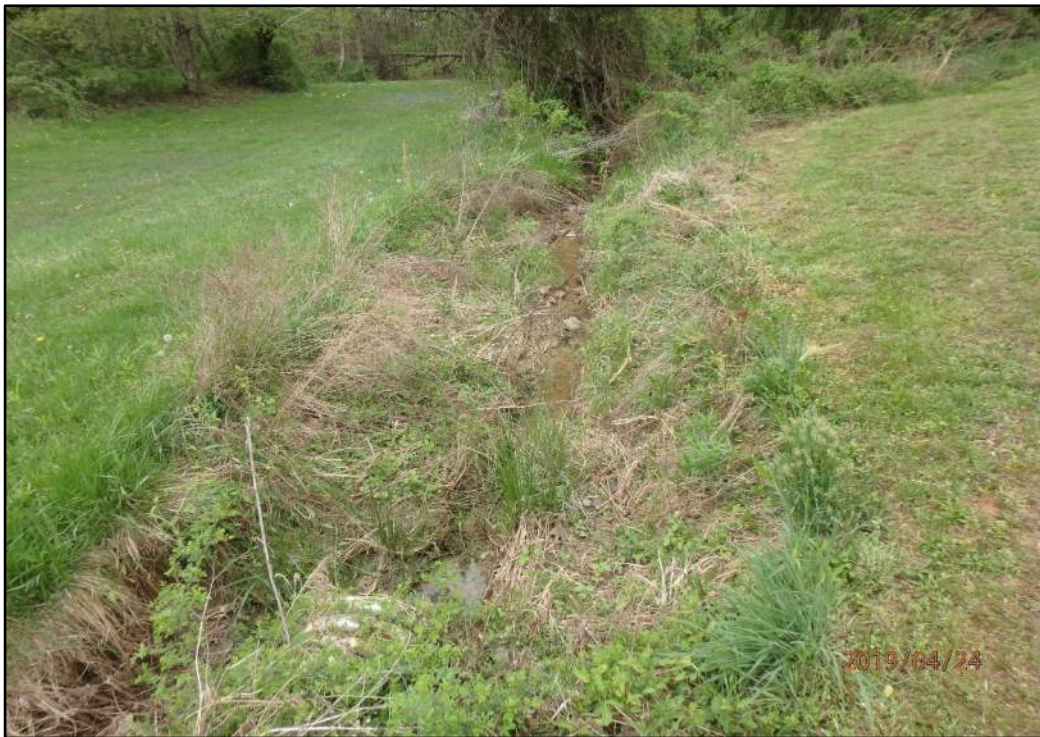
Photograph 4. Stream S001, Downstream, Facing West

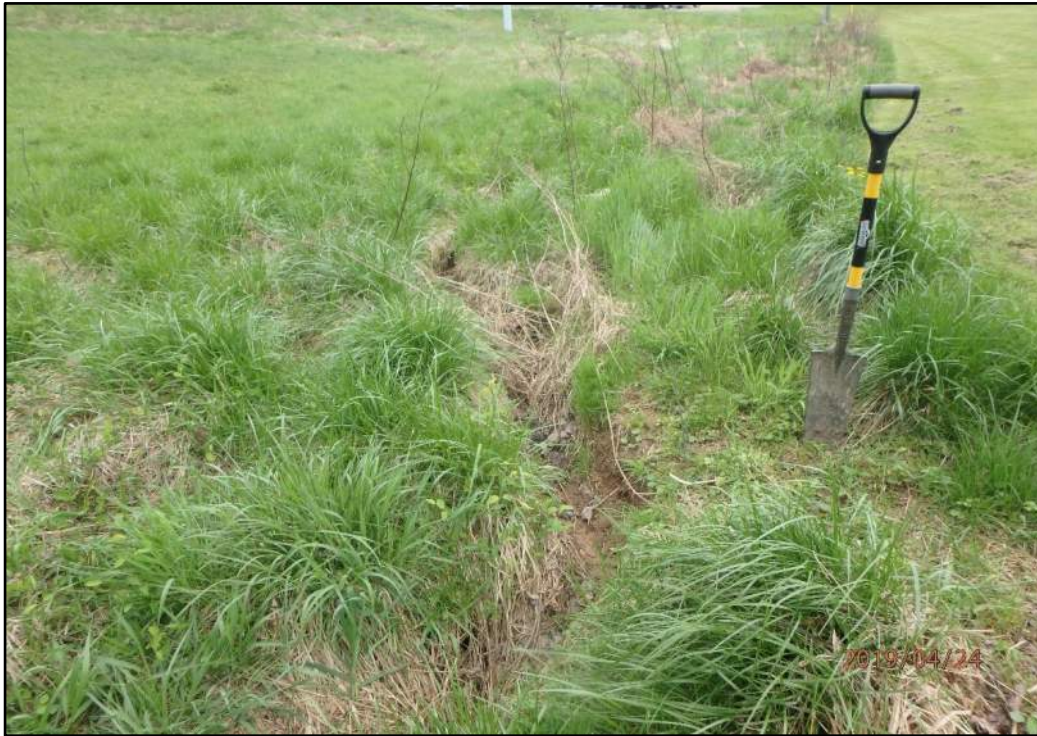
Photograph 5. Stream S002, Upstream, Facing Northeast

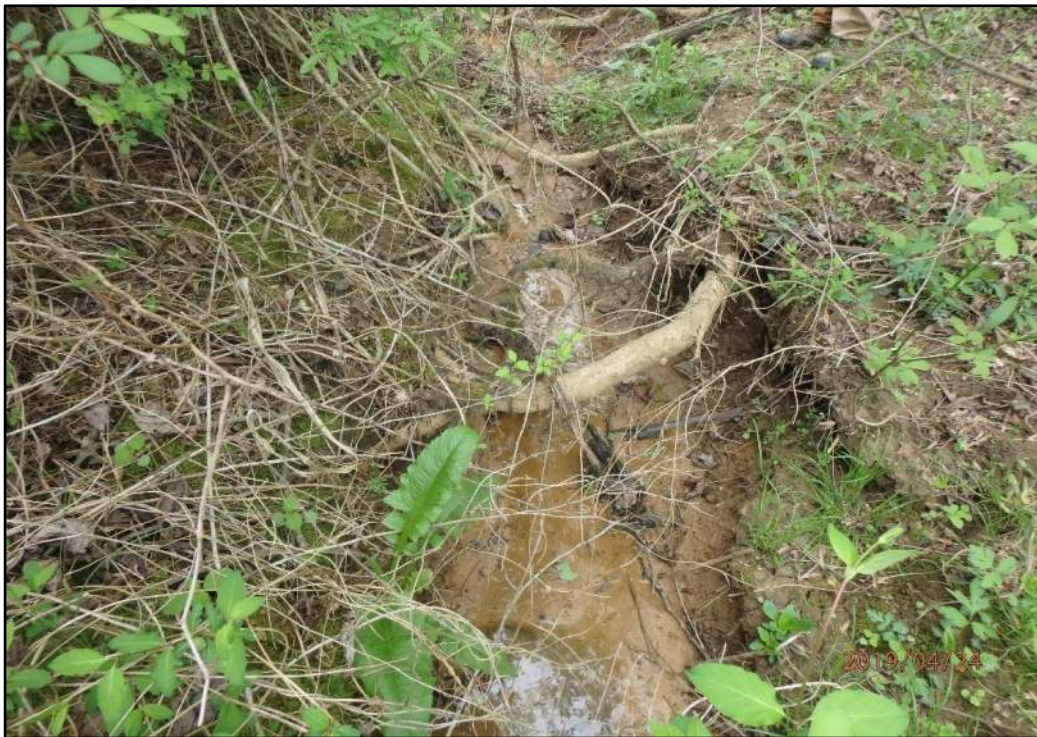
Photograph 6. Stream S002, Downstream, Facing Southwest

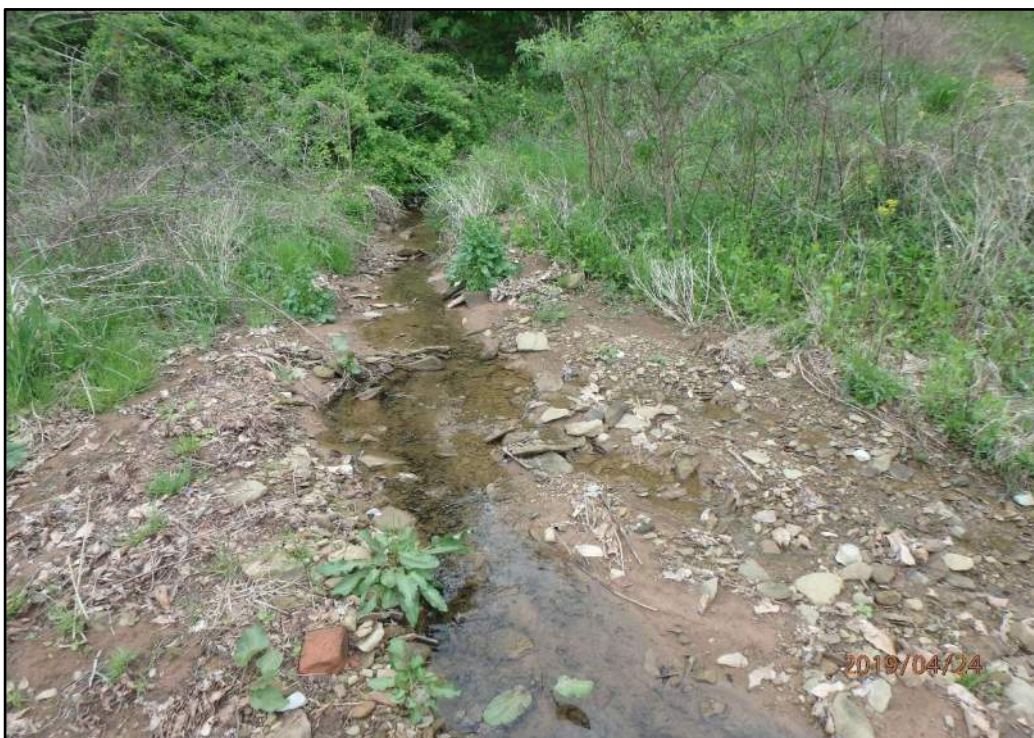
Photograph 7. Stream S003, Upstream, Facing West

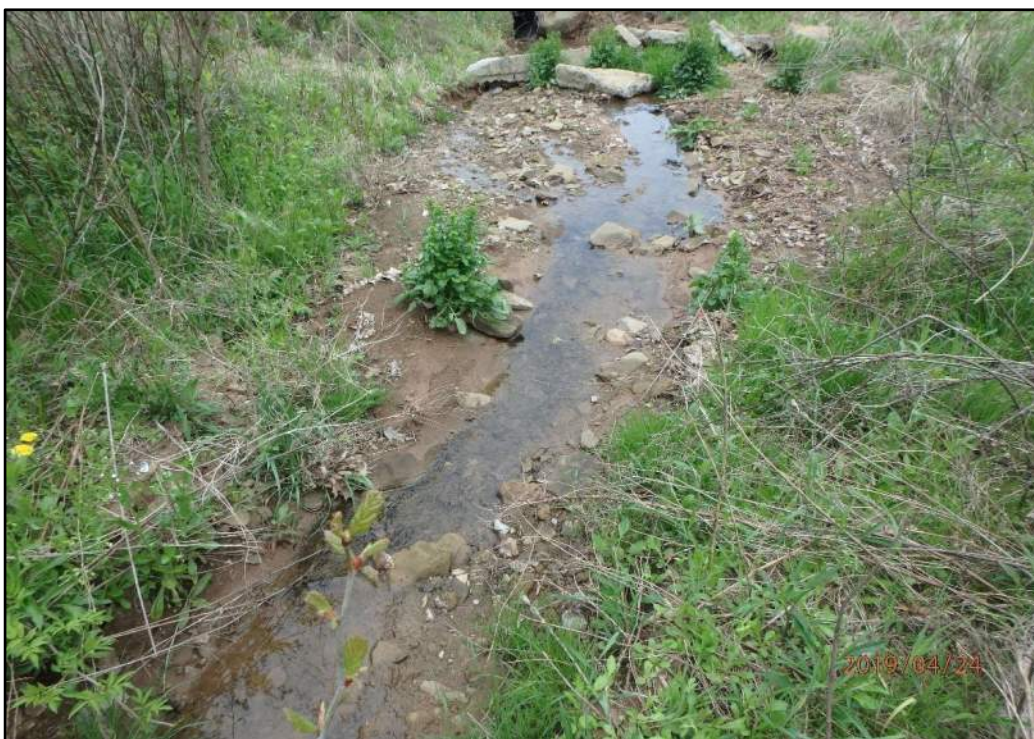
Photograph 8. Stream S003, Downstream, Facing East

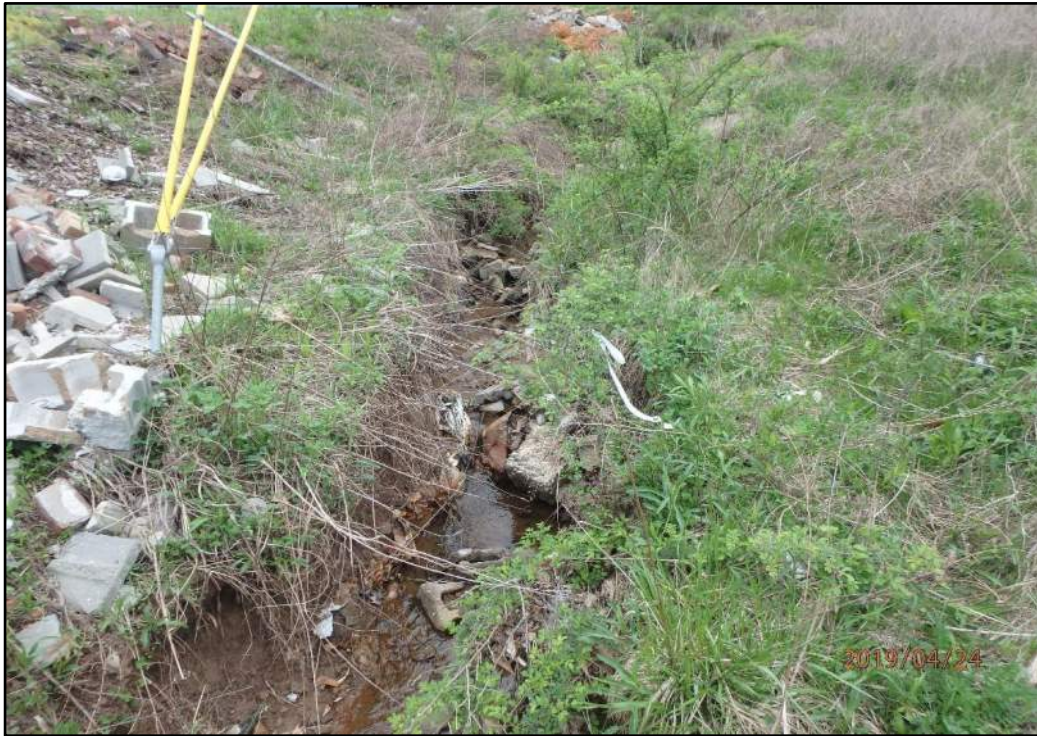
Photograph 9. Stream S004, Upstream, Facing South

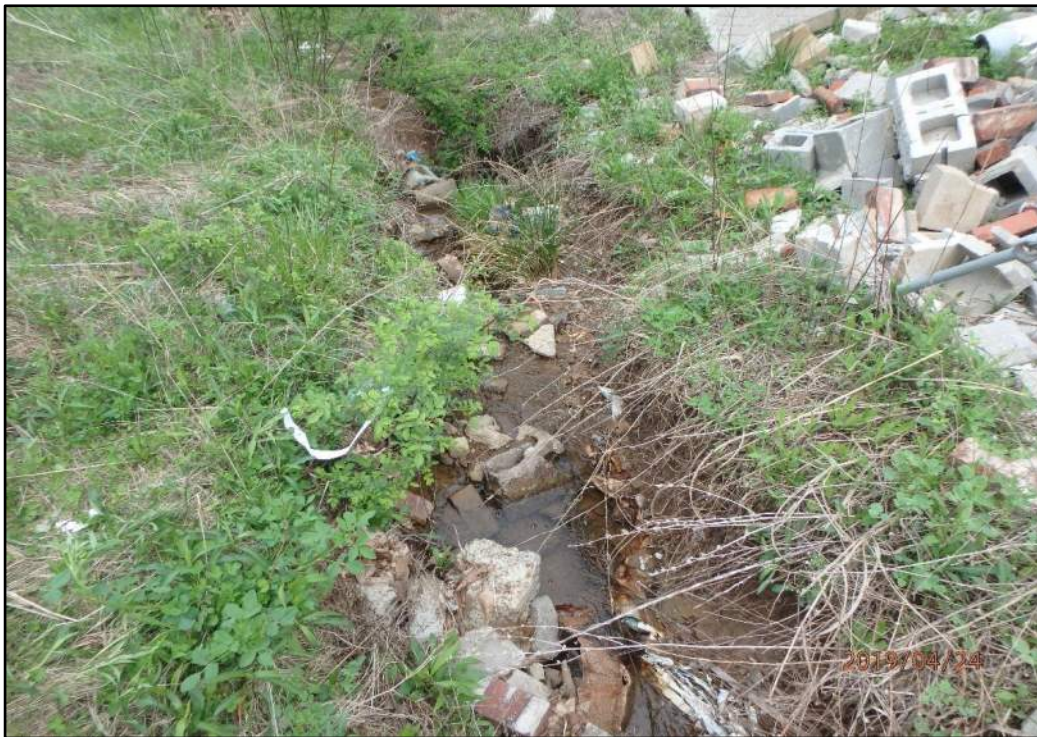
Photograph 10. Stream S004, Downstream, Facing North
