Construction Notice Mount Perry Extension 138 kV Transmission Line Project

PUCO Case No. 23-1053-EL-BNR

December 8, 2023

Ohio Power Company Mount Perry Extension 138 kV Transmission Line Project

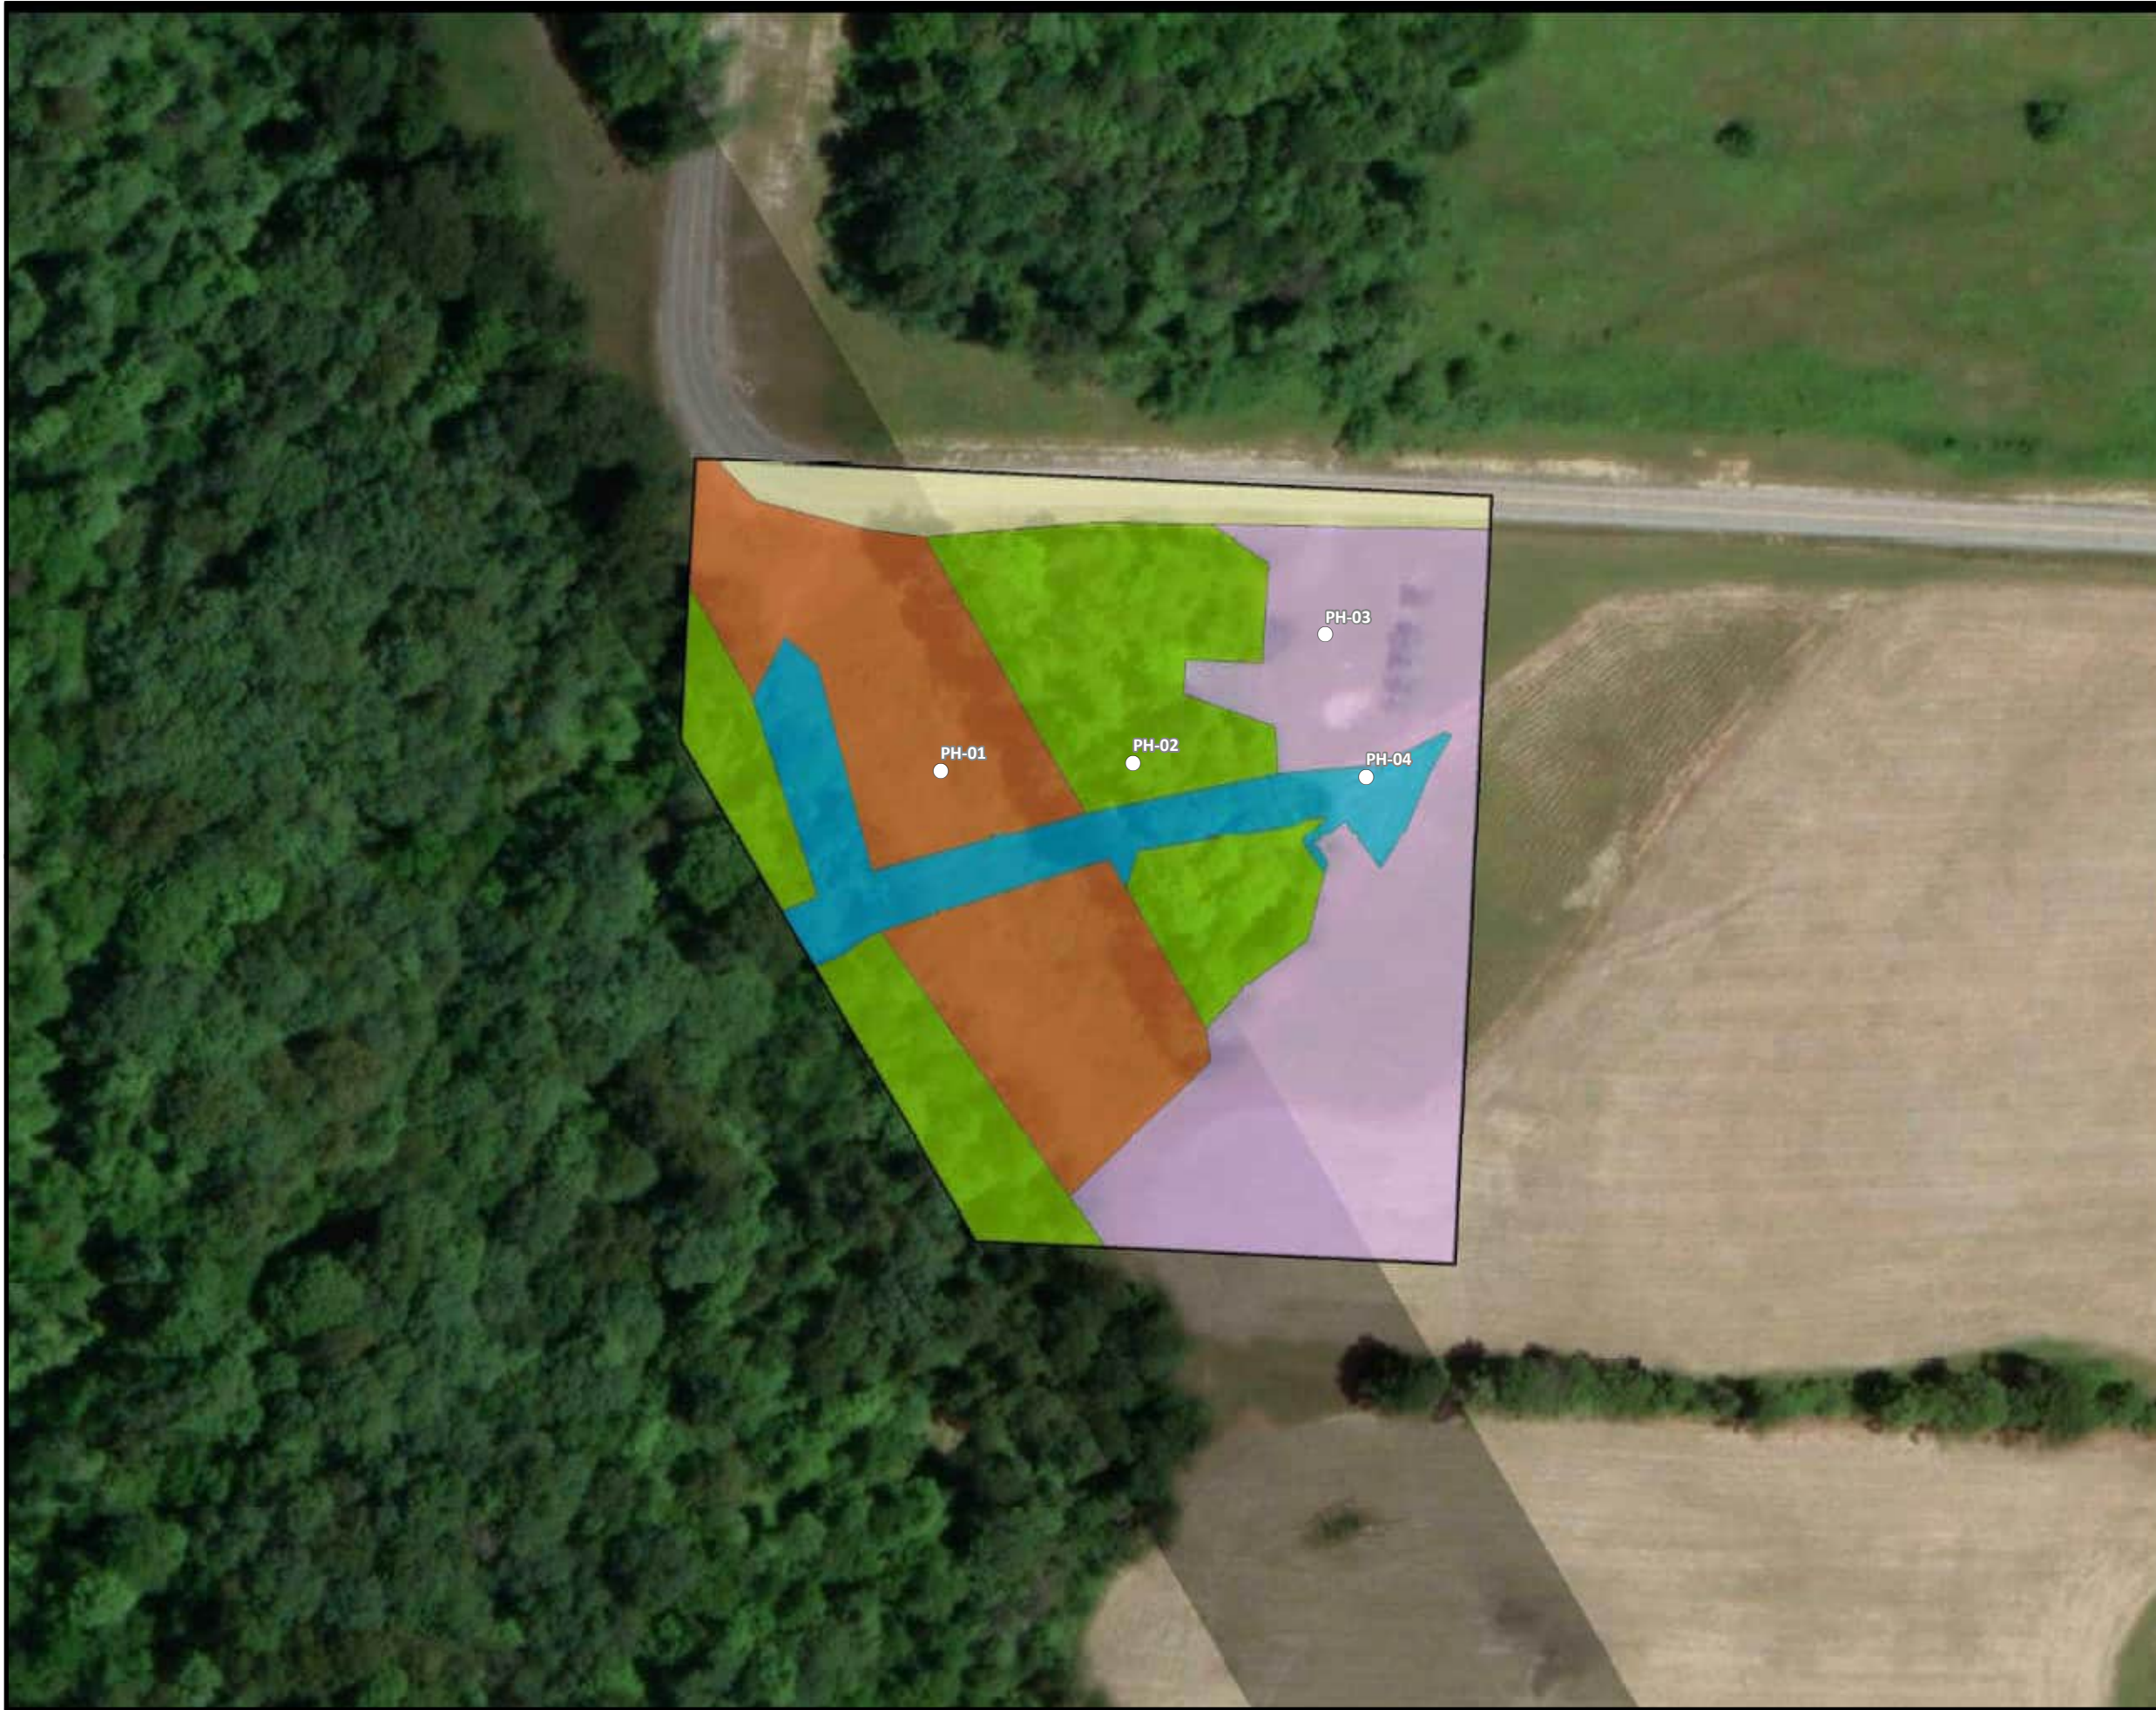
FIGURE 5
VEGETATIVE COMMUNITIES
ASSESSMENT MAP

- Legend**
- Photo Location
 - ▭ Project Survey Area
 - ▭ Crooksville-North Newark Survey Area
- Vegetative Community Type**
- Woodland
 - Pasture/Hay-Field
 - Scrub-Shrub
 - Stream/Wetland
 - Urban

Fish							
Lake Chubsucker (<i>Erimyzon sucetta</i>)	Threatened	None	Habitats include shallow riffles and shoals of major rivers and tributaries in gravel or sand substrates.	No potentially suitable habitat was observed for this species.	N/A	DOW recommends no in-water work in perennial streams from March 15 through June 30 to reduce impacts to this species.	No potentially suitable habitat was observed for this species, and no in-water work is proposed.
Birds							
Northern harrier (<i>Circus hudsonius</i>)	Endangered	None	This species hunts over grasslands and nests can be found in large marshes and grasslands.	No potentially suitable habitat was observed for this species	N/A	ODNR stated that if this type of habitat will be impacted, construction should be avoided in the habitat during the species' nesting period of April 15 to July 31.	No potentially suitable habitat was observed within the Project survey area (Figure 5).

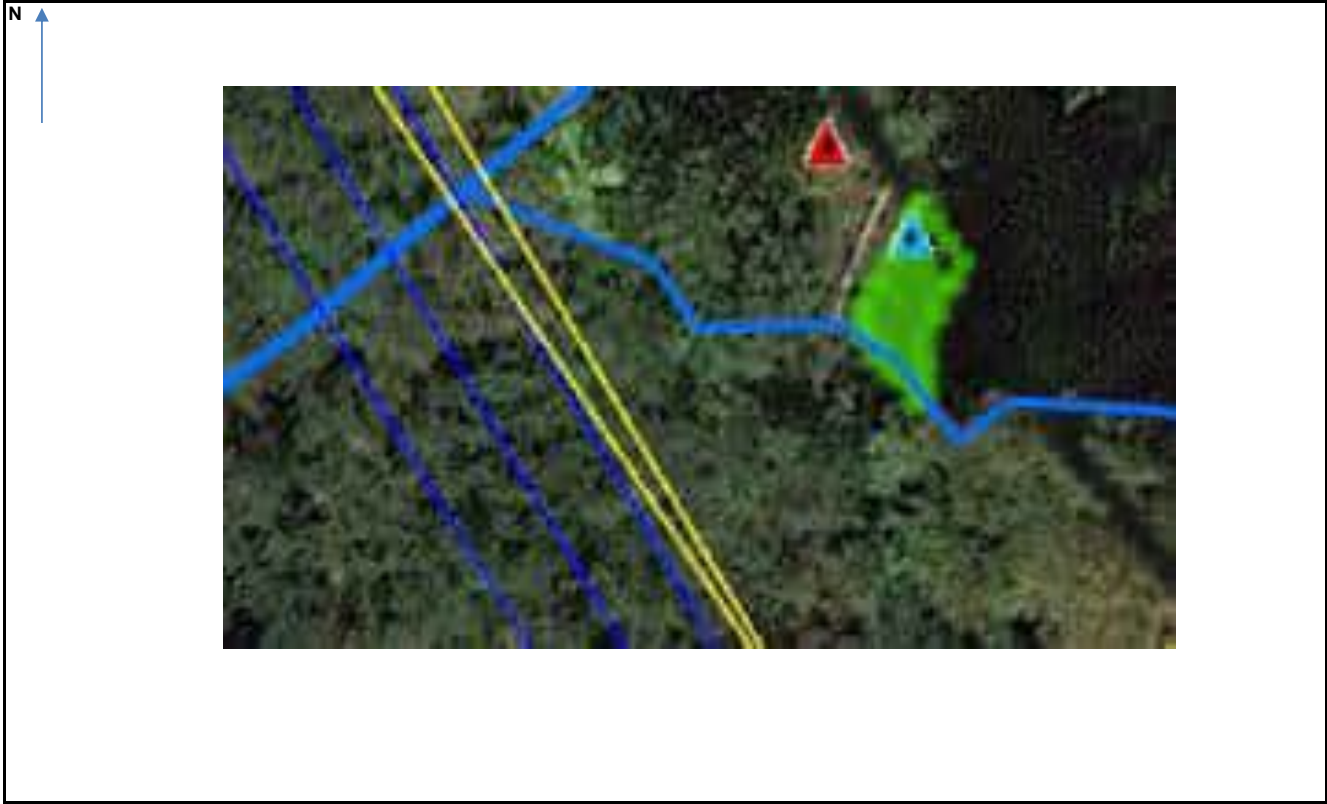
Small wetland abutting a stream. Adjacent to an existing powerline ROW.
