APPLICATION FOR APPROVAL AND CERTIFICATION OF  
ELECTRICAL TRANSMISSION LINE

Central Virginia Transmission  
Reliability Project

# **VDEQ SUPPLEMENT**

**Component 2:  
James River 138-kV Substation**

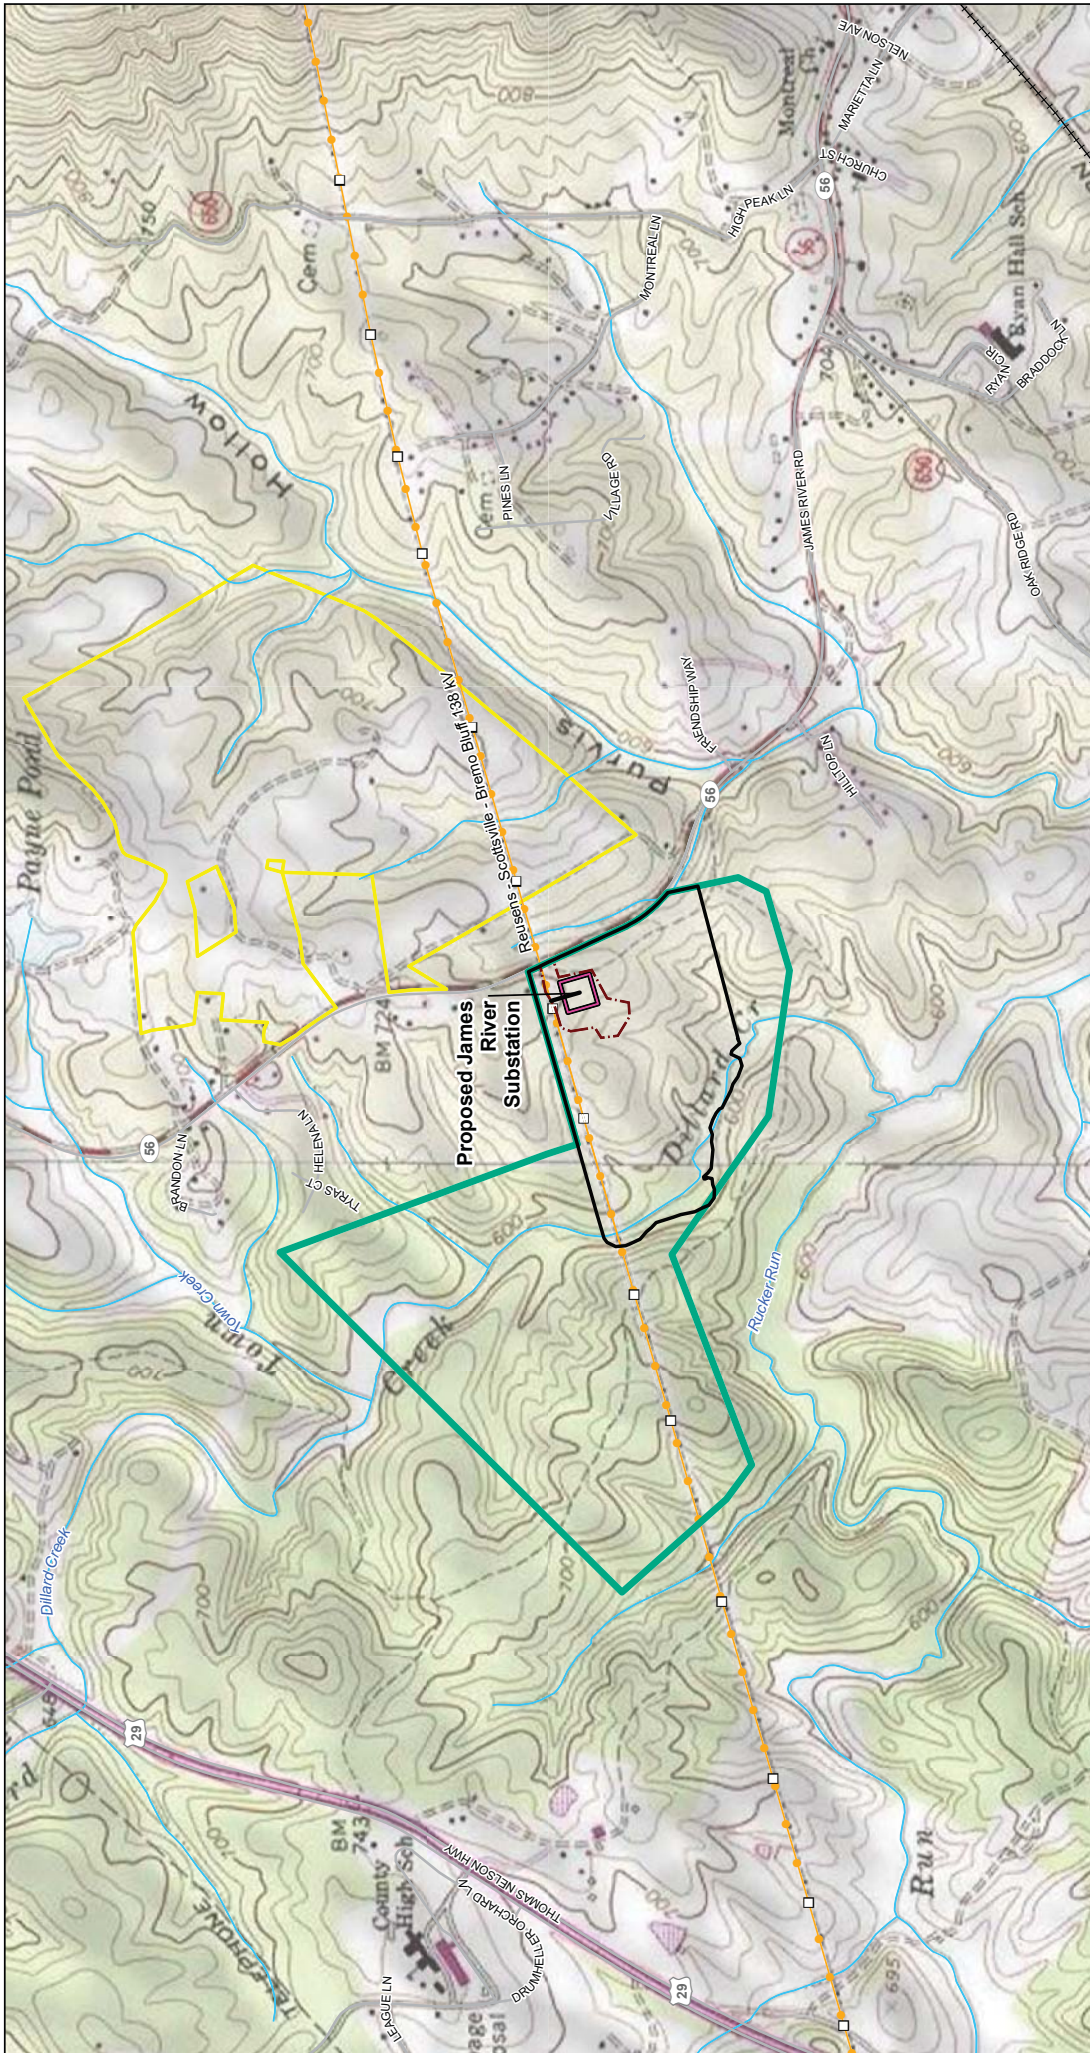
**FIGURE 1 PROJECT LOCATION**

Figure 1: Project Location

The Project consists of the construction of a new substation on a parcel that Appalachian currently has a signed option to purchase. Activities associated with the proposed Project include clearing and grading at the site, and construction of a new substation. Construction of the proposed substation is scheduled to start in April 2023, with the substation anticipated to be in-service by December 2023. An overall Project Location map can be found in **Figure 1: Project Location**.

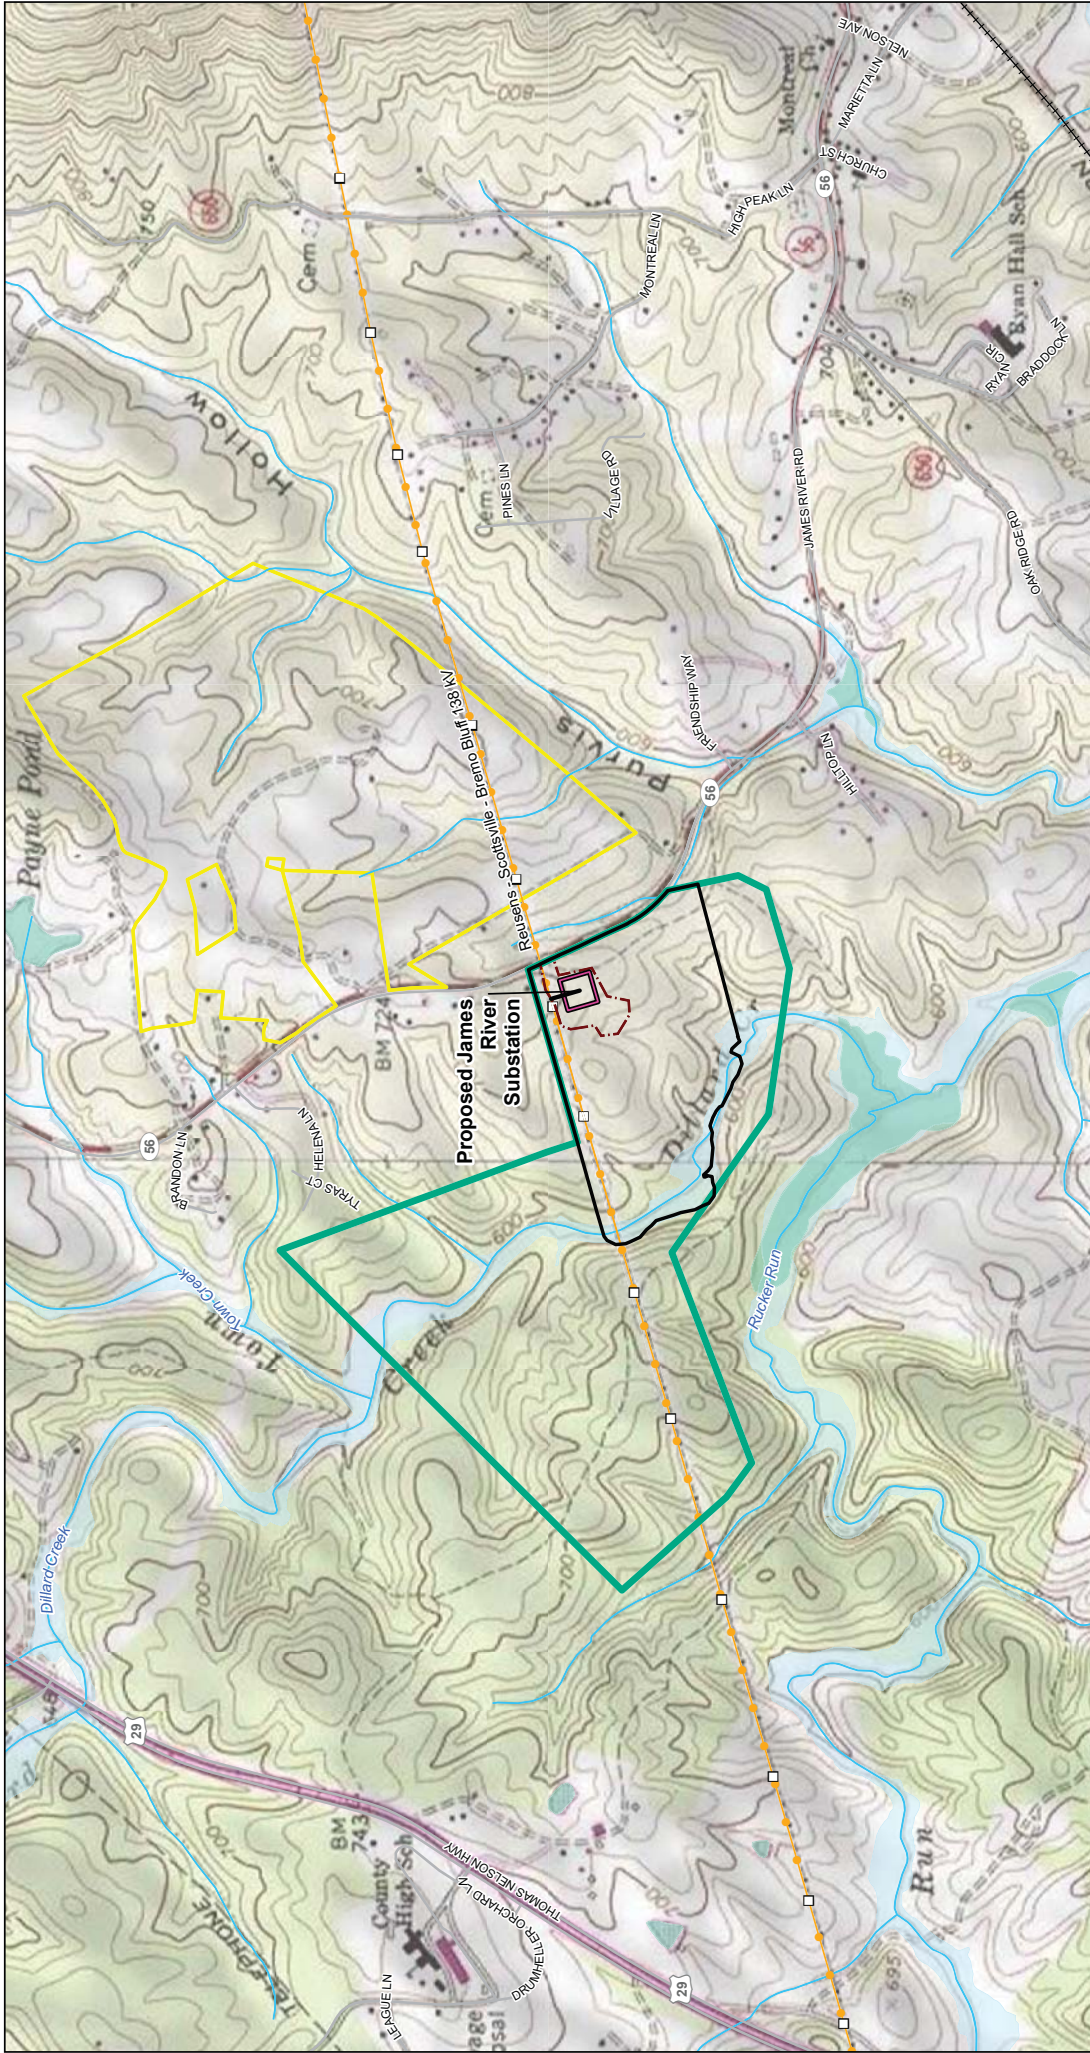
**FIGURE 2 FLOODPLAINS AND NWI WETLANDS**

**Figure 2: Floodplain and NWI Wetlands**

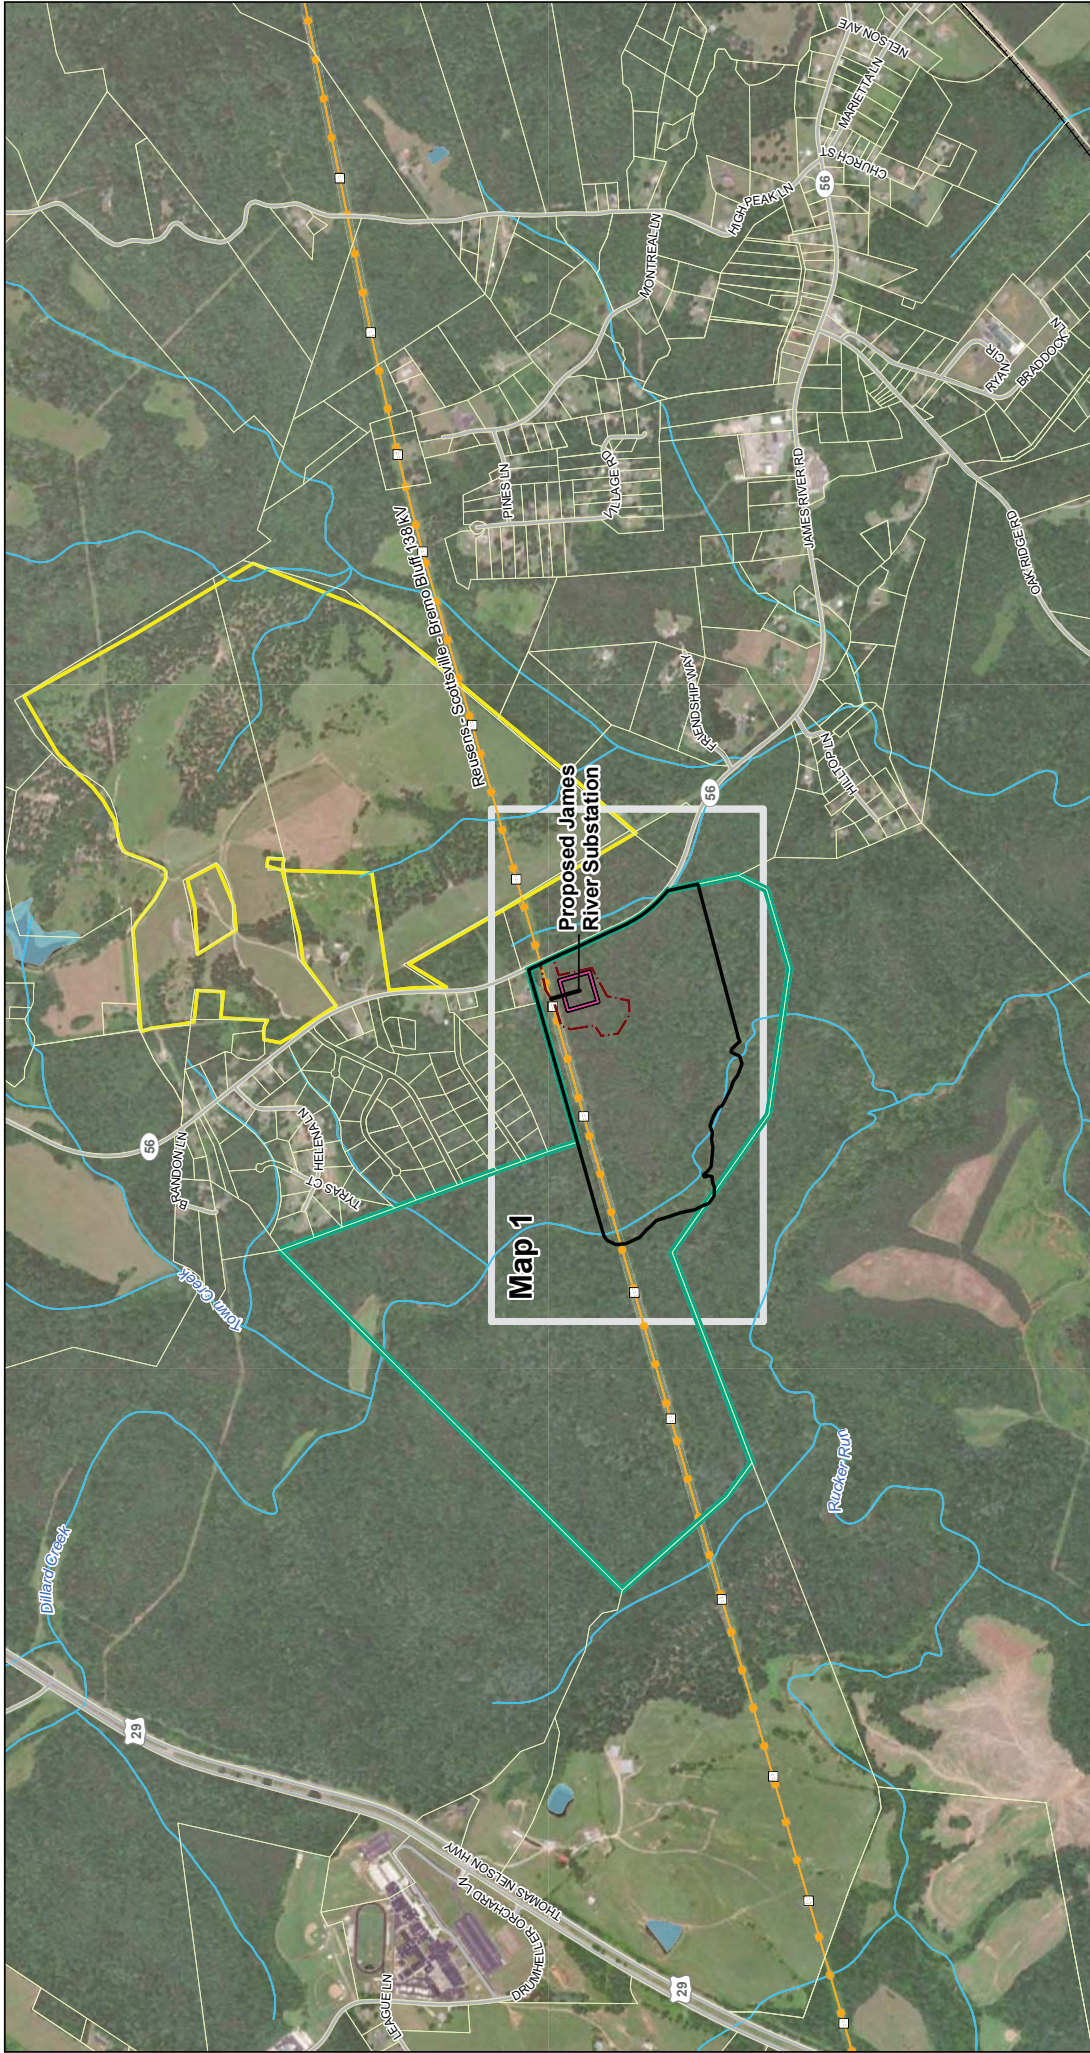
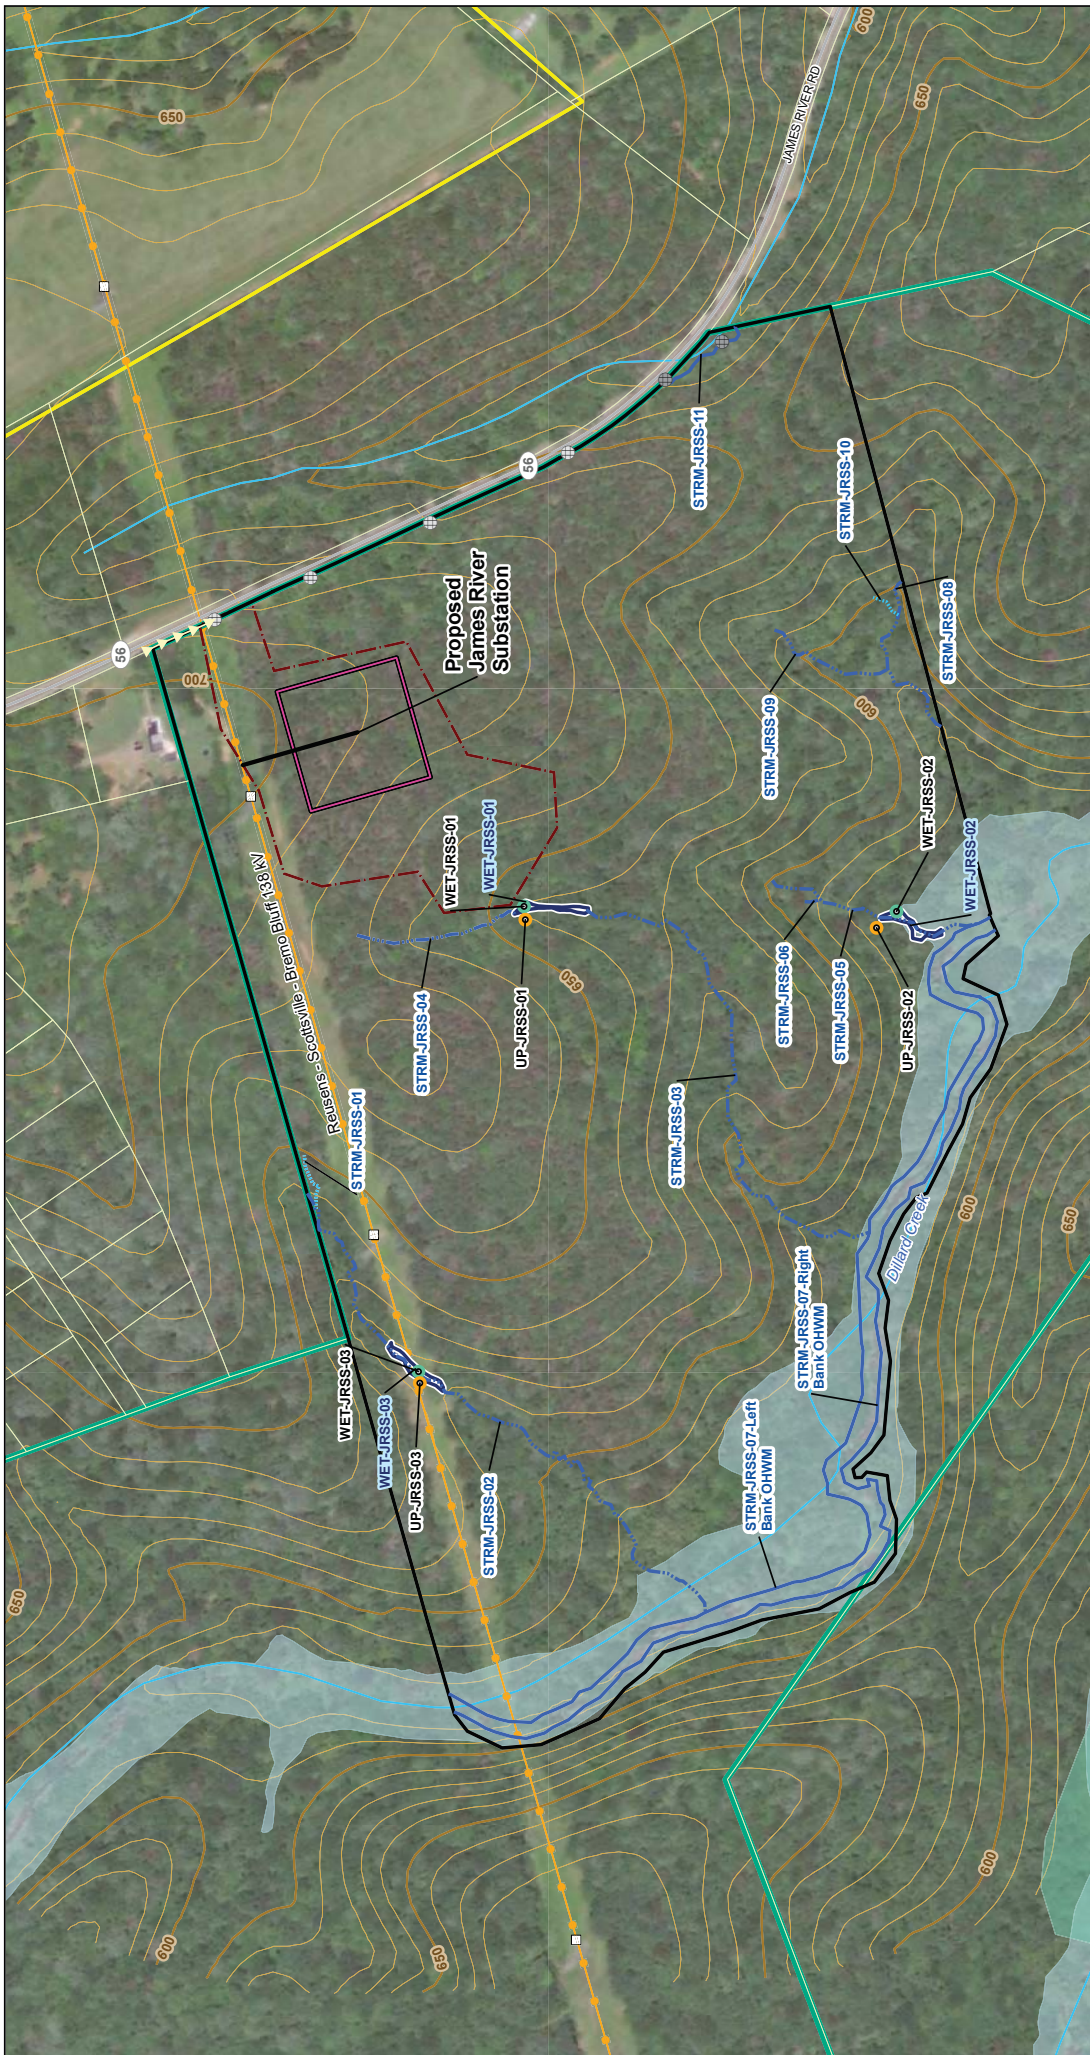
**FIGURE 3 RESOURCE LOCATION**

Figure 3: Resource Location

POWER biologists identified three wetlands totaling 0.11 acre within the Survey Area (shown on **Figure 3: Resource Location**). Details of these wetlands can be found in Table 1 of Attachment A. Representative photographs of these wetlands can be found in Attachment B; the USACE Wetland Determination Data Forms for these wetlands can be found in Attachment C; and the corresponding Upland Data Forms can be found in Attachment D.

POWER biologists identified 11 streams within the Survey Area. The total length of delineated streams within the Survey Area is 6,931 linear feet (shown on **Figure 3: Resource Location**). Additional details on the streams can be found in Table 2 of Attachment A. Representative photographs of these resources can be found in Attachment B.

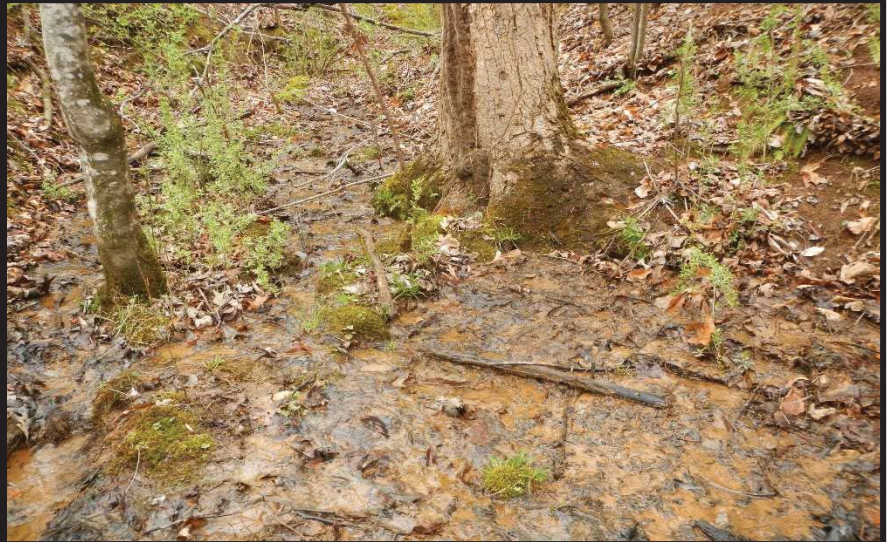
Direction of View:  
North

Date:  
March 23, 2020

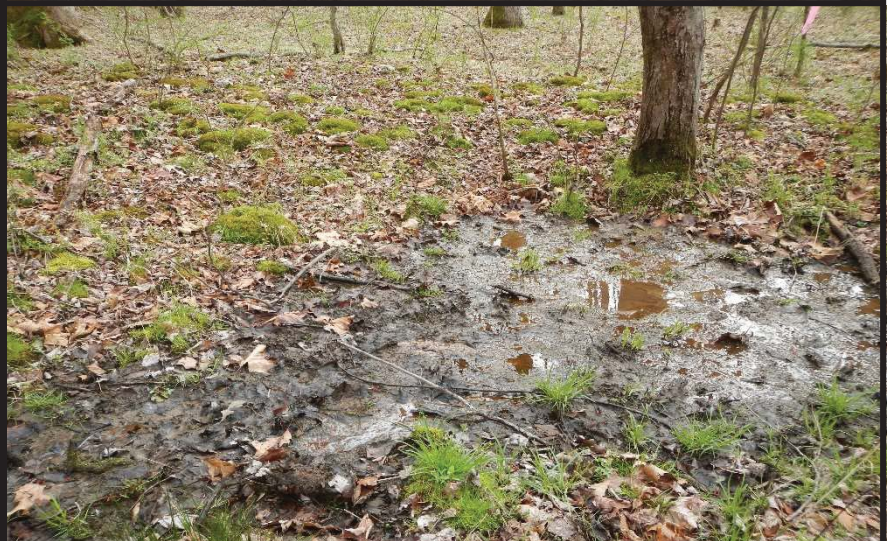
**Photograph 2:**

Wetland WET-JRSS-02 (Scrub-Shrub  
Wetland, PSS)

Direction of View:  
East

A direct hydrologic connection with an intermittent stream (STRM-JRSS-05) was observed in the field. Stream STRM-JRSS-05 flows through this wetland. This stream is likely a water of the US and Wetland WET-JRSS-02 is, therefore, likely jurisdictional.

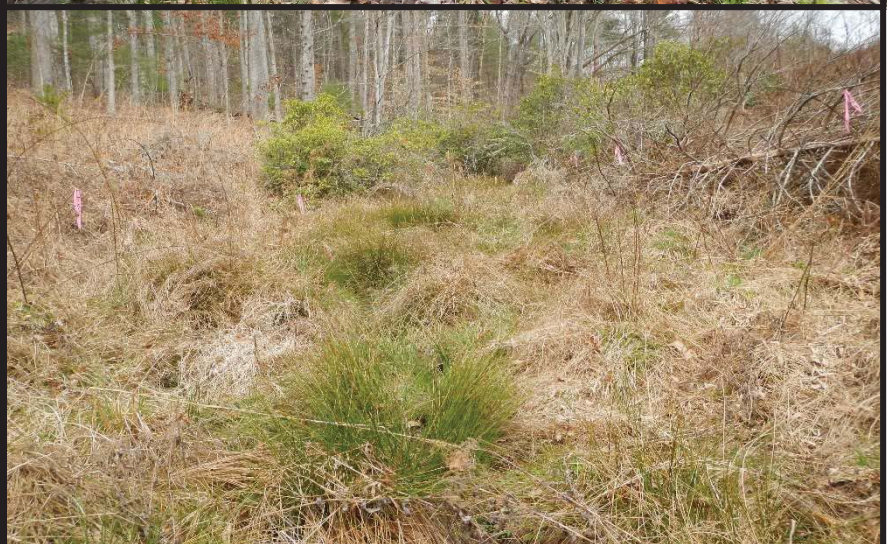
**Photograph 3:**

Wetland WET-JRSS-03 (Emergent  
Wetland, PEM)

Direction of View:  
Northeast

Remarks:  
 A direct hydrologic connection with an intermittent stream (STRM-JRSS-02) was observed in the field. Stream STRM-JRSS-02 flows through this wetland. This stream is likely a water of the US and Wetland WET-JRSS-03 is, therefore, likely jurisdictional.

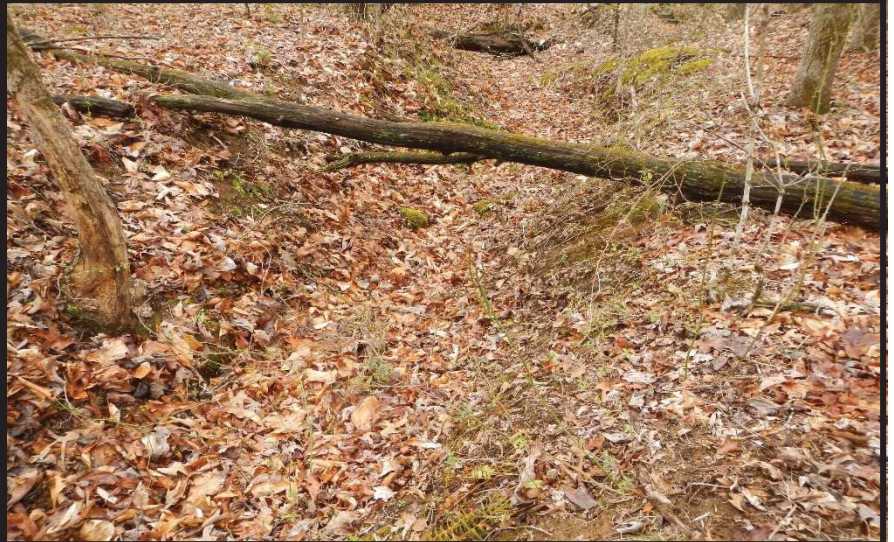
**Photograph 4:**

Stream STRM-JRSS-01 (Ephemeral Stream)

Direction of View:  
Downstream (West)

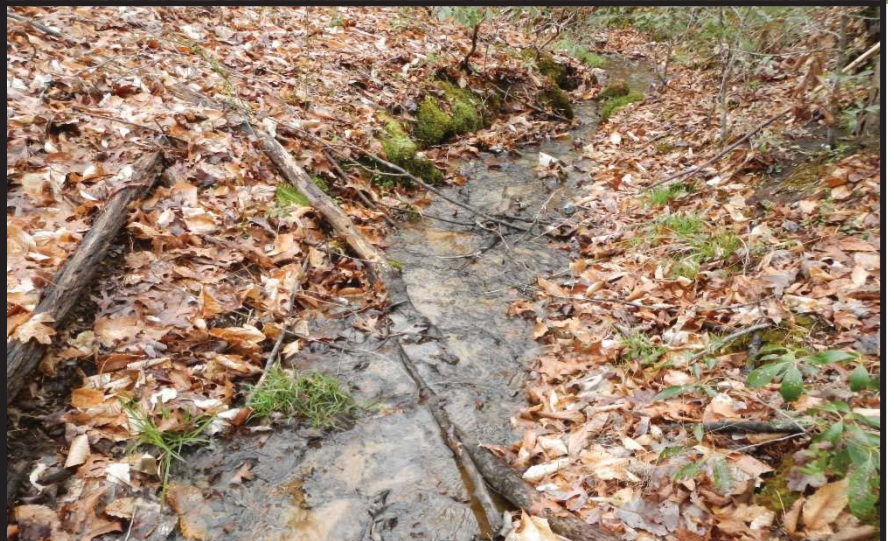
**Photograph 5:**

Stream STRM-JRSS-02 (Intermittent Stream)

Direction of View:  
Downstream (West)

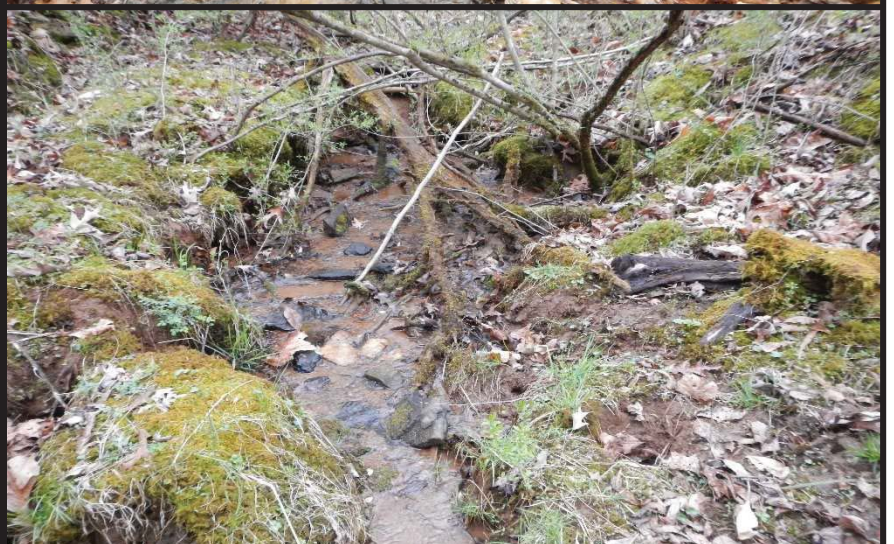
**Photograph 6:**

Stream STRM-JRSS-03 (Intermittent Stream)

Direction of View:  
Upstream (Northeast)

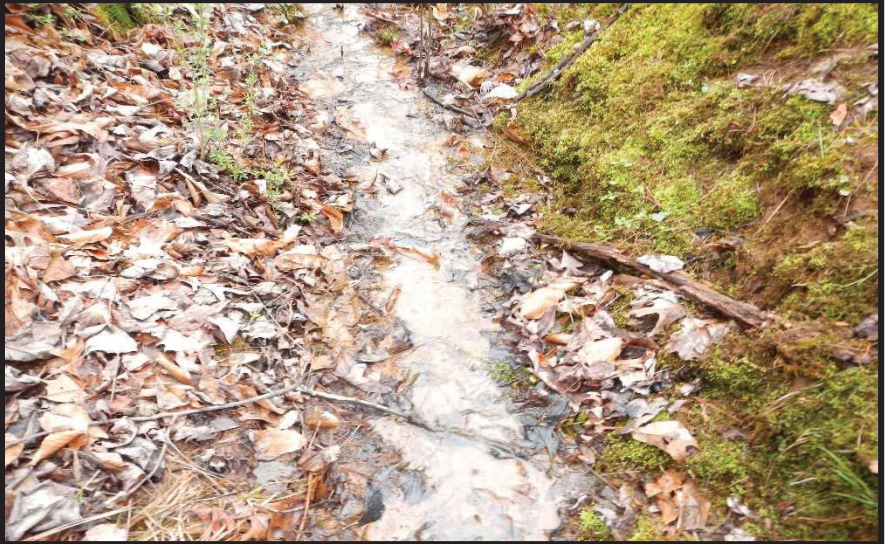
**Photograph 7:**

Stream STRM-JRSS-04 (Intermittent Stream)

Direction of View:  
Downstream (South)

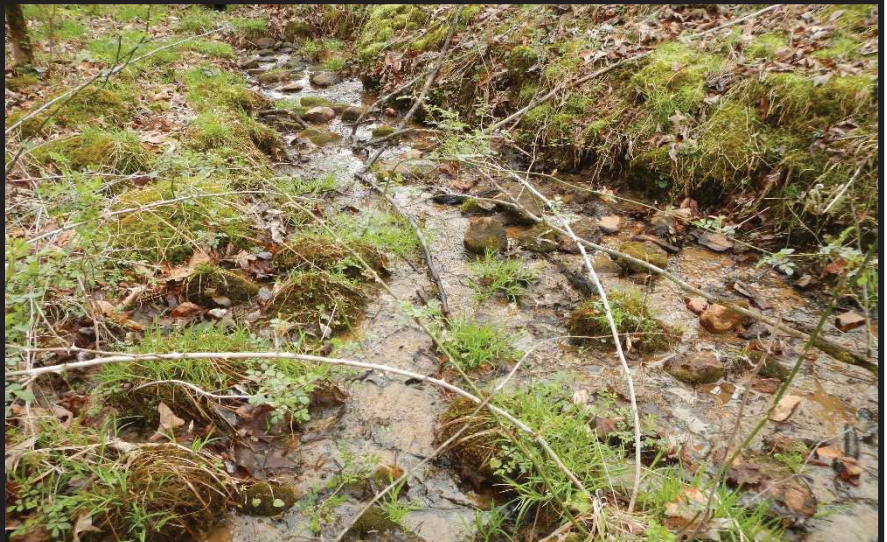
**Photograph 8:**

Stream STRM-JRSS-05 (Intermittent Stream)

Direction of View:  
Downstream (South)

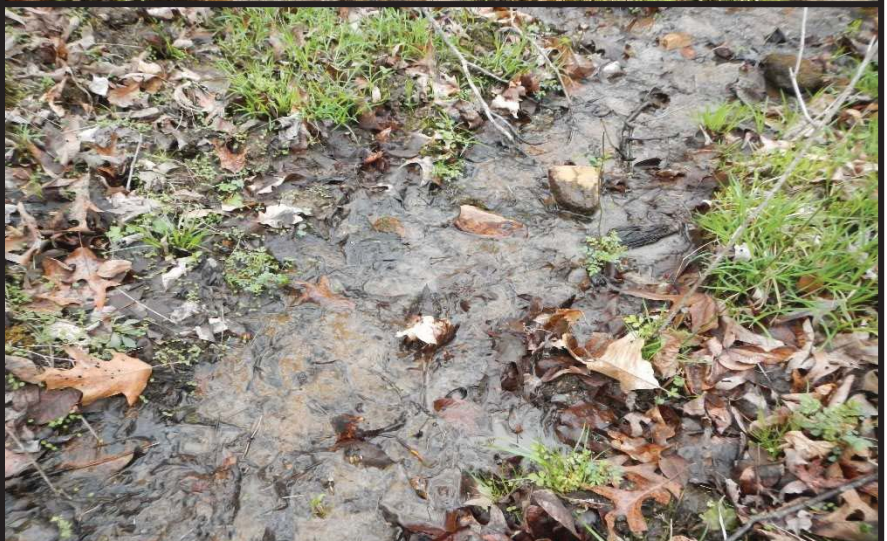
**Photograph 9:**

Stream STRM-JRSS-06 (Intermittent Stream)

Direction of View:  
Downstream (Southeast)

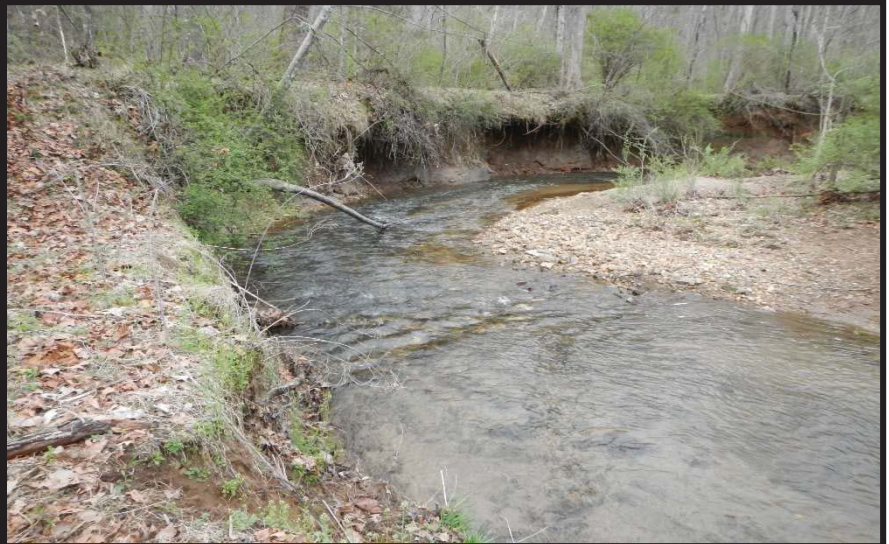
**Photograph 10:**

Stream STRM-JRSS-07 (Perennial Stream, Dillard Creek)

Direction of View:  
Downstream (Northeast)

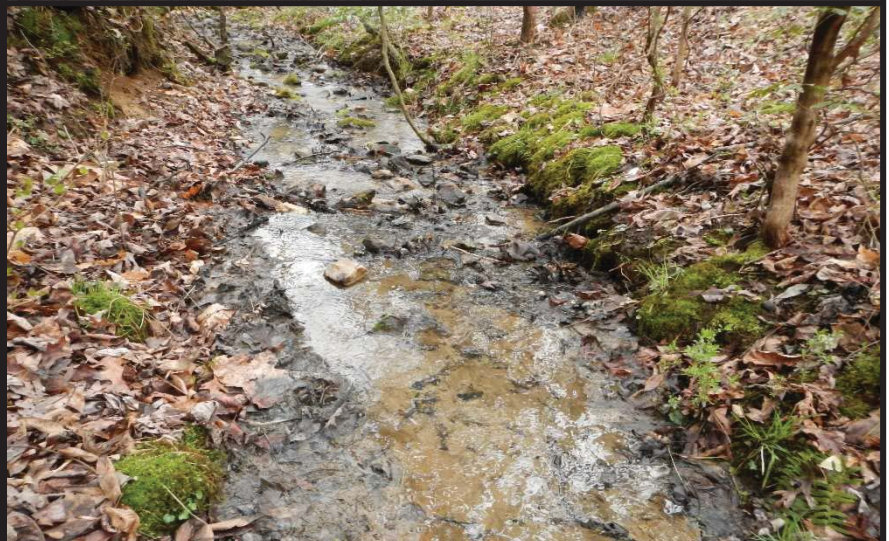
**Photograph 11:**

Stream STRM-JRSS-08 (Intermittent Stream)

Direction of View:  
Downstream (Southwest)

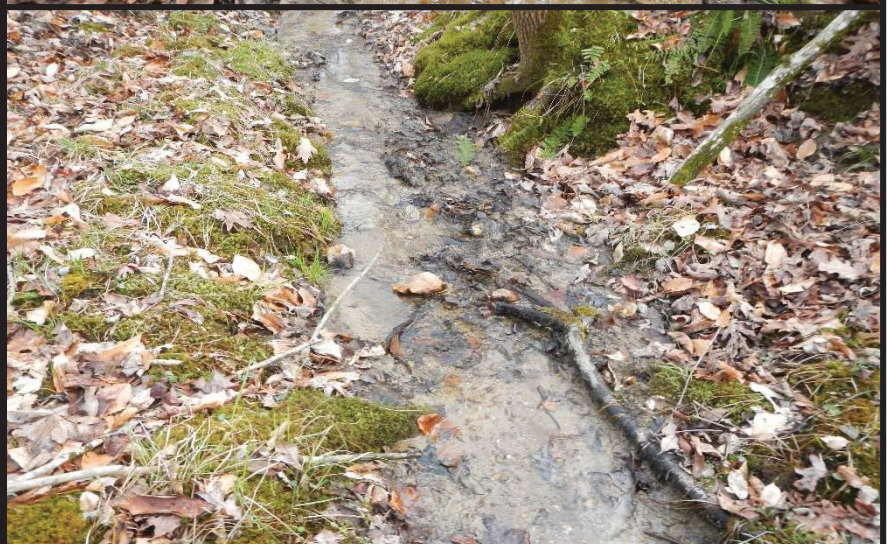
**Photograph 12:**

Stream STRM-JRSS-09 (Intermittent Stream)

Direction of View:  
Downstream (South)

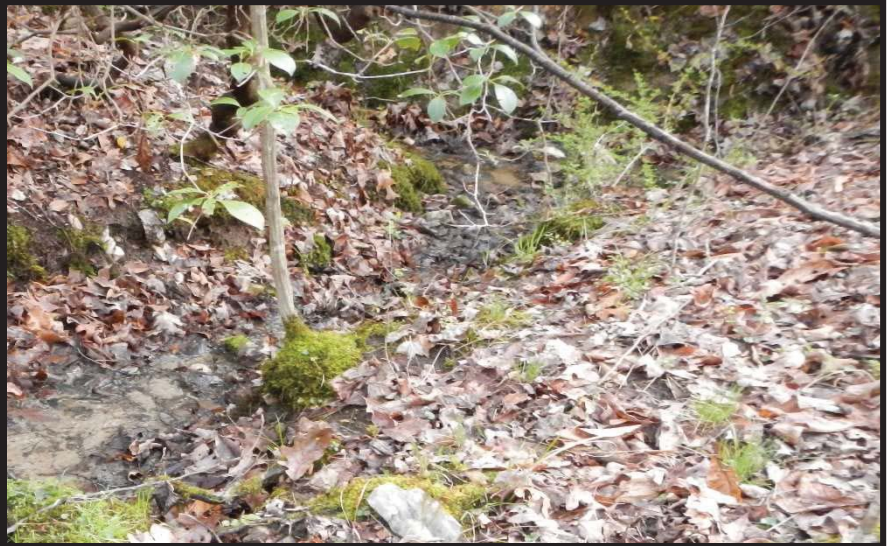
**Photograph 13:**

Stream STRM-JRSS-10 (Ephemeral Stream)

Note: This stream contained flowing water in the channel during the field survey on March 23, 2020, due to stormwater runoff resulting from approximately 0.39 inches of rainfall over the 24 hour period preceding the survey (precipitation data sourced from Weather Underground's historical dataset for Lynchburg, Virginia, located at [www.wunderground.com](http://www.wunderground.com)).

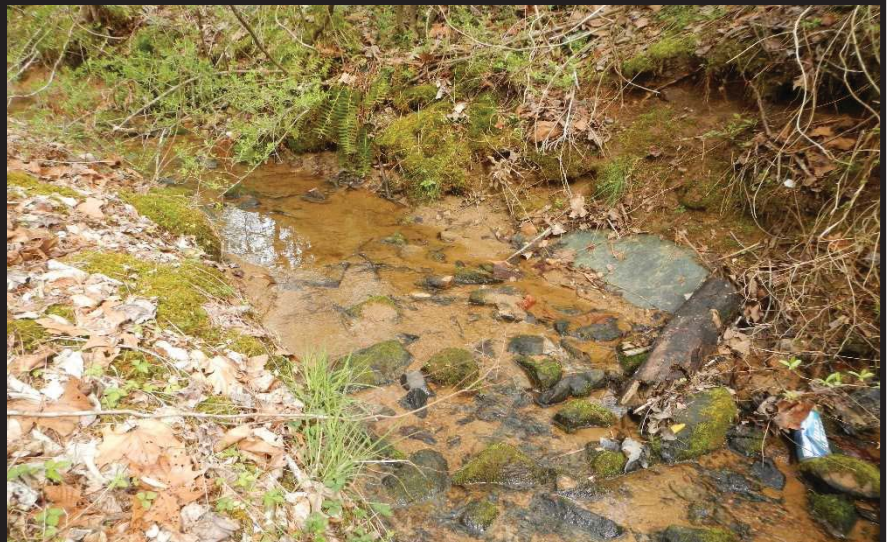
**Photograph 14:**

Stream STRM-JRSS-11 (Perennial Stream)

Direction of View:  
Upstream (Northwest)

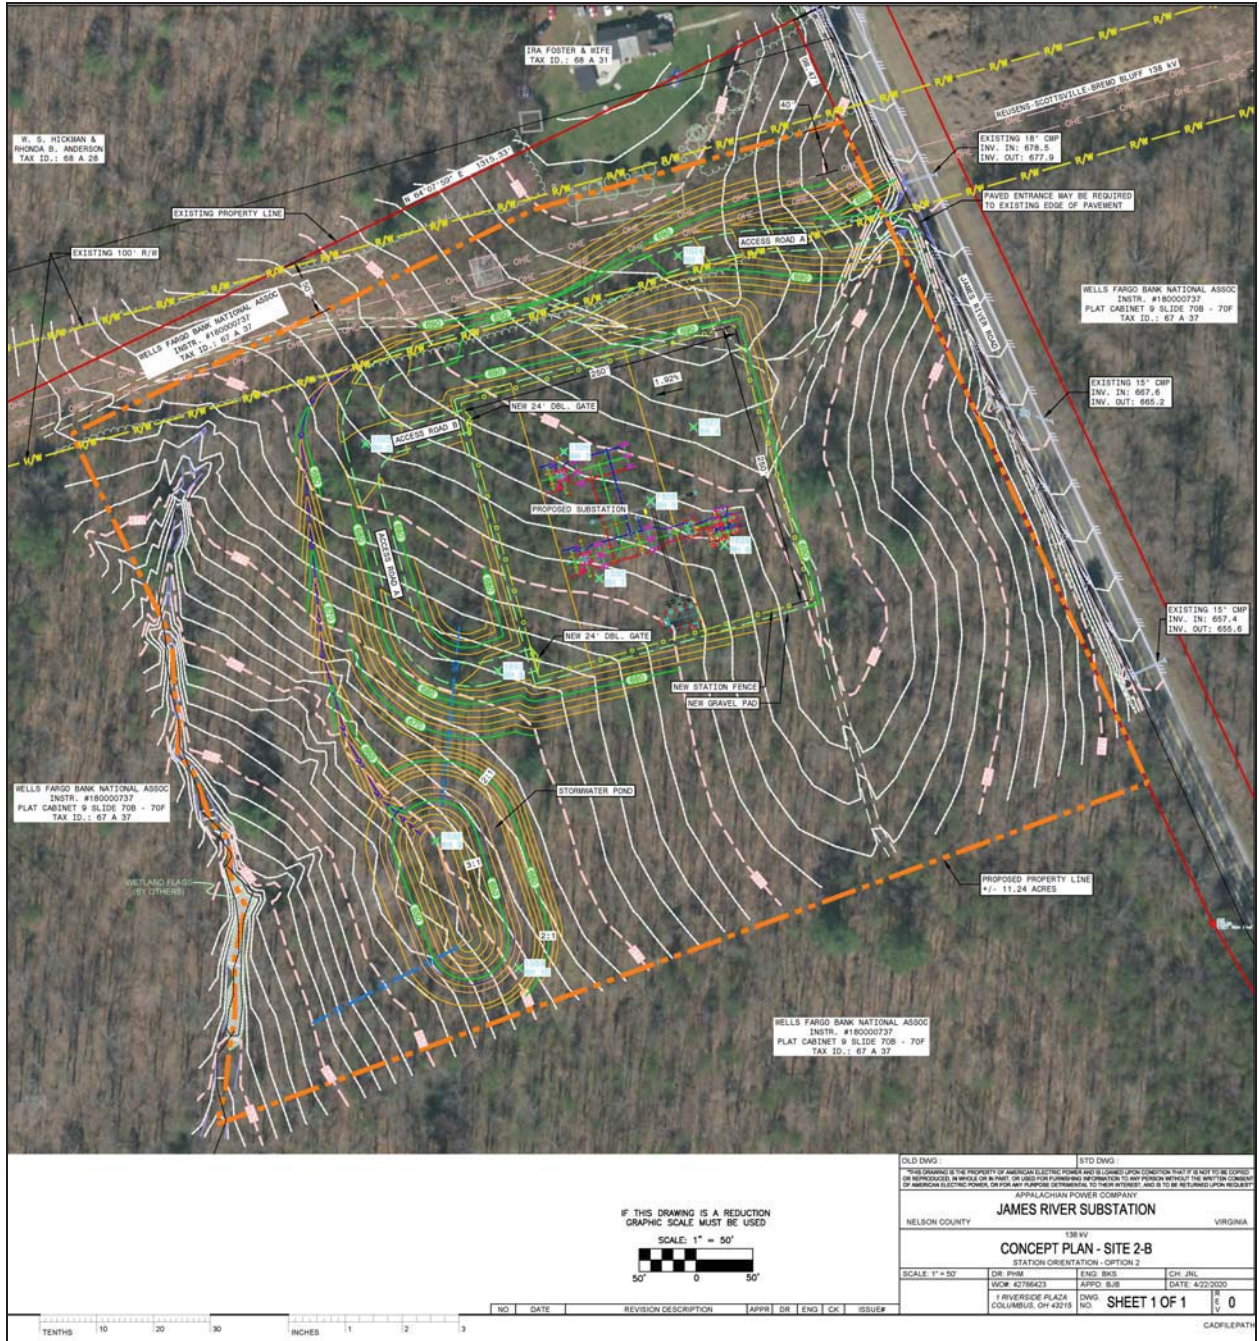
Figure 2-3: Site Plan and schematics. Source: POWER Engineers, Inc.

As part of the Project, Appalachian Power proposes to construct a new in-line substation with a one span drop from the existing Reusens - Scottsville - Bremono 138 kV transmission line (Figure 2-2). The new substation will be 11.24 acres and be built on a currently wooded property bordering the existing 100-foot transmission line right-of-way (ROW) (Figure 2-3). Two existing structures on each side of the proposed substation location and one within the footprint will be rebuilt to provide the new connection.
