APPLICATION FOR APPROVAL AND CERTIFICATION OF
ELECTRICAL TRANSMISSION LINE

Central Virginia Transmission
Reliability Project

**SOAPSTONE 138 kV SUBSTATION
VDEQ SUPPLEMENT**

**Component 3:
Soapstone 138-kV Substation**

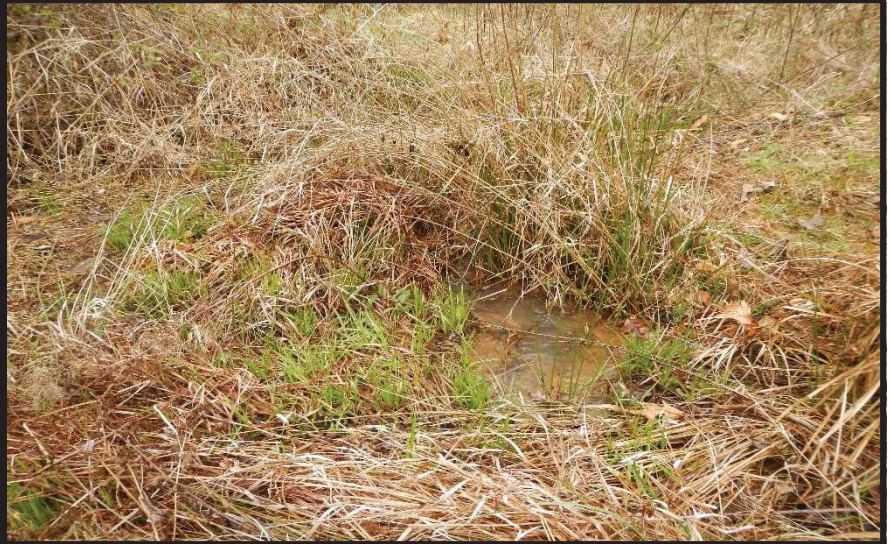
Photograph 2:

Wetland WET-SSS-02 (Scrub-Shrub
Wetland, PSS)

Direction of View:
North

POWER biologists identified three wetlands totaling 2.02 acres within the Survey Area (shown on **Figure 3: Resource Location**). Details of these wetlands can be found in Table 1 of Attachment A. Representative photographs of these wetlands can be found in Attachment B; the USACE Wetland Determination Data Forms for these wetlands can be found in Attachment C; and the corresponding Upland Data Forms can be found in Attachment D.

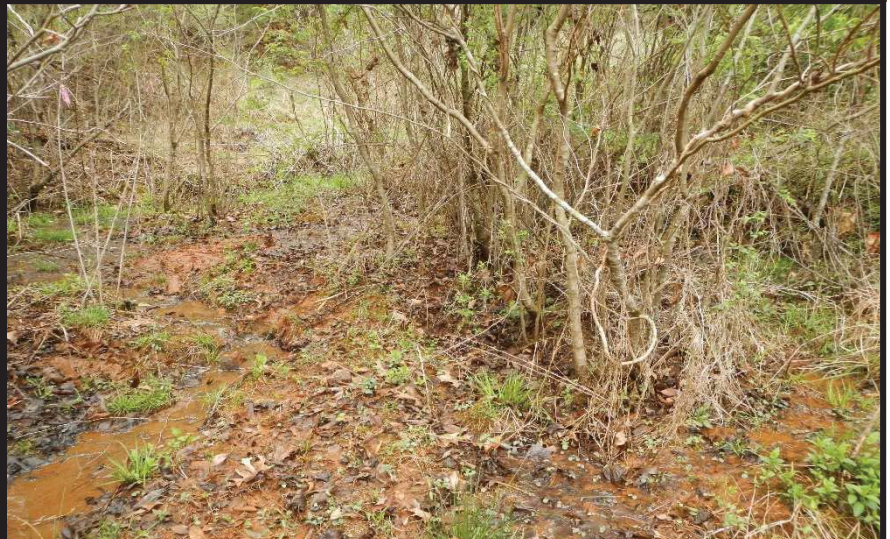
Photograph 3:

Wetland WET-SSS-03A
(Unconsolidated Bottom Portion of
Wetland, PUB)

Direction of View:
North

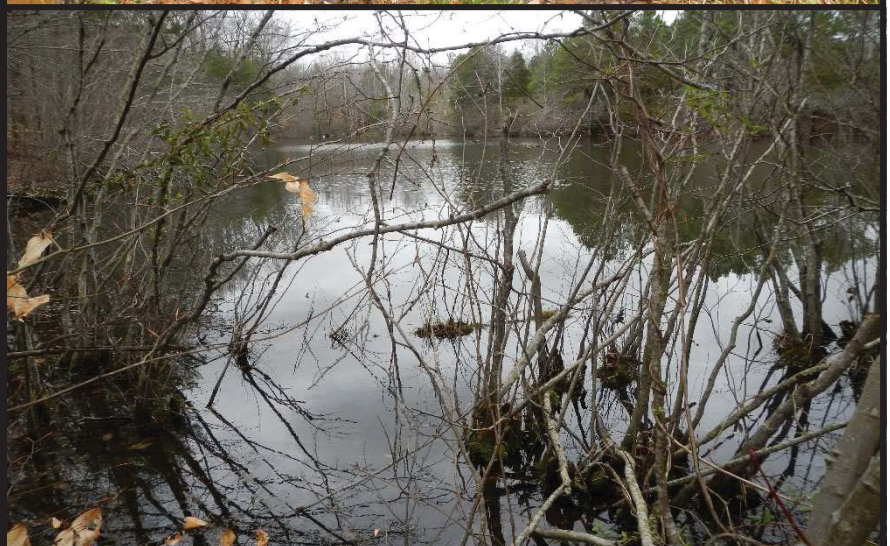
Photograph 4:

Wetland WET-SSS-03B (Emergent
Portion of Wetland, PEM)

Direction of View:
North

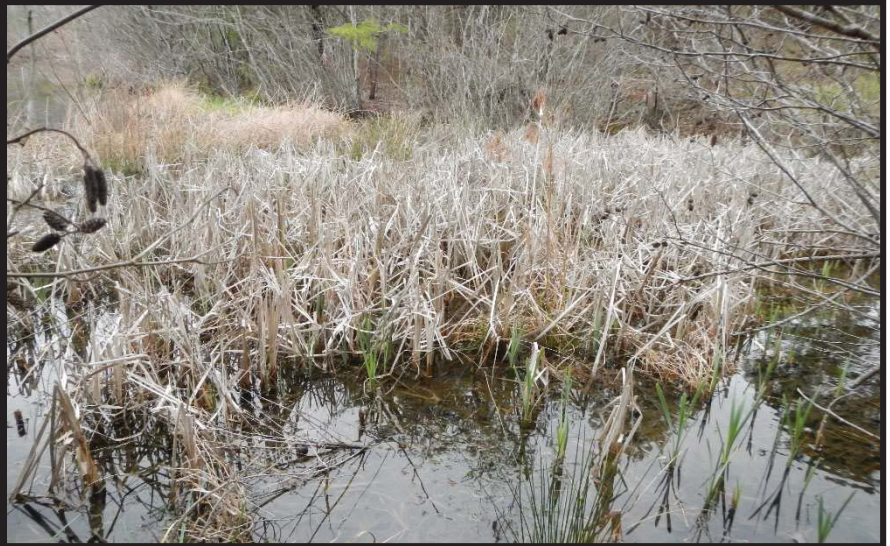
Photograph 5:

Wetland WET-SSS-03C (Scrub-Shrub
Portion of Wetland, PSS)

Direction of View:
Southeast

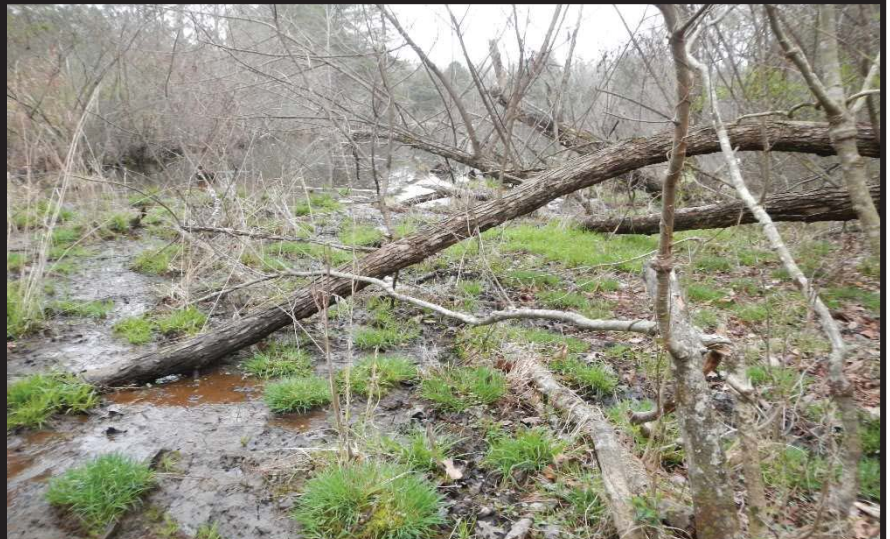
Photograph 6:

Stream STRM-SSS-01 (Intermittent
Stream)

Direction of View:
Downstream (Southeast)

POWER biologists identified six streams within the Survey Area. The total length of delineated streams within the Survey Area is 2,700 linear feet (shown on **Figure 3: Resource Location**). Additional details on the streams can be found in Table 2 of Attachment A. Representative photographs of these resources can be found in Attachment B.

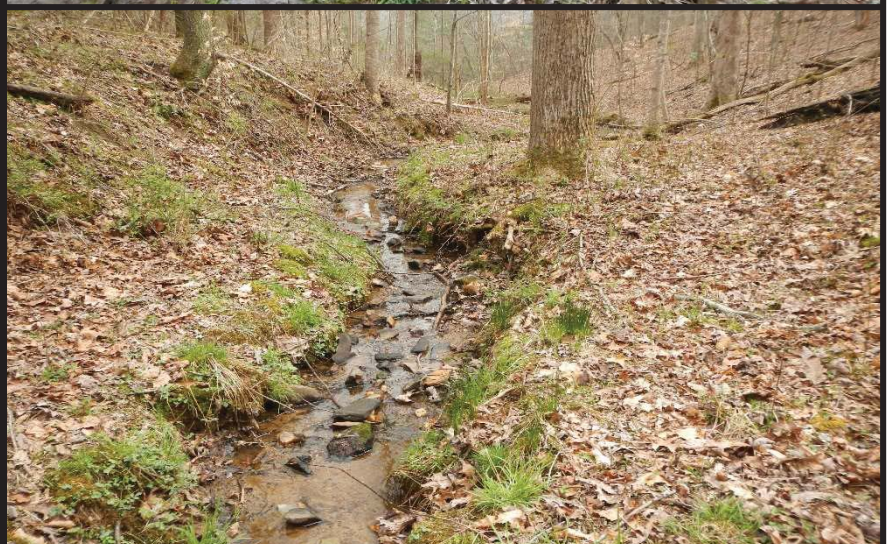
Photograph 7:

Stream STRM-SSS-02 (Perennial Stream)

Direction of View:
Downstream (Southwest)

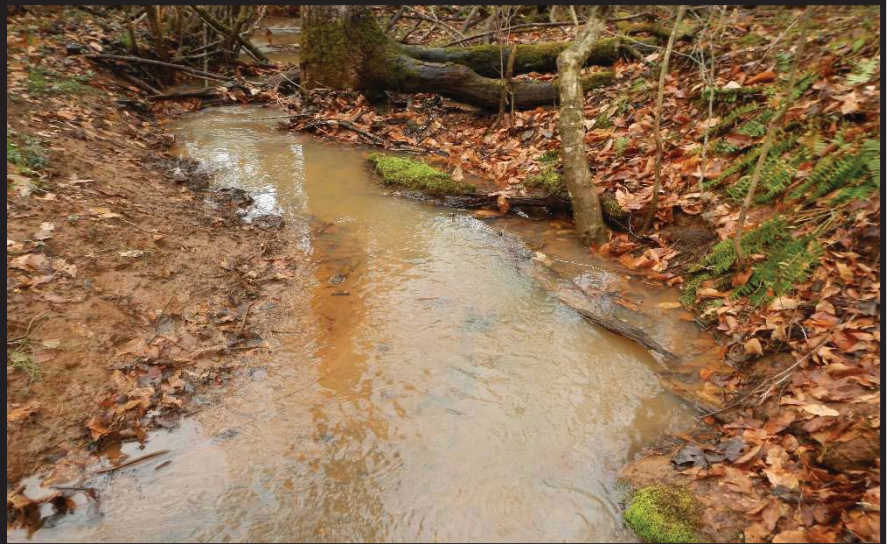
Photograph 8:

Stream STRM-SSS-03 (Intermittent Stream)

Direction of View:
Upstream (Southeast)

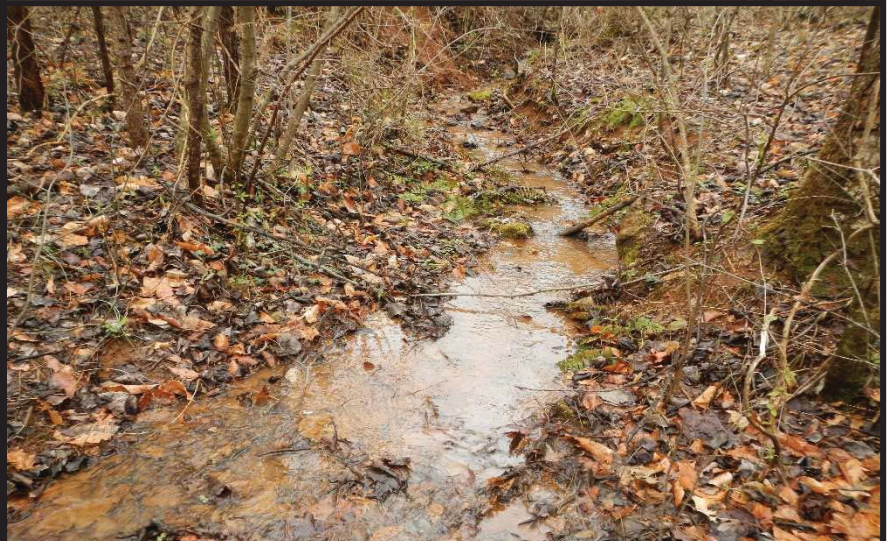
Photograph 9:

Stream STRM-SSS-04 (Ephemeral Stream)

Direction of View:
Upstream (Southeast)

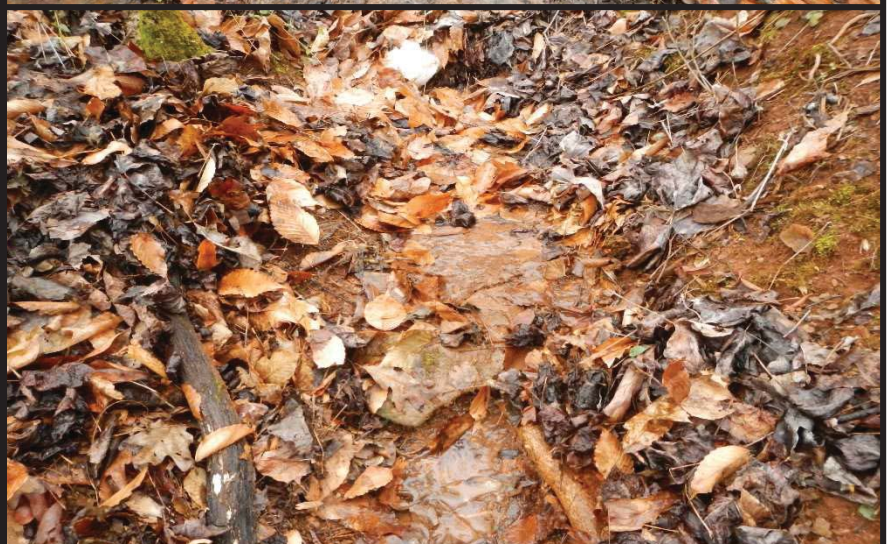
Photograph 10:

Stream STRM-SSS-05 (Ephemeral Stream)

Direction of View:
Downstream (Northeast)

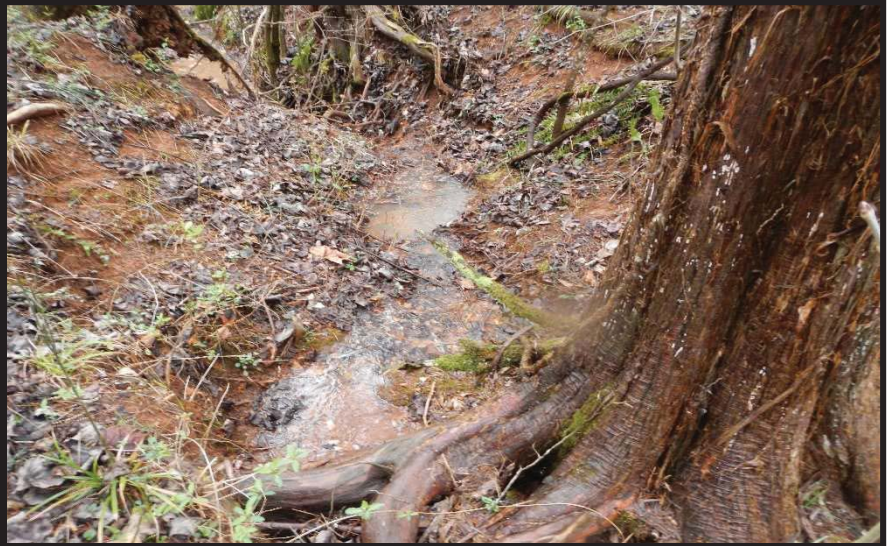
Photograph 11:

Stream STRM-SSS-06 (Intermittent Stream)

Direction of View:
Upstream (Northwest)

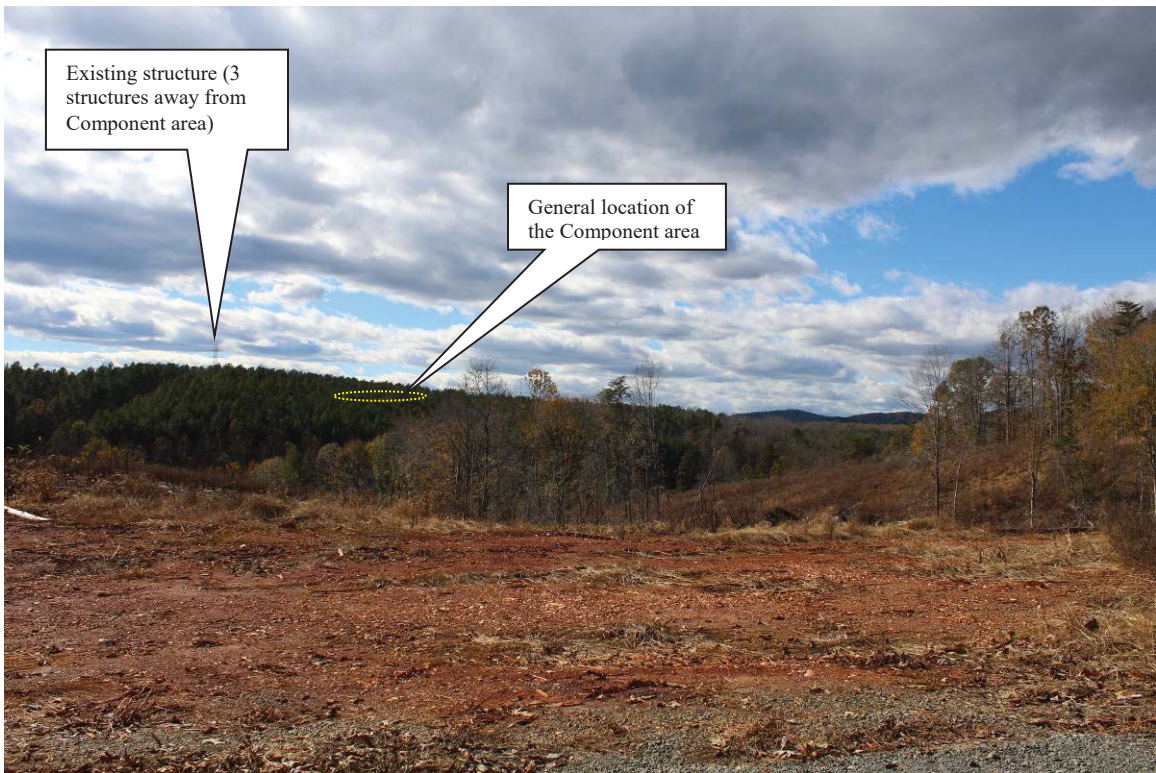
Photo 2: View from Old Green Mountain Road towards the Component area (not visible) showing existing transmission line structures

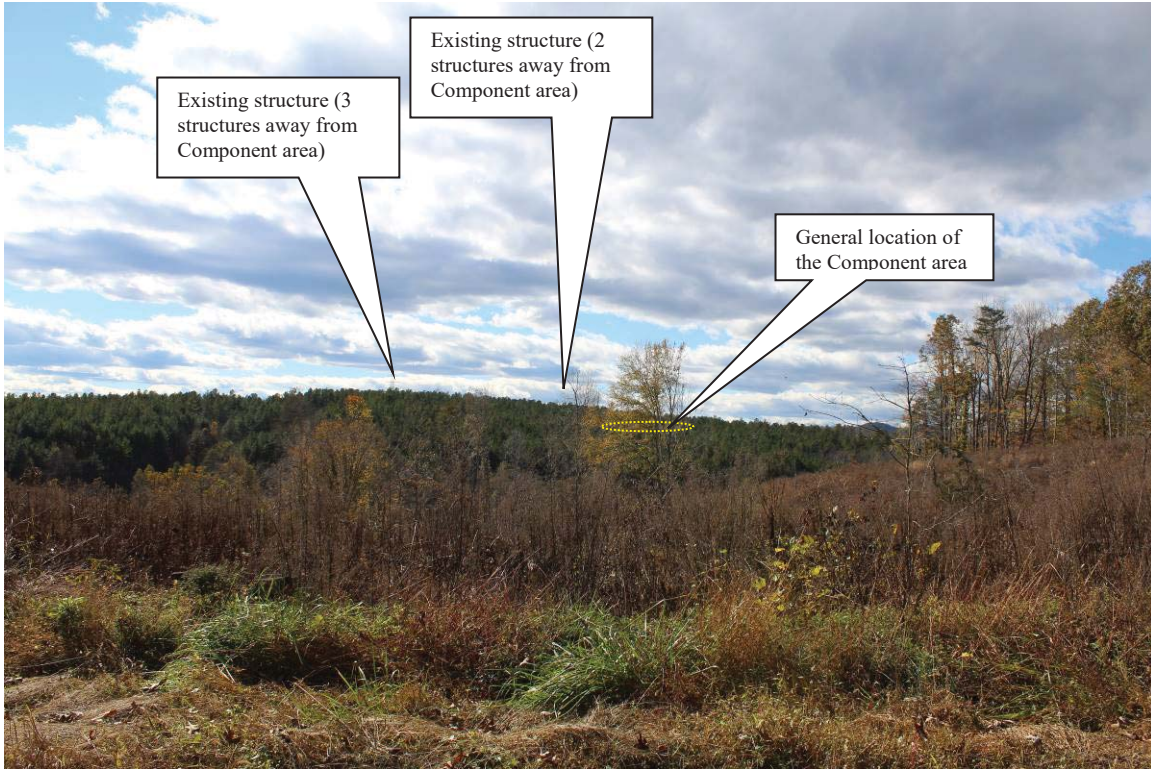
Photo 3: View from Old Green Mountain Road towards the Component area (not visible) showing existing transmission line structures

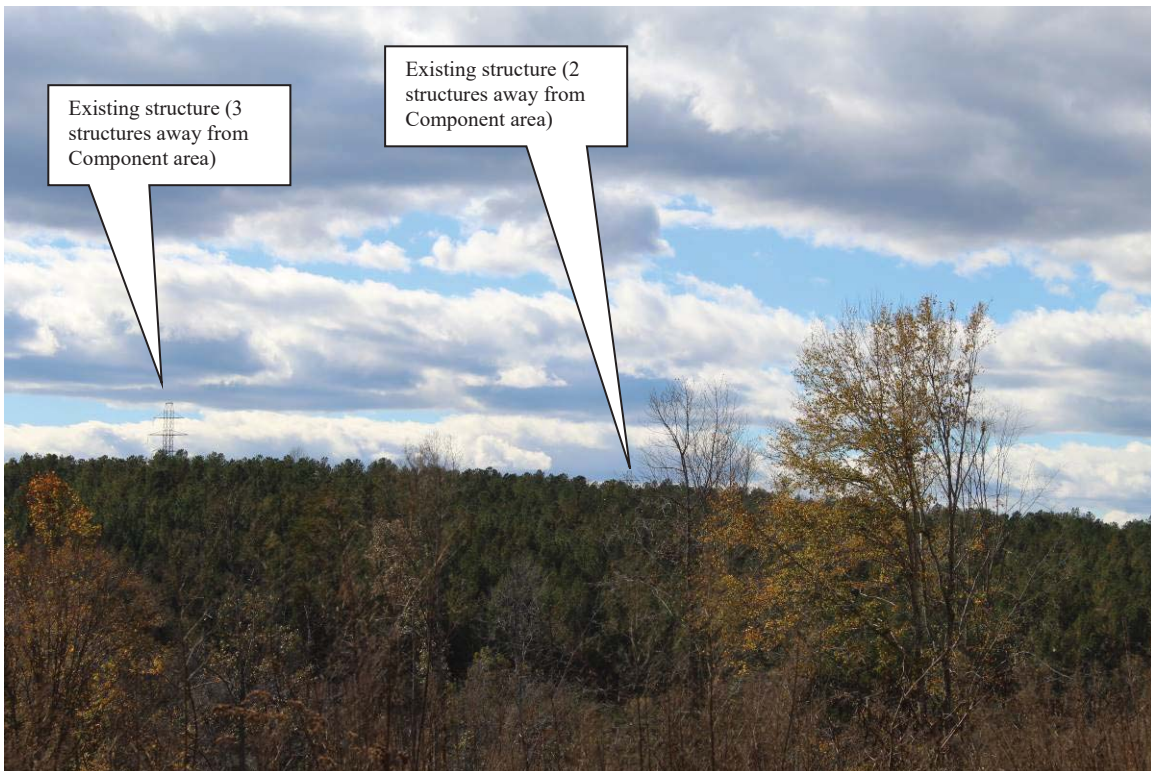
Photo 4: Detail of existing structures from Old Green Mountain Road with the Component area beyond (not visible)

As the existing structures in the immediate vicinity of the Project area range from roughly 100 feet to 120 feet and are not visible from any publicly accessible location in the historic district, the proposed 55-foot monopole tap structures that will be the tallest feature of the project will likewise not be visible. It is therefore D+A's opinion that the proposed project will have ***no impact*** on the Southern Albemarle Rural Historic District.
