# Letter of Notification for the Baku 765 kV Station Project

PUCO Case No. 26-0867-EL-BLN

Submitted by:  
AEP Ohio Transmission Company, Inc.

August 27, 2026

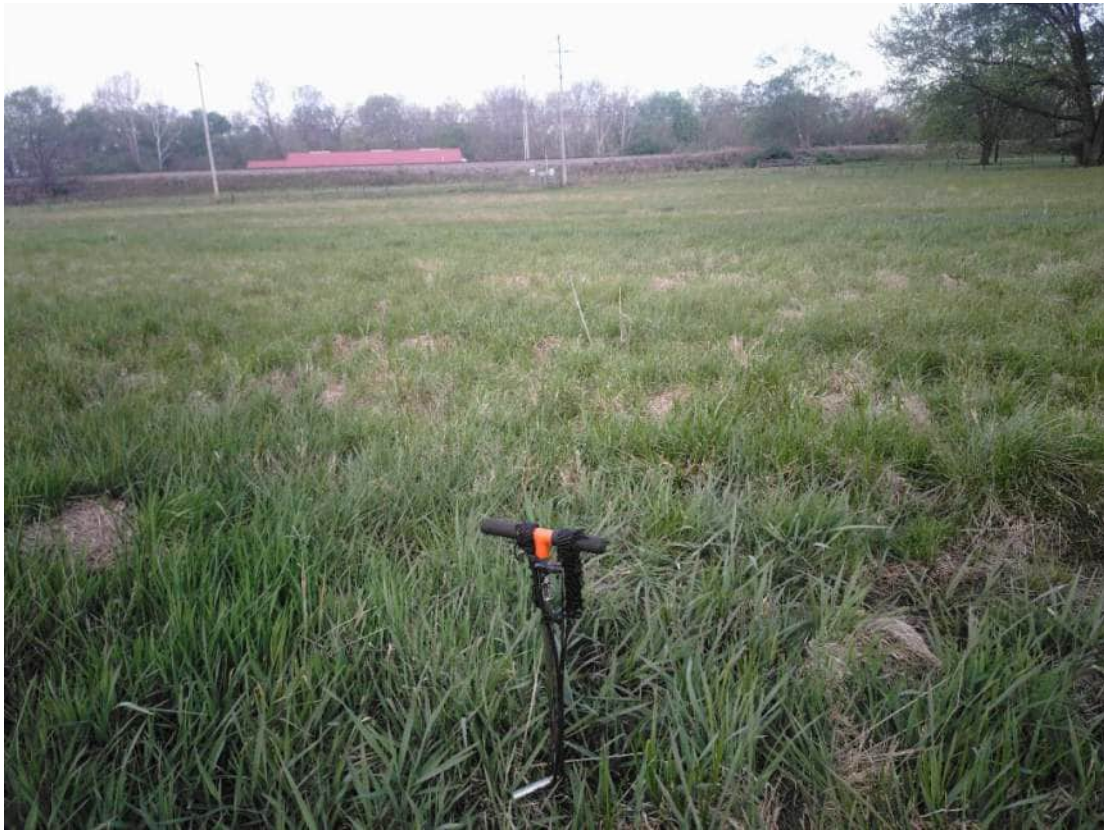
**ID: W-BS-1-1 Date: 4/14/2026 Direction: W Class: PEM Position: Wetland Overview**

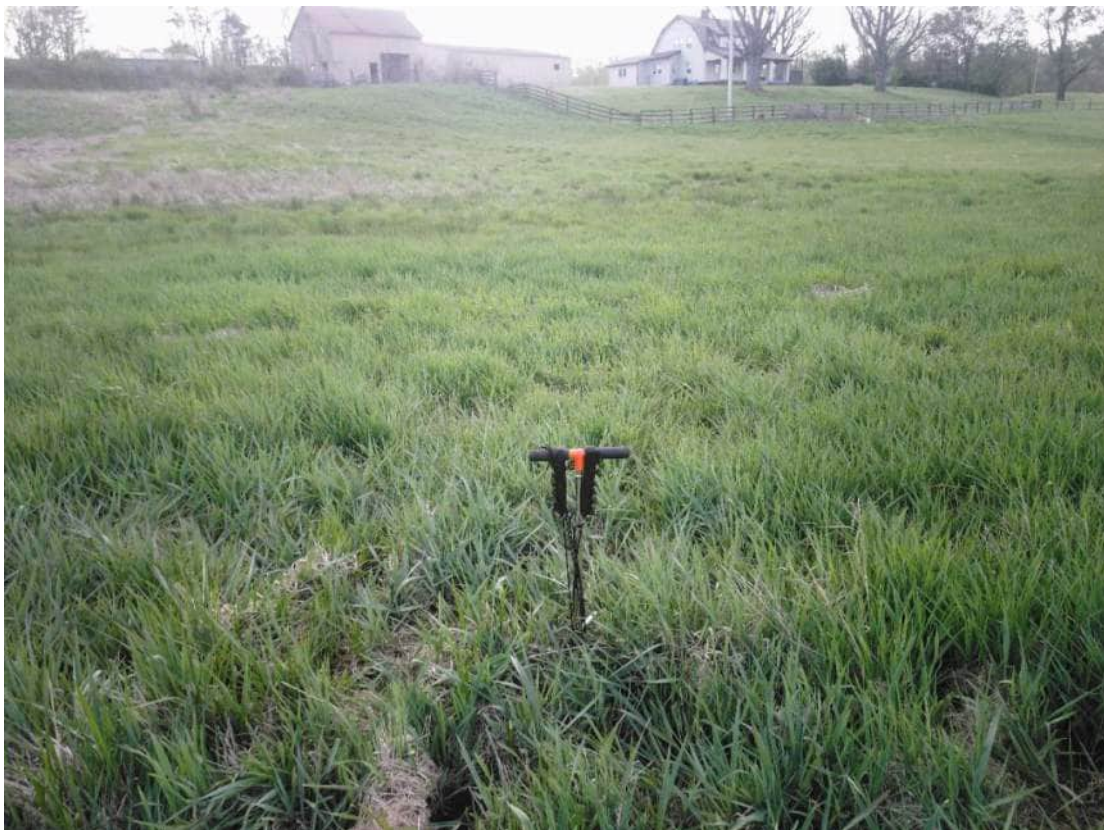
**ID: W-BS-1-1 Date: 4/14/2026 Direction: E Class: PEM Position: Wetland Overview**

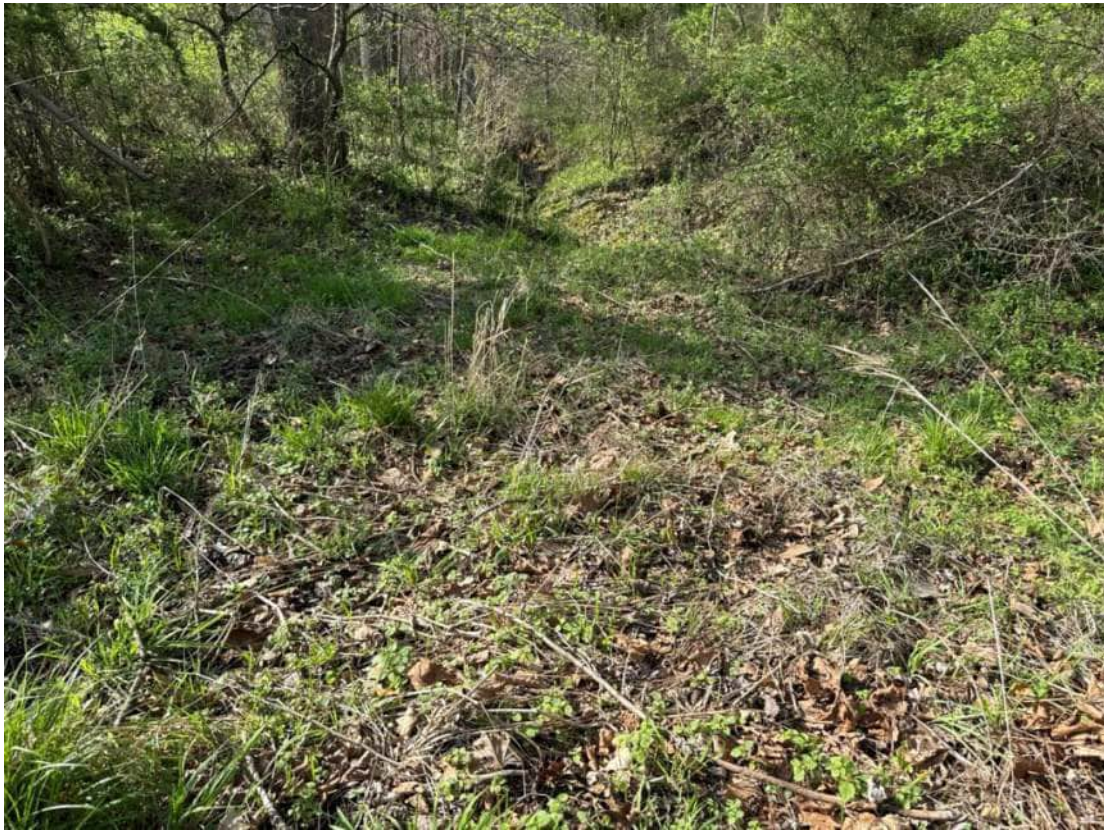
ID: W-BS-5-1 Date: 4/14/2026 Direction: S Class: PEM Position: Wetland Overview

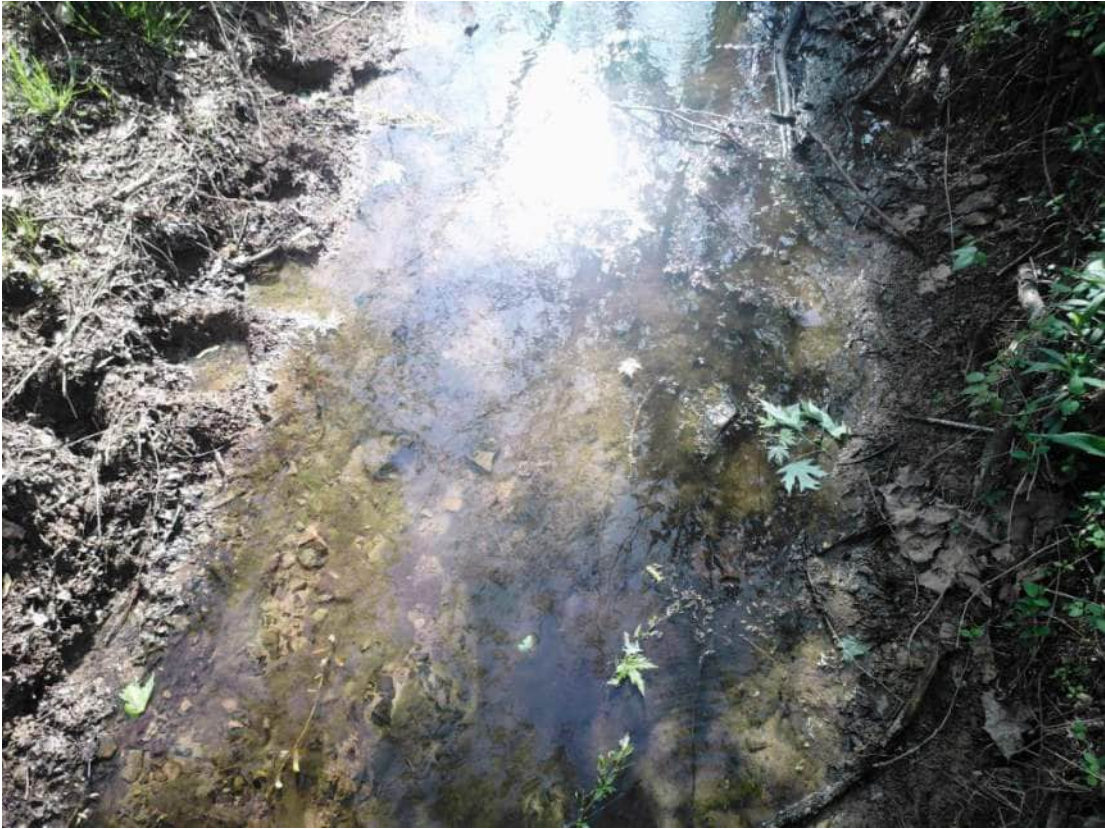
**ID: S-BS-1-1 Date: 4/14/2026 Direction: W Position: Across**
