Construction Notice for the Sadiq Switch-Texas Eastern 138-kV Transmission Line Project

PUCO Case No. 24-0945EL-BNR

Submitted by: Ohio Power Company

Sadiq Switch – Texas Eastern 138 kV Transmission Line Project

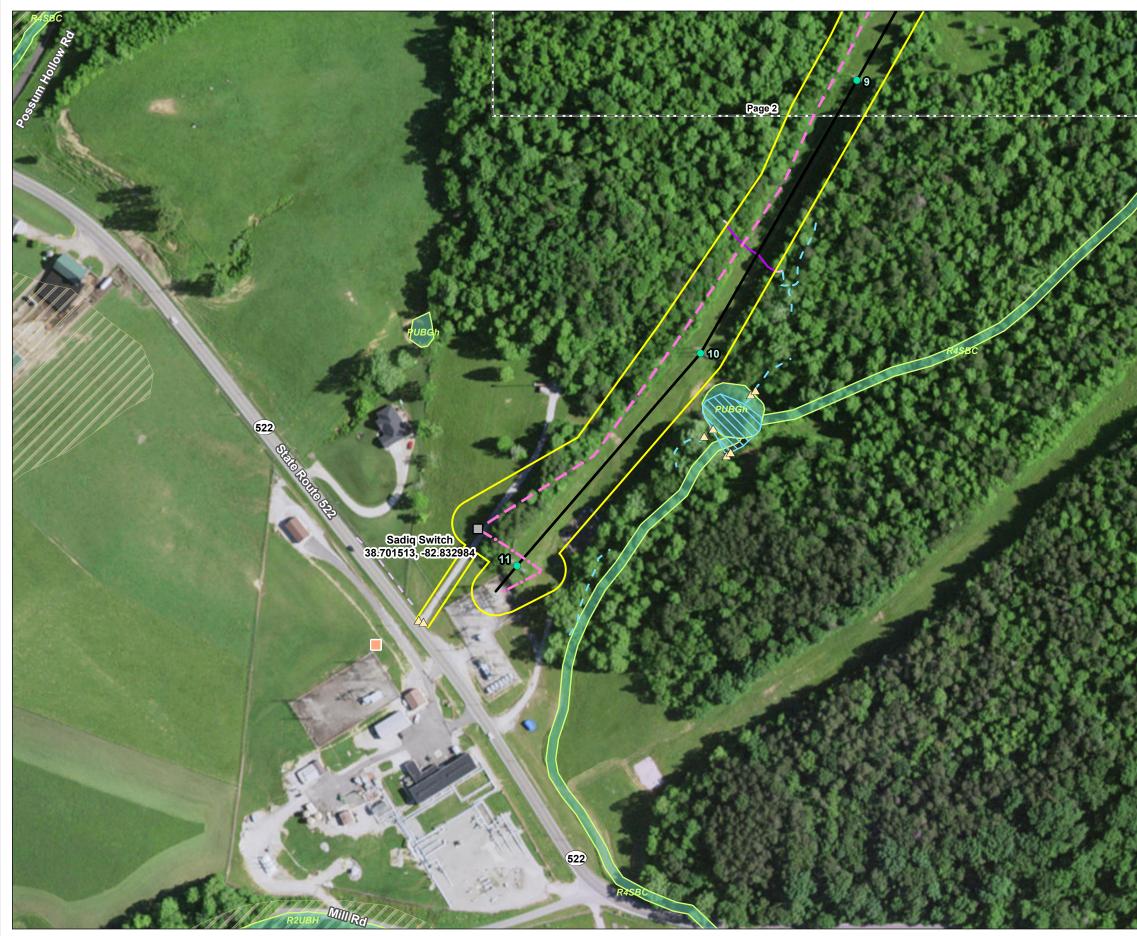
Figure No. 2 Title Wetland and Waterbody Delineation Map Client/Project AEP Ohio Transmission Company, Inc. 3708590 Sadiq Switch-East Wheelersburg 138 kV Line Rebuild Project Project Location Scioto County, Ohio Prepared by JLH on 2021-10-21 TR by MK on 2022-10-17 IR by AS on 2022-10-18 N 200 100 Feet (At original document size of 11x17) 1:2,400 Legend AEP Substation Field Delineated Waterway Line AEP Switch Approximate Existing Structure to Waterway be Removed Field Delineated ► Existing Transmission Line Waterway Area Approximate Open Water Proposed \mathcal{D} Transmission Line Approximate Wetland Line Project Area \triangle Culvert Field Delineated Emergent Wetland Storm Drain National Wetlands Wetland Inventory Feature Determination Sample Point FEMA Flood Hazard Area Upland Drainage 100-year Floodplain Feature Floodway* Approximate Upland Drainage Feature

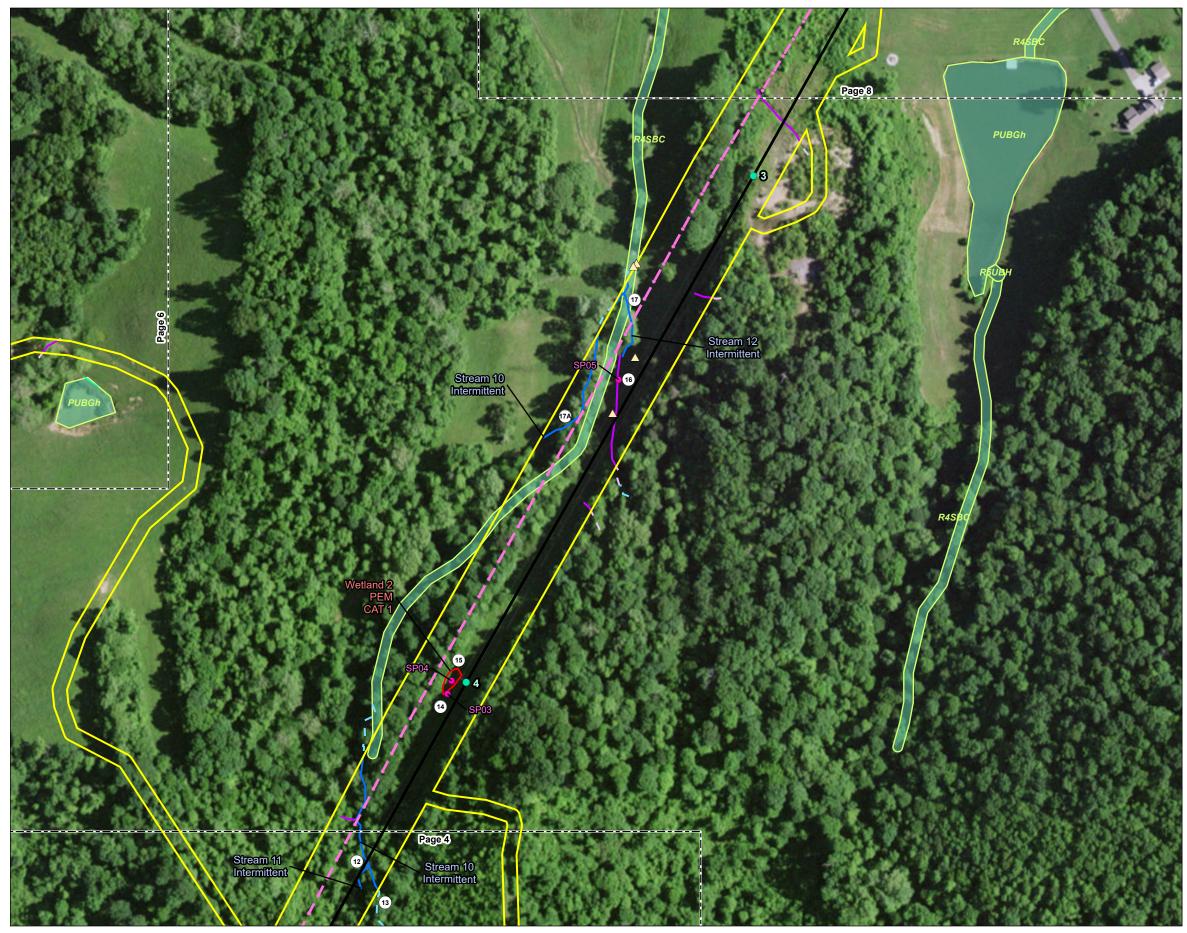
Figure No. 2 Title Wetland and Waterbody Delineation Map Client/Project AEP Ohio Transmission Company, Inc. 93708590 Sadiq Switch-East Wheelersburg 138 kV Line Rebuild Project Project Location Scioto County, Ohio Prepared by JLH on 2021-10-21 TR by MK on 2022-10-17 IR by AS on 2022-10-18 N 100 200 Feet (At original document size of 11x17) 1:2.400 Legend AEP Substation Field Delineated Waterway Line AEP Switch Approximate Existing Structure to Waterway be Removed Field Delineated Existing Transmission Line Waterway Area Approximate Open Water Proposed \mathcal{D} Transmission Line Approximate Wetland Line Project Area \triangle Culvert Field Delineated Emergent Wetland Storm Drain National Wetlands Wetland Inventory Feature Determination Sample Point FEMA Flood Hazard Area Upland Drainage 100-year Floodplain Feature Floodway* Approximate Upland Drainage Feature

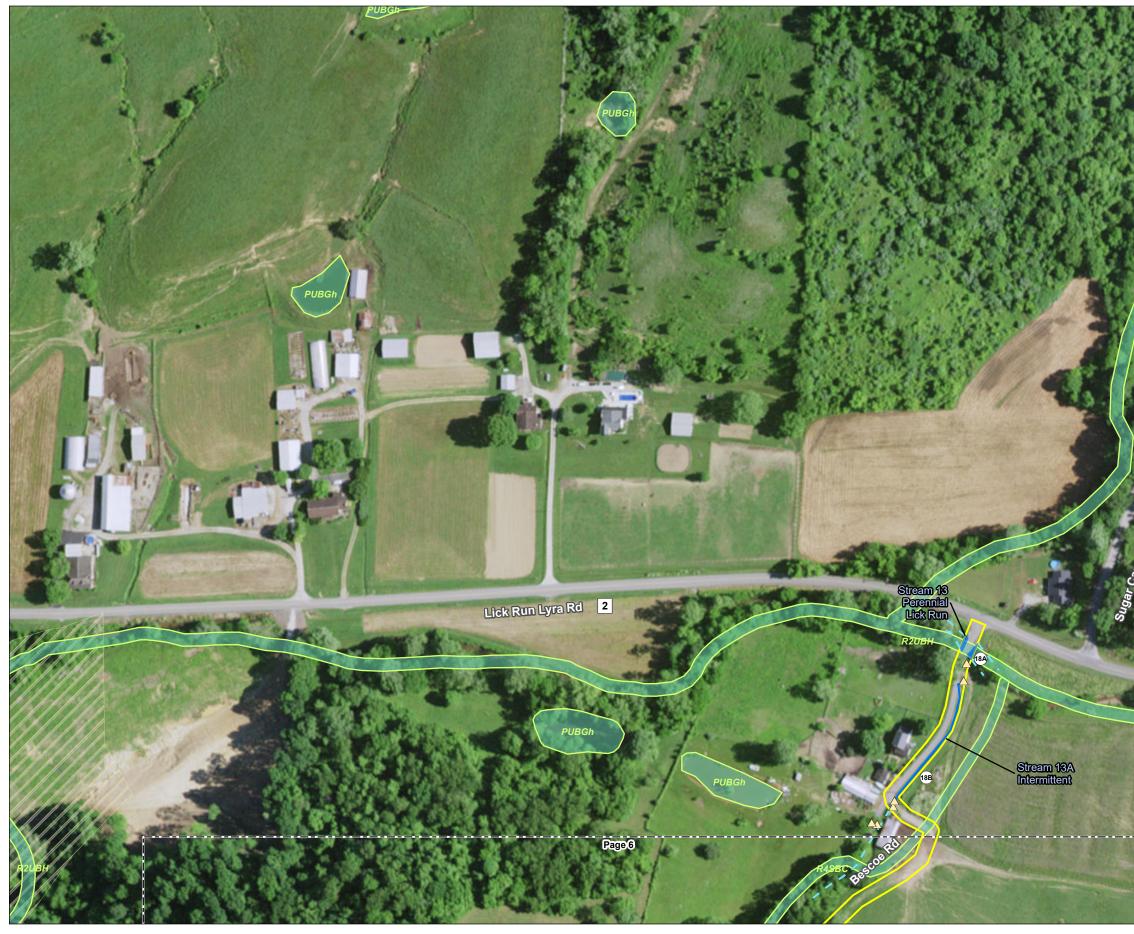
Figure No. 2 Title Wetland and Waterbody Delineation Map Client/Project AEP Ohio Transmission Company, Inc. 93708590 Sadiq Switch-East Wheelersburg 138 kV Line Rebuild Project Project Location Scioto County, Ohio Prepared by JLH on 2021-10-21 TR by MK on 2022-10-17 IR by AS on 2022-10-18 N 100 200 Feet (At original document size of 11x17) 1:2,400 Legend AEP Substation Field Delineated Waterway Line AEP Switch Approximate Existing Structure to Waterway be Removed Field Delineated ► Existing Transmission Line Waterway Area Approximate Open Water Proposed \mathcal{D} Transmission Line Approximate Wetland Line Project Area Culvert \triangle Field Delineated Emergent Wetland Storm Drain National Wetlands Wetland Inventory Feature Determination Sample Point FEMA Flood Hazard Area Upland Drainage 100-year Floodplain Feature Floodway* Approximate Upland Drainage Feature O Photo Location

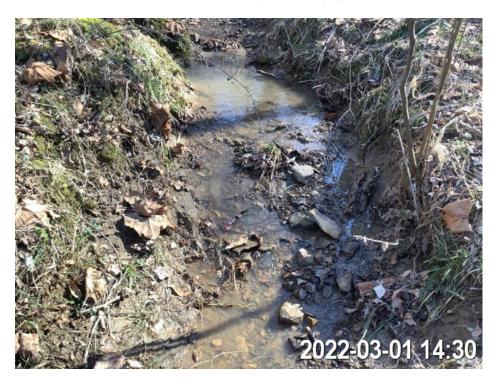
Photo Location 3. View of Stream 3 (intermittent), typical substrates.

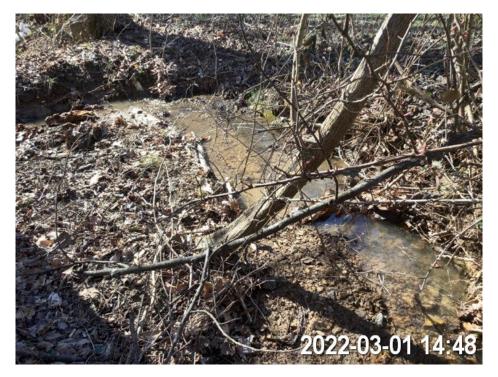
Photo Location 4. View of Stream 4 (intermittent). Photograph taken facing downstream, northwest.

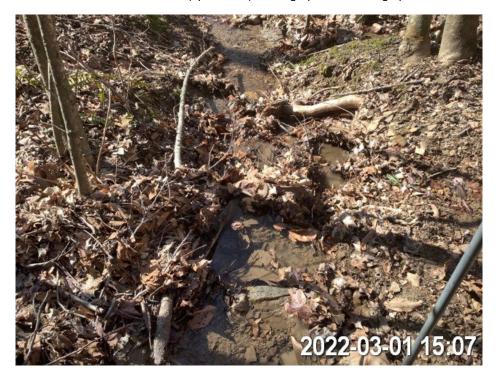
Photo Location 5. View of Stream 5 (ephemeral). Photograph taken facing downstream, southwest.

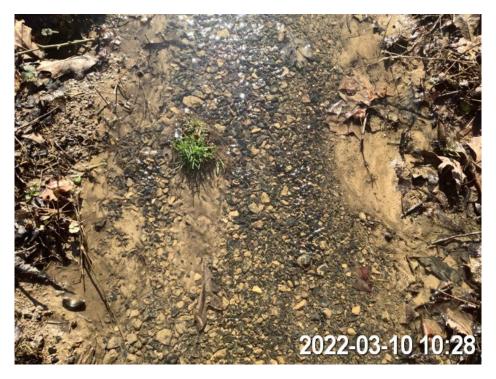
Photo Location 6. View of Stream 6 (intermittent), typical substrates.

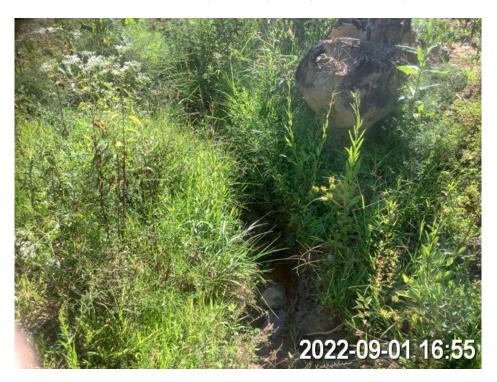
Photo Location 6A. View of Stream 6A (ephemeral). Photograph taken facing downstream, southwest.

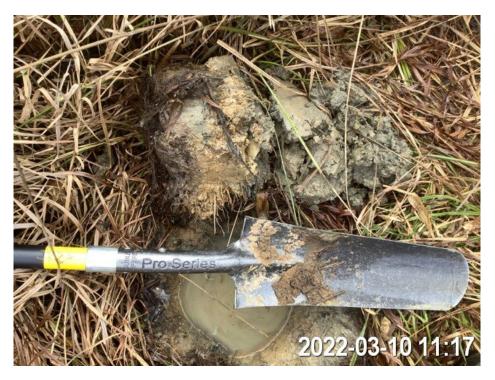
Photo Location 9. View of wetland determination sample point (SP02; PEM), soil profile.

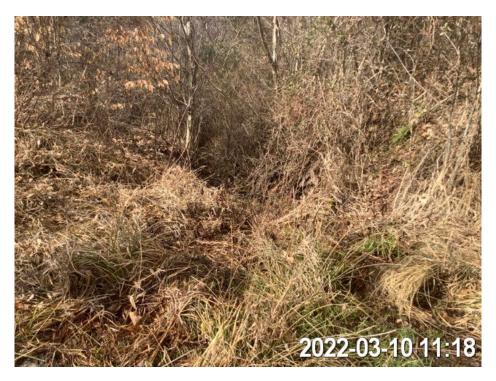
Photo Location 9. View of Wetland 1. Photograph taken facing west.

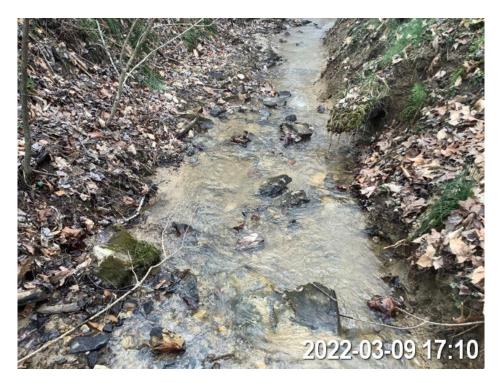
Photo Location 10. View of Stream 8 (intermittent). Photograph taken facing downstream, west.

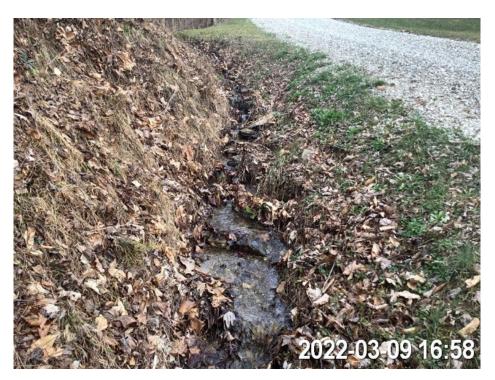
Photo Location 11. View of Stream 9 (ephemeral). Photograph taken facing upstream, east.

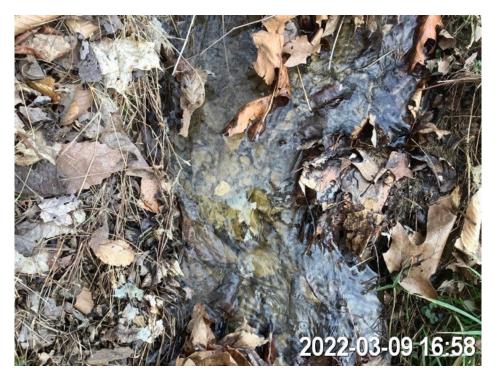
Photo Location 11. View of Stream 9 (ephemeral), typical substrates.

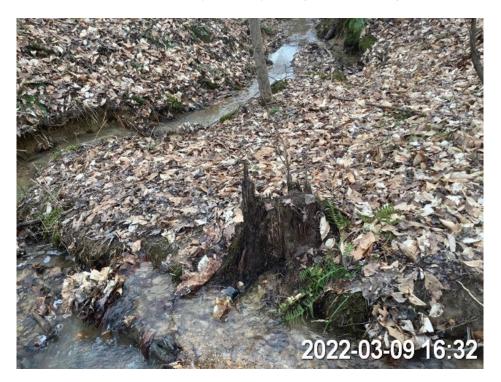
Photo Location 11A. View of Stream 9A (ephemeral). Photograph taken facing downstream, south.

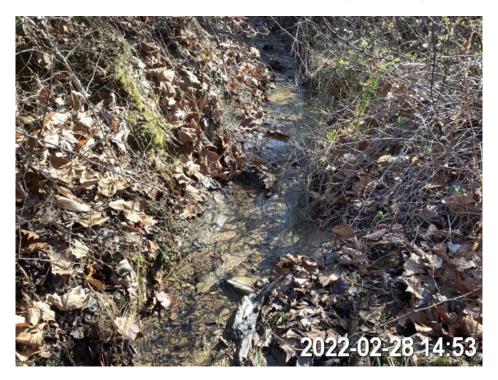
Photo Location 17. View of Stream 12 (intermittent). Photograph taken facing upstream, southwest.

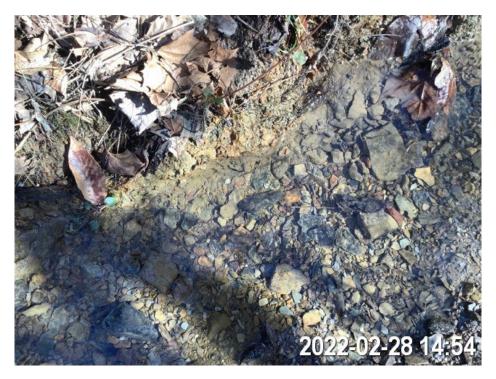
Photo Location 17. View of Stream 12 (intermittent), typical substrates.

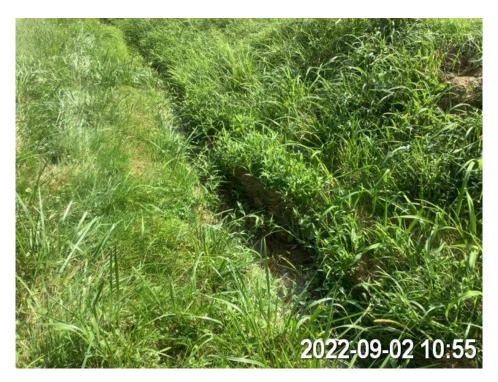
Photo Location 18B. View of Stream 13A (intermittent). Photograph taken facing downstream, southwest.

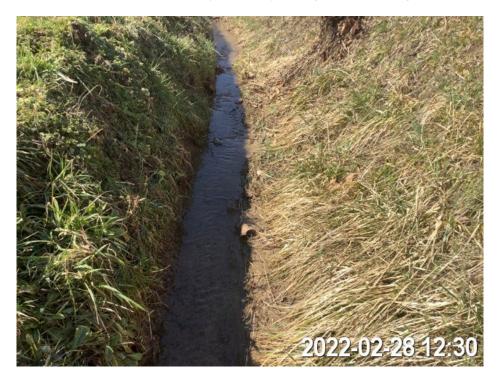
Photo Location 19. View of Stream 14 (intermittent). Photograph taken facing downstream, west.
