# Construction Notice for Haviland-North Delphos 138 kV Line Adjustment Project

PUCO Case No. 24-0946-EL-BNR

October 24, 2024

**AEP Ohio Transmission Company, Inc.  
Haviland-North Delphos 138 kV Line Adjustment Project**

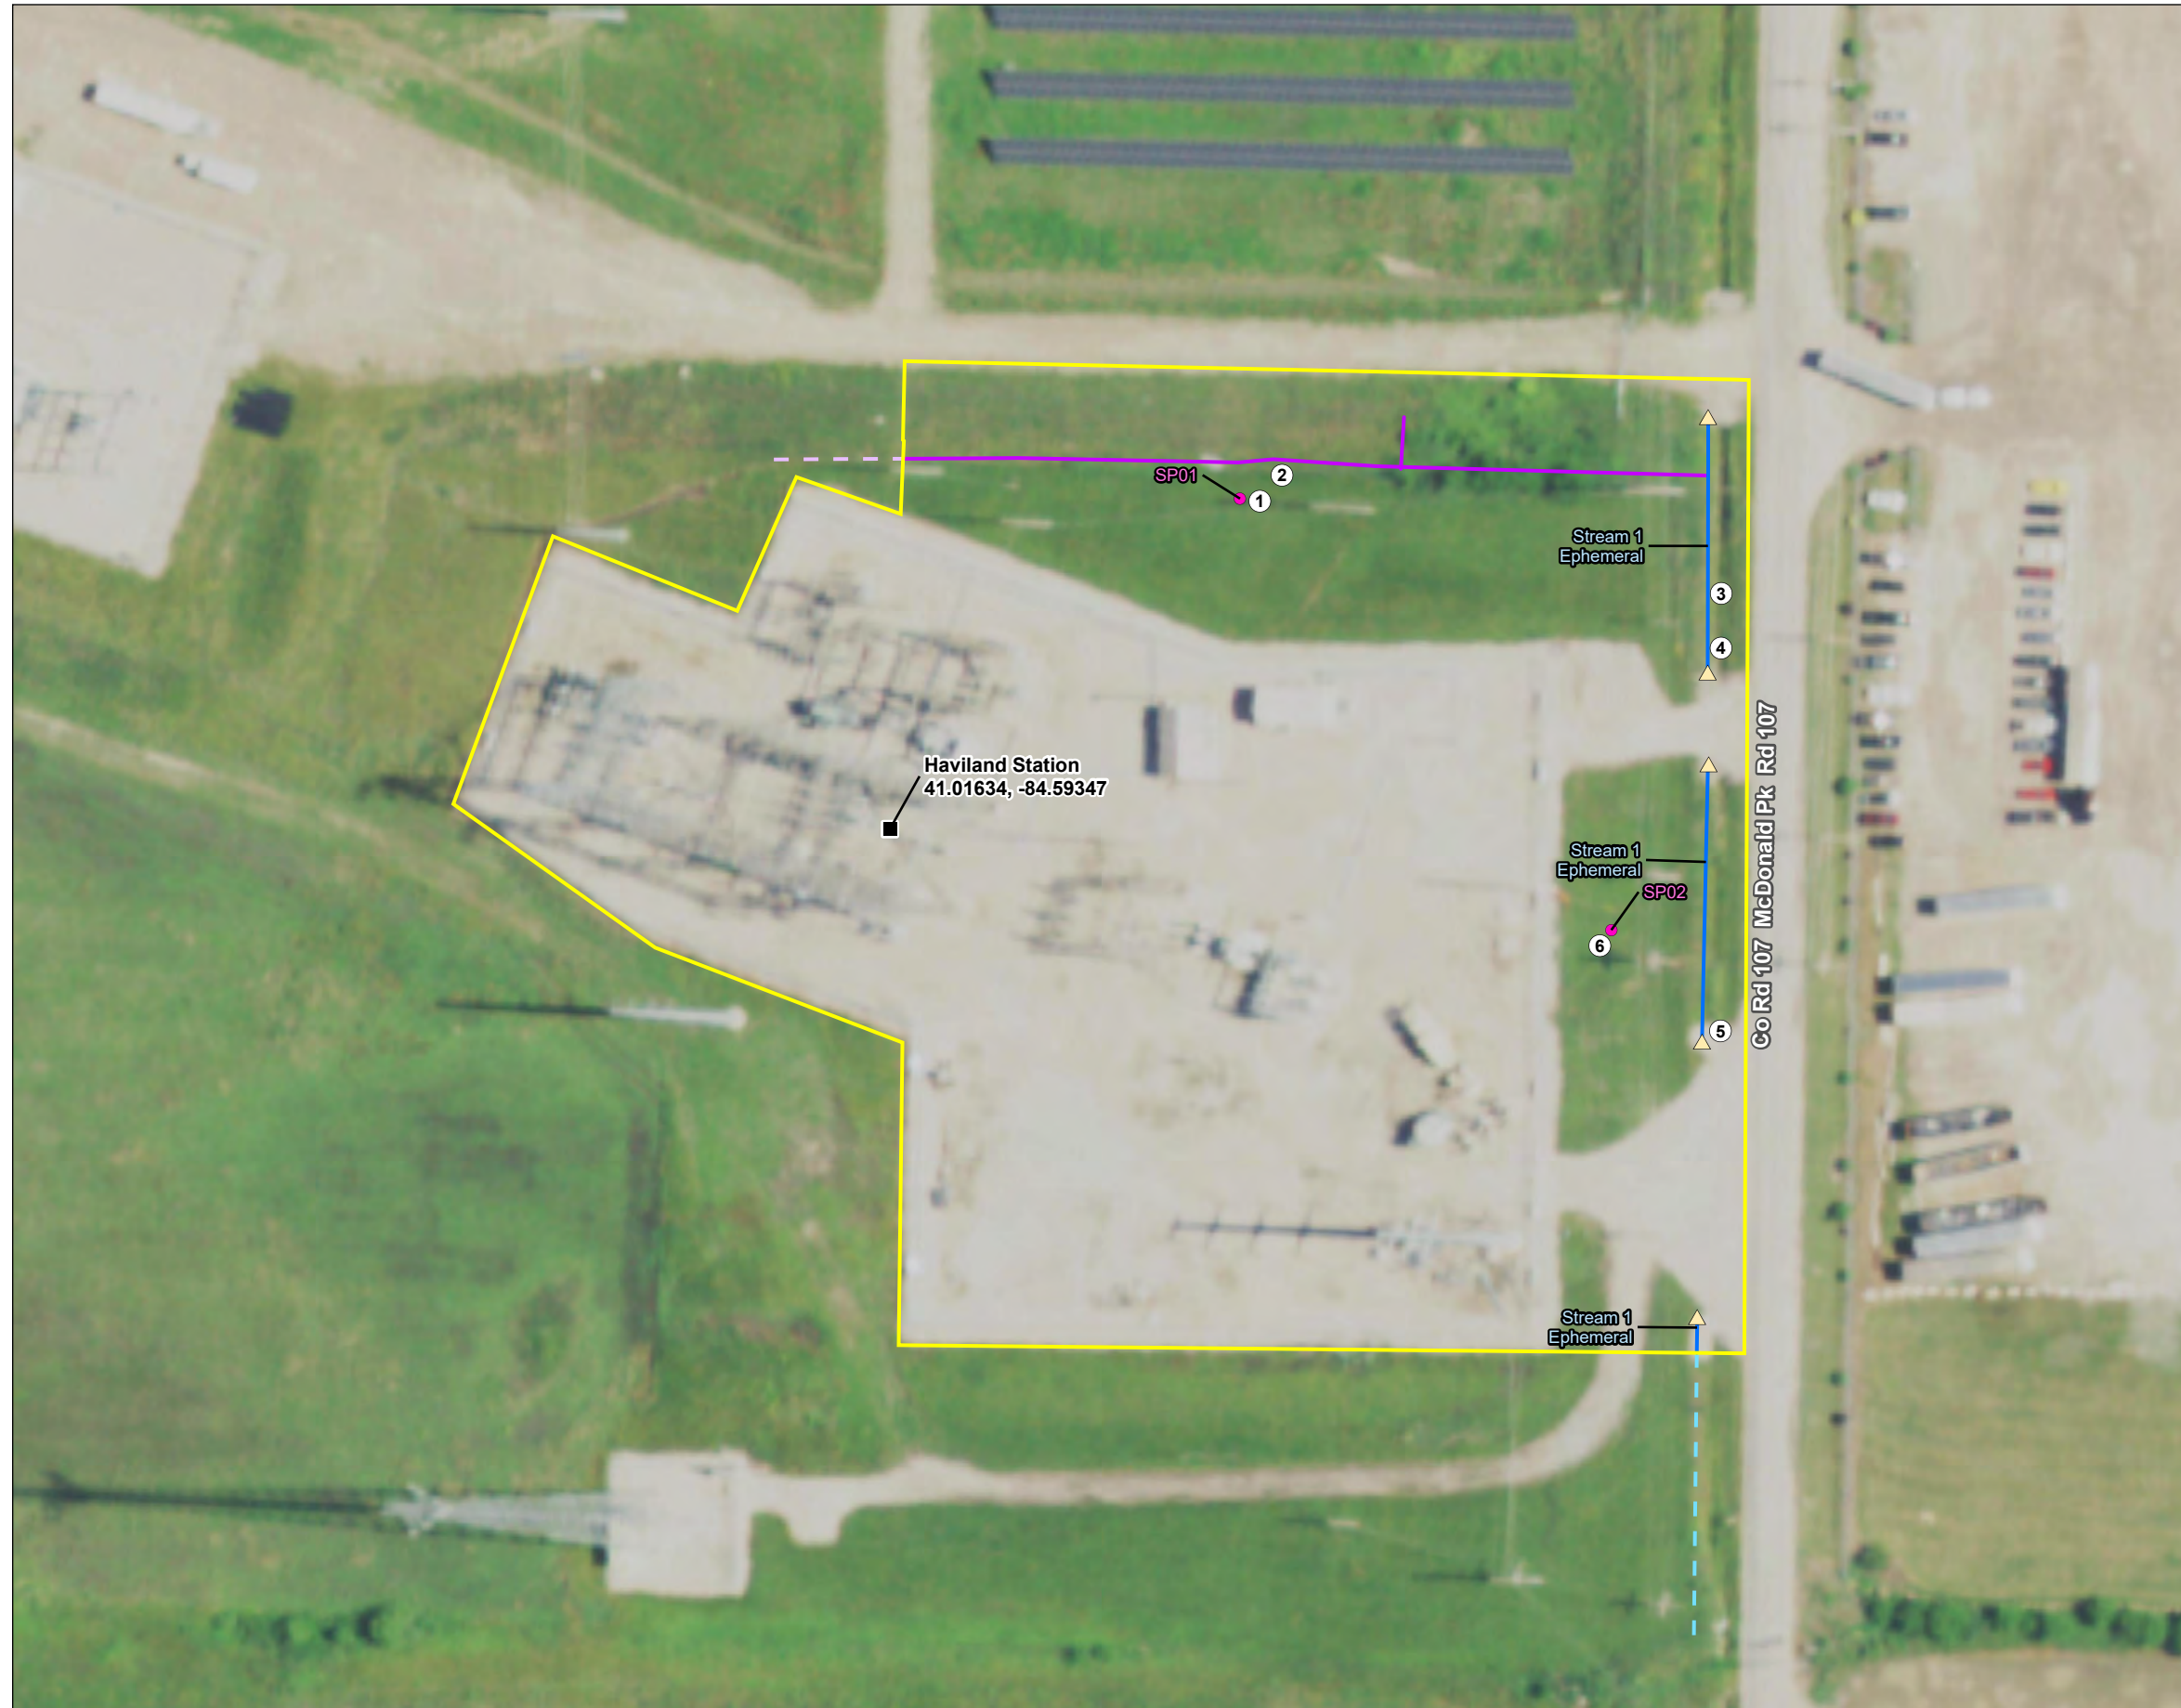
## A.2      **FIGURE 2 – WETLAND AND WATERBODY DELINEATION MAP**

- AEP Substation
- Project Area
- Photo Location
- △ Existing Culvert
- Wetland Determination Sample Point Location
- Upland Drainage Feature
- - - Approximate Upland Drainage Feature
- ~ Field Delineated Waterway
- - - Approximate Waterway
- National Wetlands Inventory Feature\*
- FEMA Flood Hazard Area\*
- ▨ 100-year Floodplain
- ▨ Floodway

An ecological resources survey and wetland and waterbody delineation study was completed by the Company's consultant for the Project area in January and June of 2024. The Ecological Survey Report is included in Appendix C and contains more information regarding the habitats and land uses observed within the Project area. No wetlands, streams, or open waters were observed within the Project area.

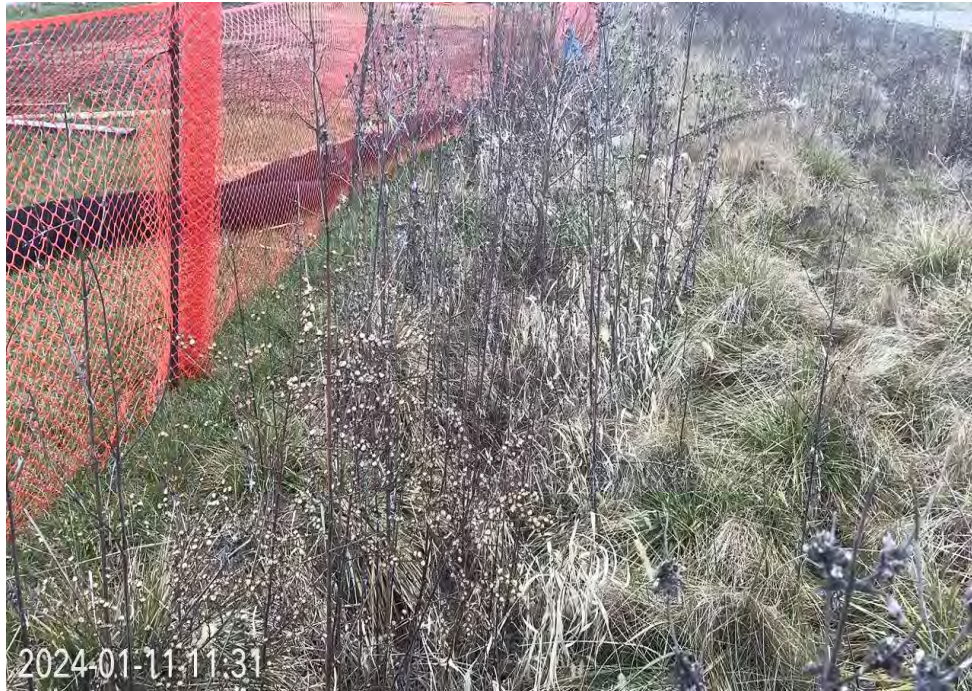
Photograph Location 2. Representative view of an upland drainage feature within the Project area. Photograph taken facing west.

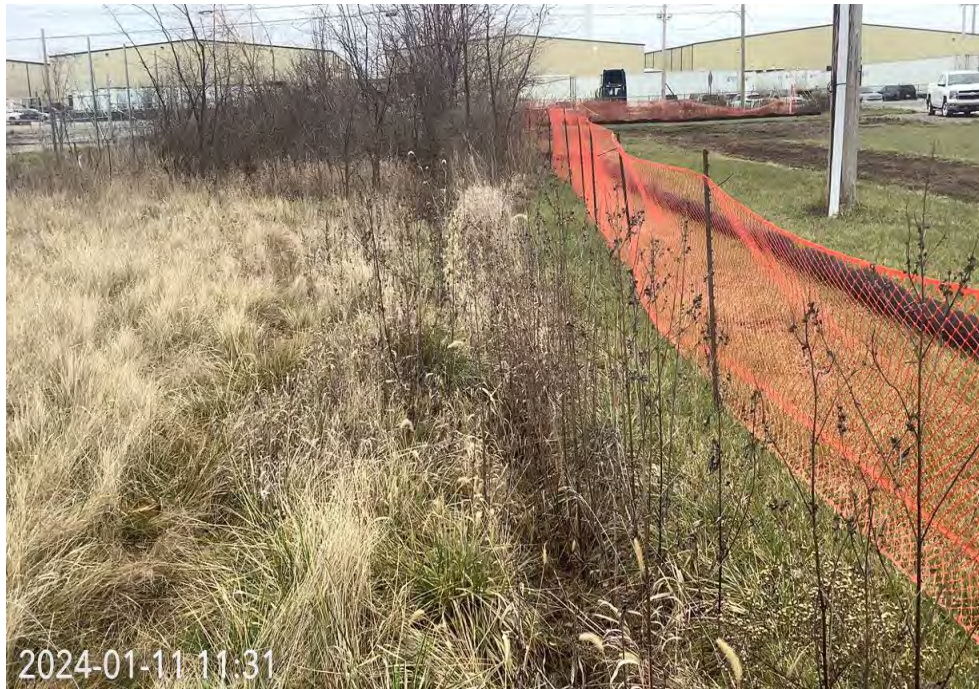
Photograph Location 2. Representative view of an upland drainage feature within the Project area. Photograph taken facing east.

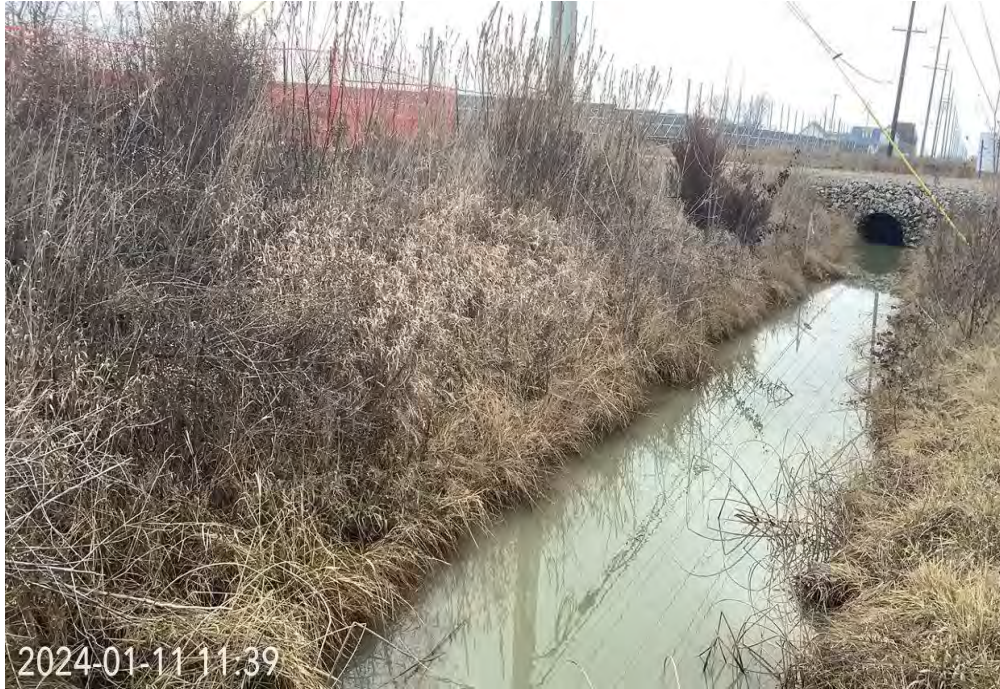
Photograph Location 3. View of Stream 1. Photograph taken facing upstream/north.

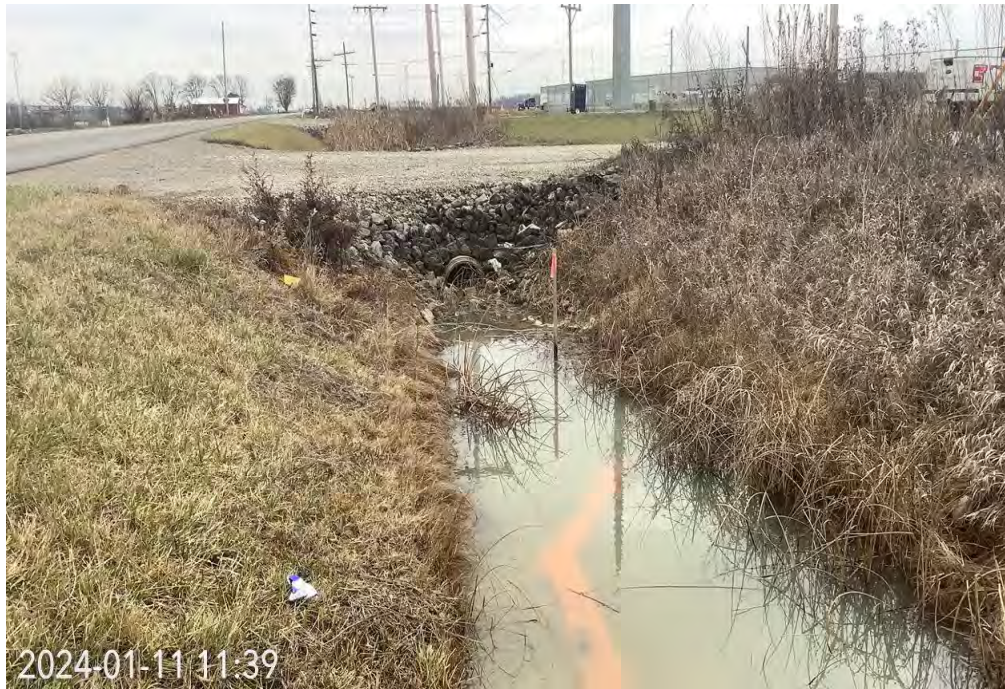
Photograph Location 3. View of Stream 1. Photograph taken facing downstream/south.

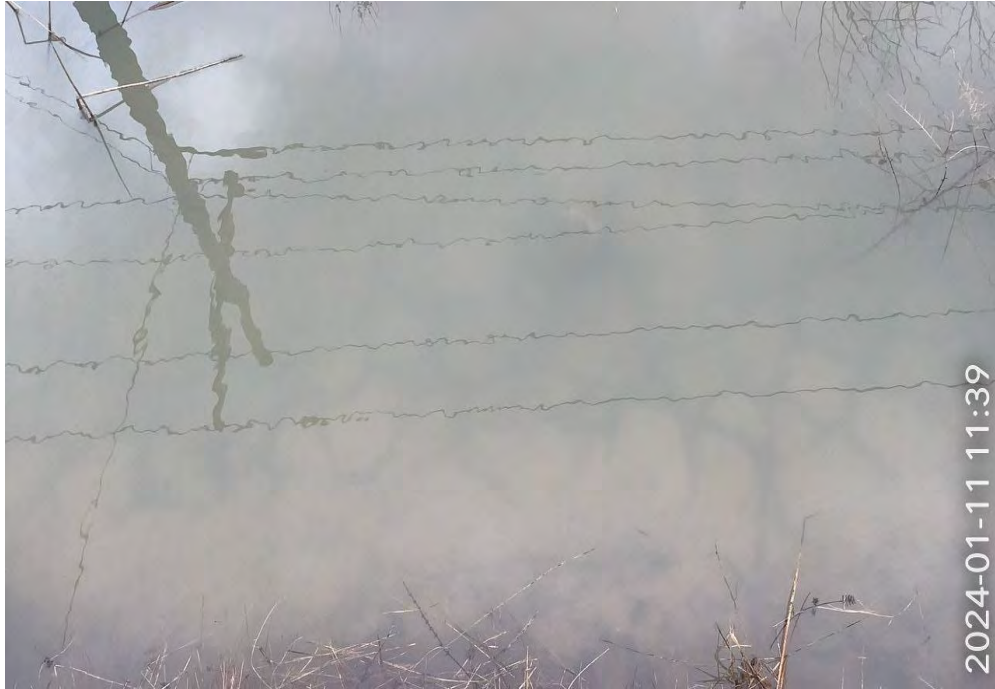
Photograph Location 3. View of substrates of Stream 1.

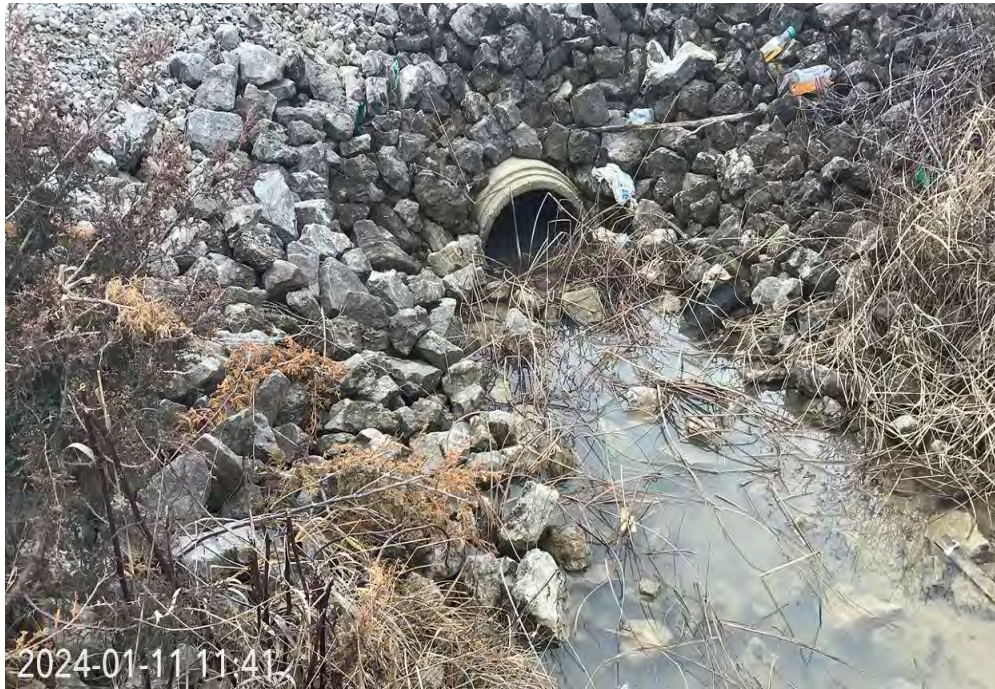
Photograph Location 4. Representative view of an existing culvert within the Project area. Photograph taken facing south.

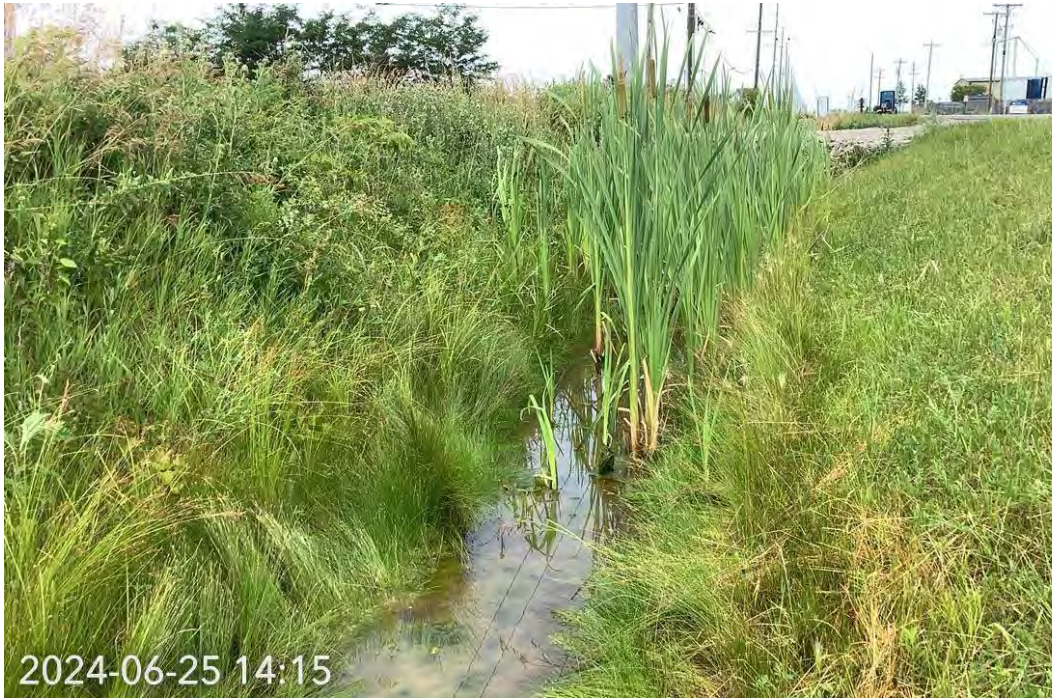
Photo Location 5. View of Stream 1. Photograph taken facing upstream/north.

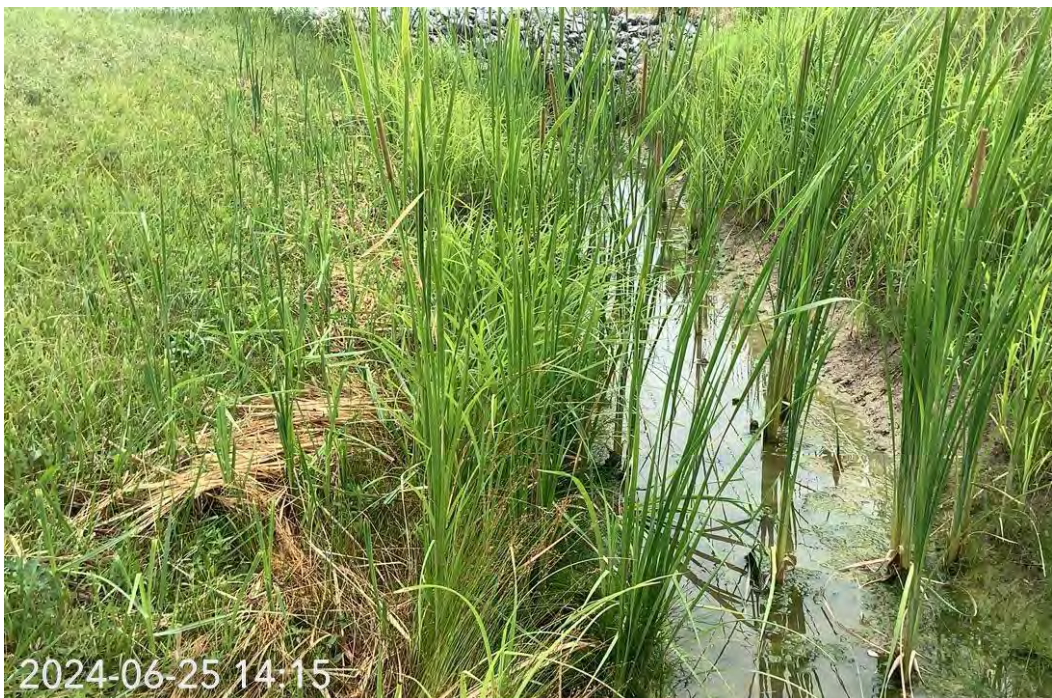
Photo Location 5. View of Stream 1. Photograph taken facing downstream/south.

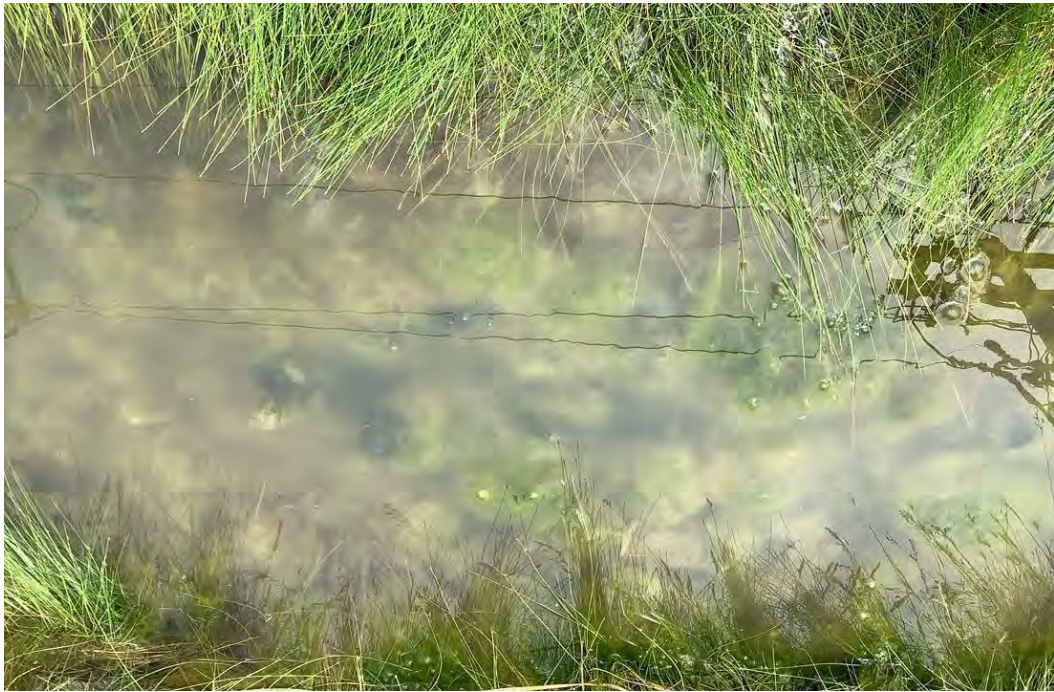
Photo Location 5. View of substrates of Stream 1.
