Letter of Notification for the South Kenton- Westminster and North Waldo-South Kenton 138 kV Transmission Line Relocations Project

PUCO Case No. 25-1022-EL-BLN

Submitted by:
AEP Ohio Transmission Company, Inc.

November 17, 2025

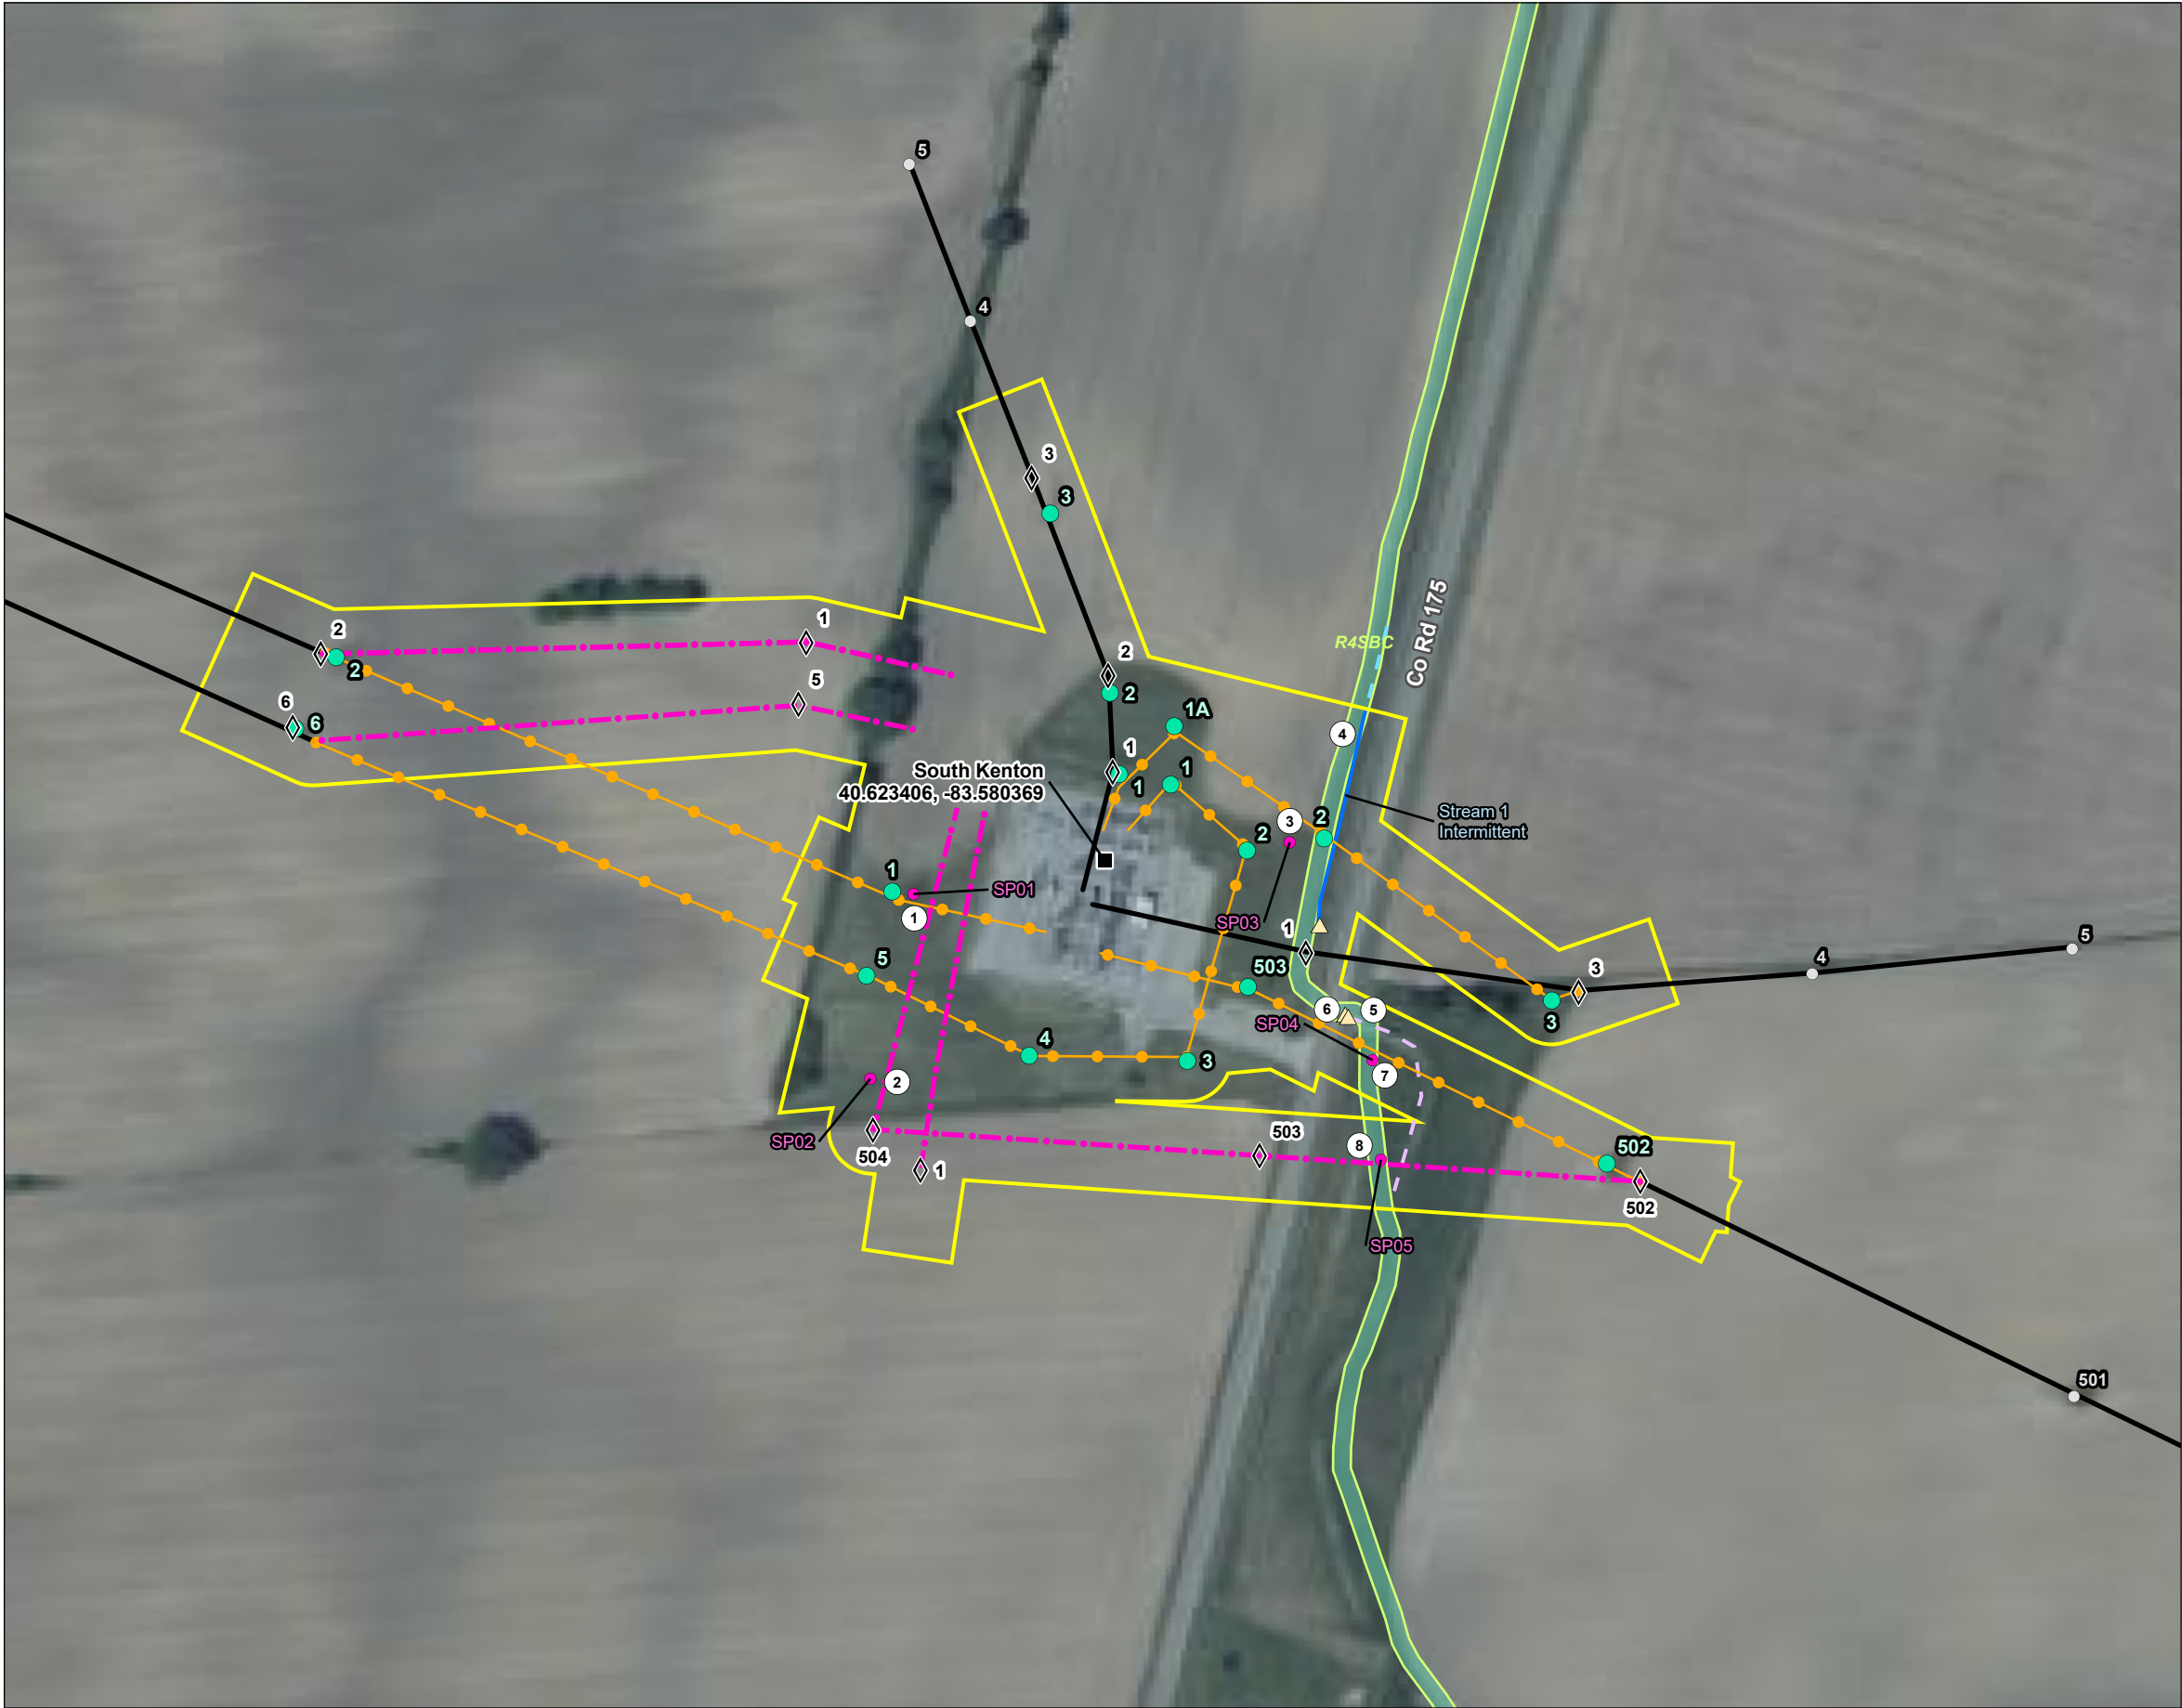
Figure No.
2
Title
Wetland and Waterbody Delineation Map

A.2 FIGURE 2 – WETLAND AND WATERBODY DELINEATION MAP

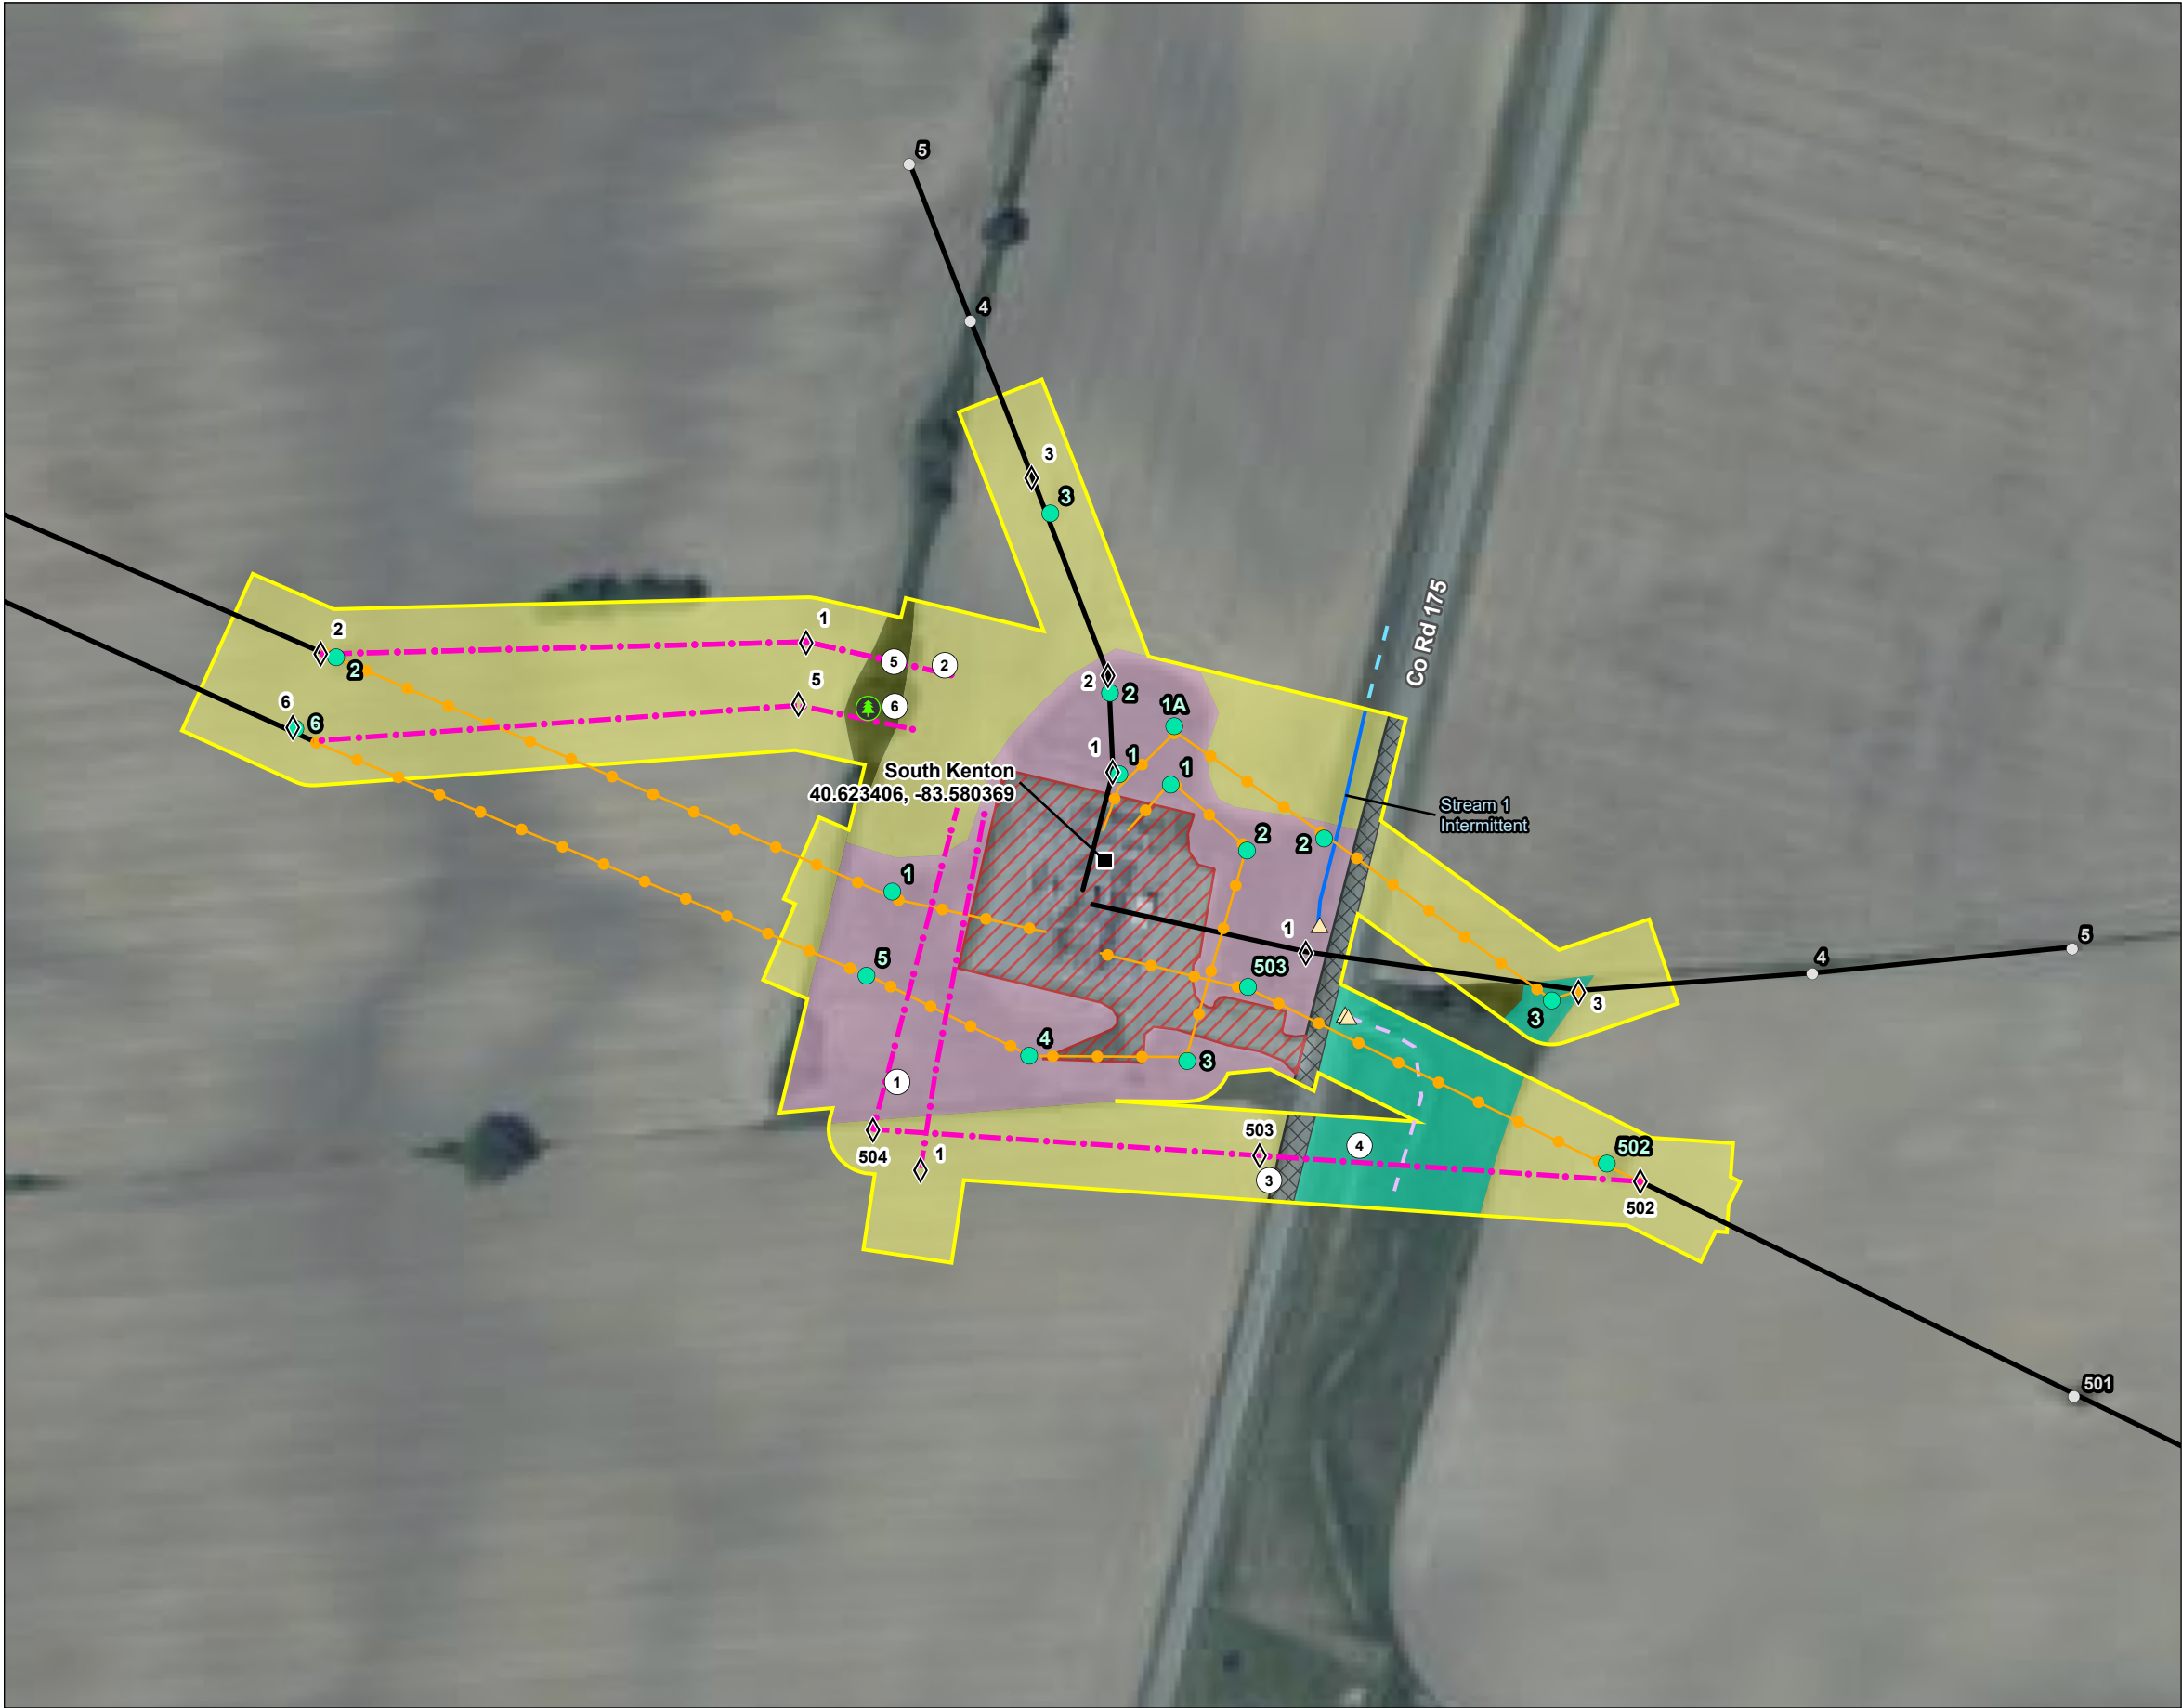
Figure No.
3
Title
Habitat Assessment Map

A.3 FIGURE 3 – HABITAT ASSESSMENT MAP

Stantec completed field surveys for threatened and endangered species or their habitats on April 19, 2023, and August 6, 2025. Figure 3 (Appendix A) shows the vegetation communities/habitats and land cover types identified within the Project area and the locations of any identified rare, threatened, or endangered species habitat observed within the Project area during the time of the habitat assessment surveys. Representative photographs of the vegetation communities/habitats and land cover types identified within the Project area are included in Appendix C of this report (photo locations are shown on Figure 3, Appendix A). Information regarding the vegetation communities/habitats/land cover types identified within the Project area is provided in Table 1.

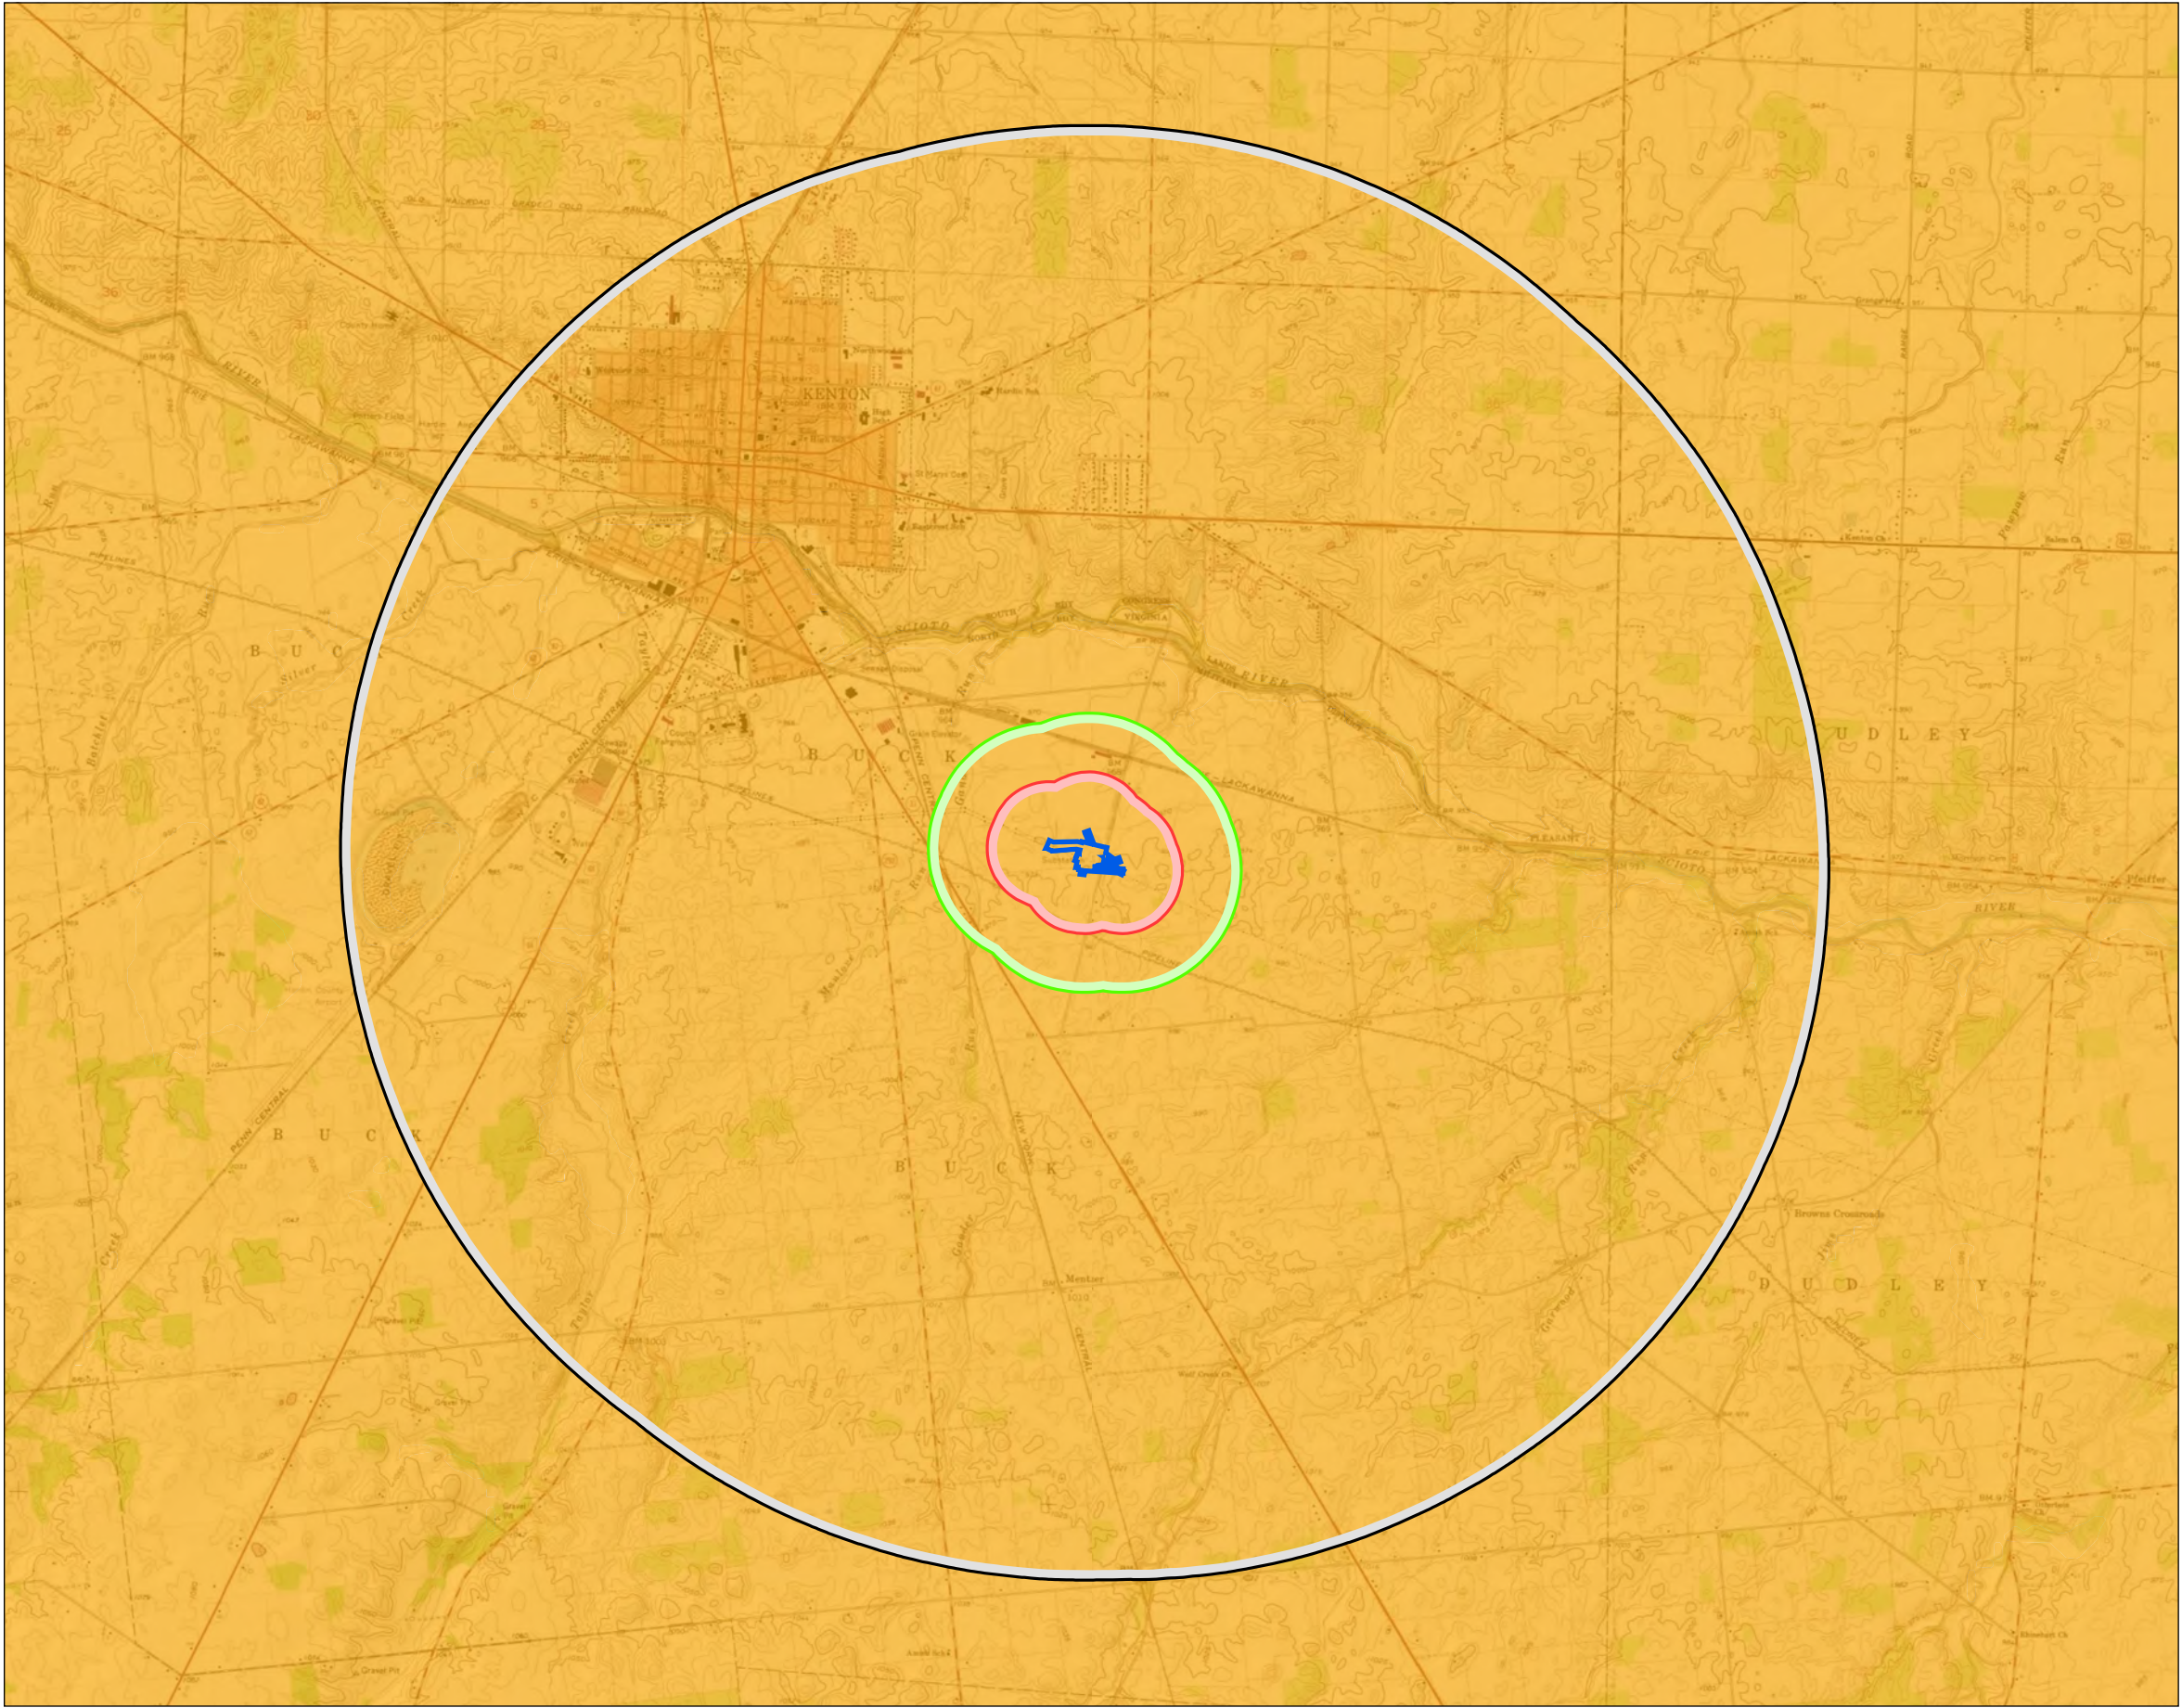
Figure No.
4

Title
Bat Hibernacula Desktop Study Map

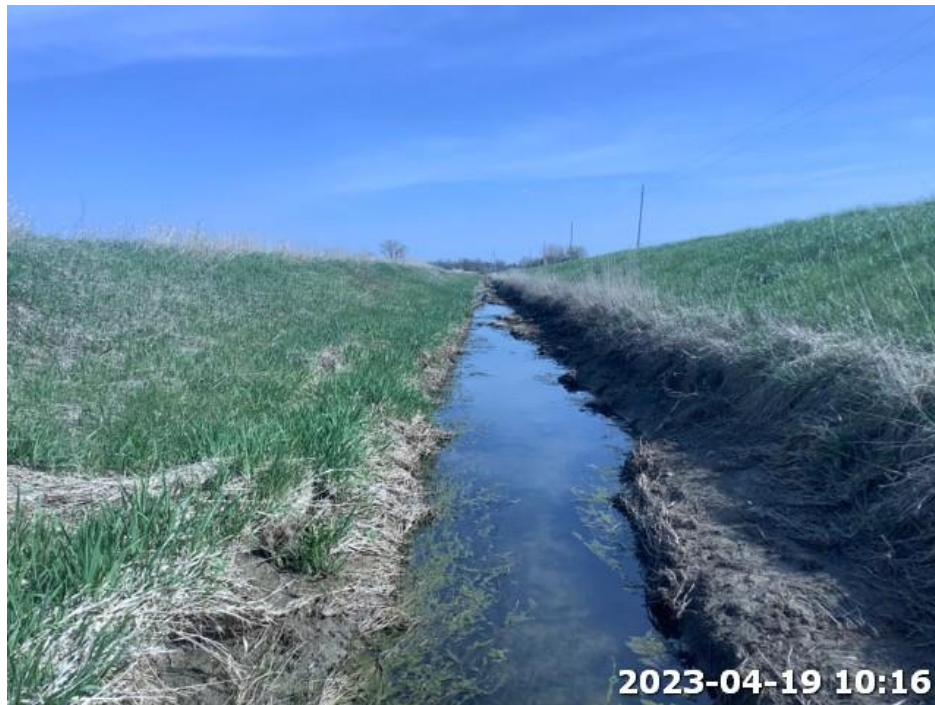
Photo Location 4. View of Stream 1. Photograph taken facing upstream/north.

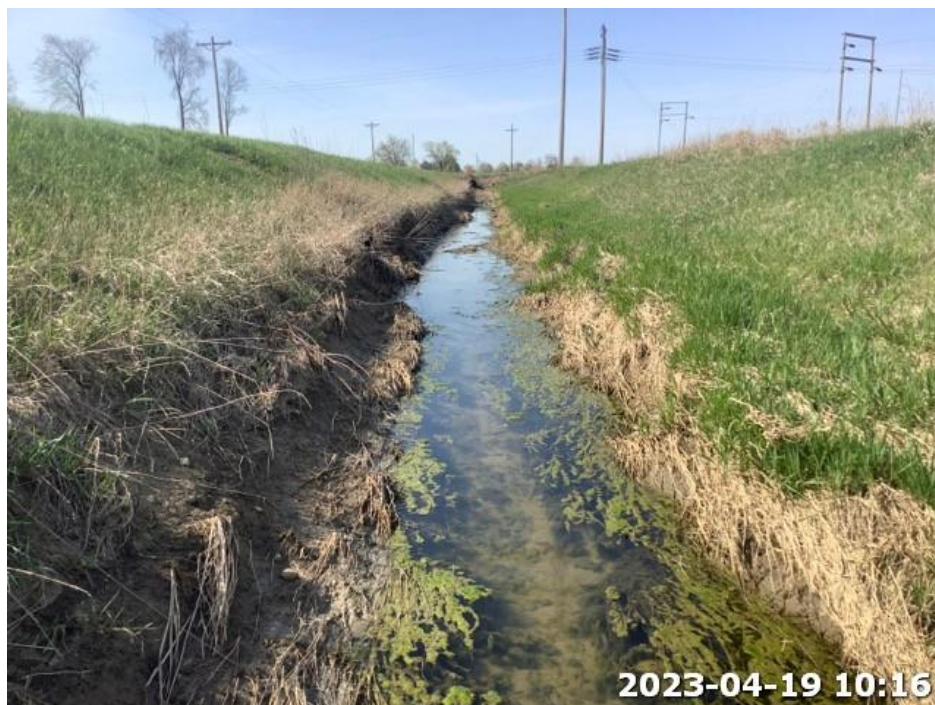
Photo Location 4. View of Stream 1. Photograph taken facing downstream/south.

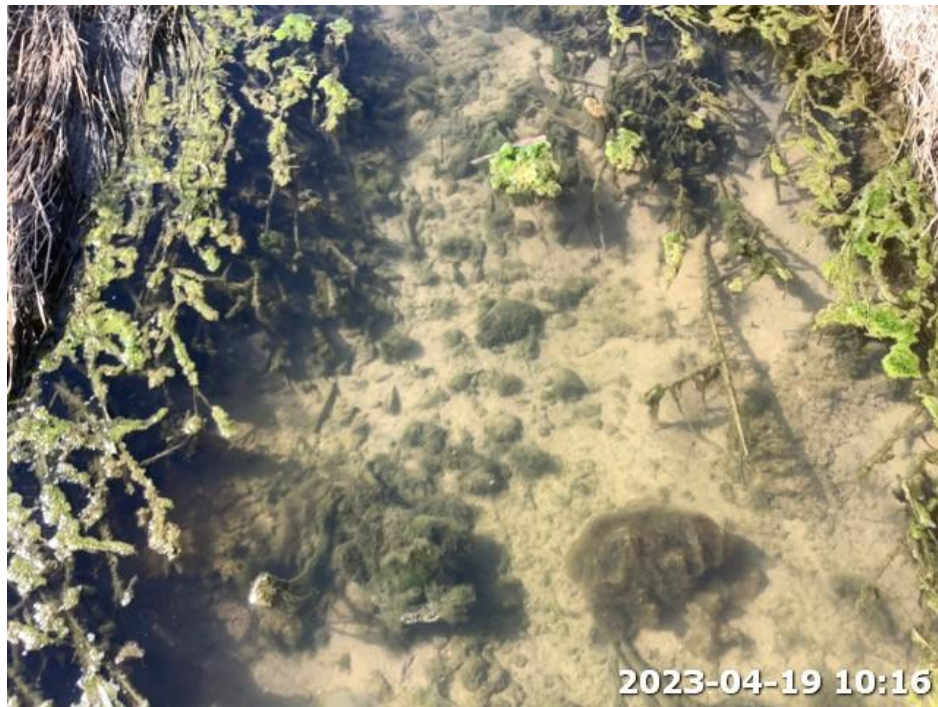
Photo Location 4. View of substrates of Stream 1.

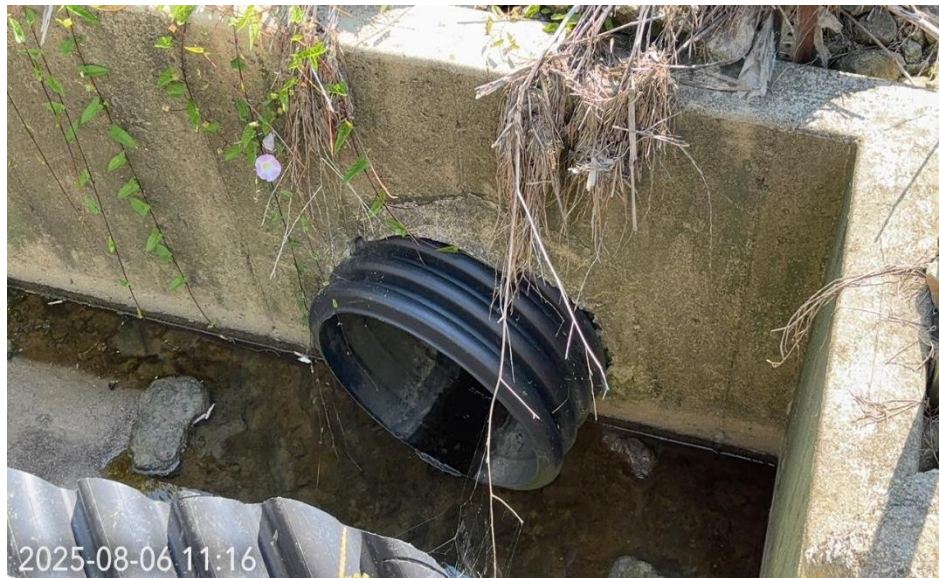
Photo Location 6. Representative view of existing culvert. Photograph taken facing east.

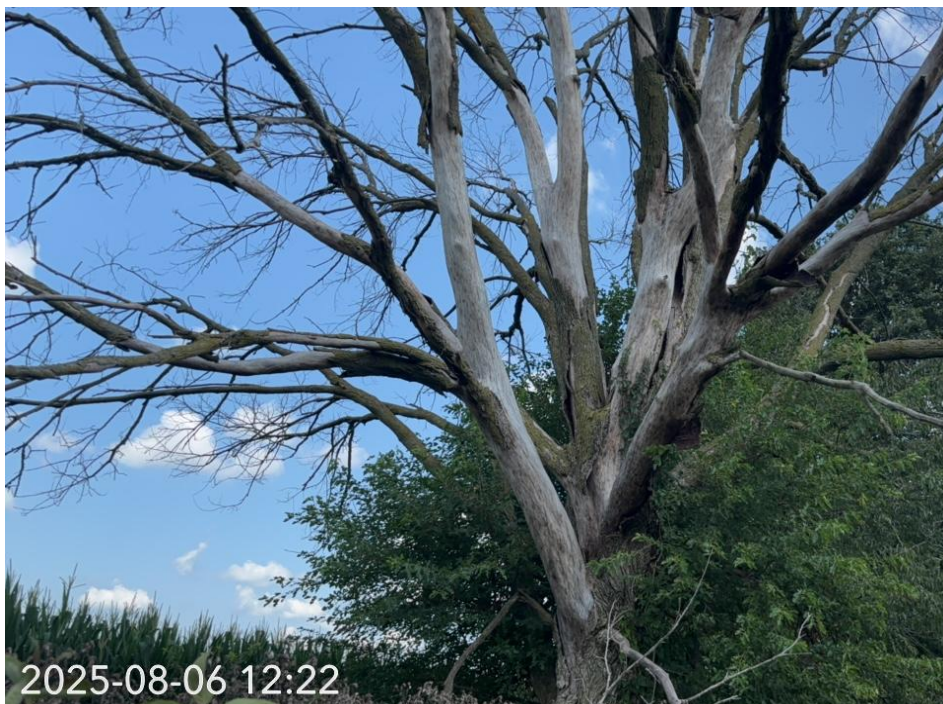
Photo Location 6. Representative view of a potential bat roost tree observed within the Project area. Photograph taken facing northwest.
