Letter of Notification for the Blackbird Temporary 138kV Extension Project

PUCO Case No. 25-0872-EL-BLN

Submitted by:
Ohio Power Company

November 3, 2025

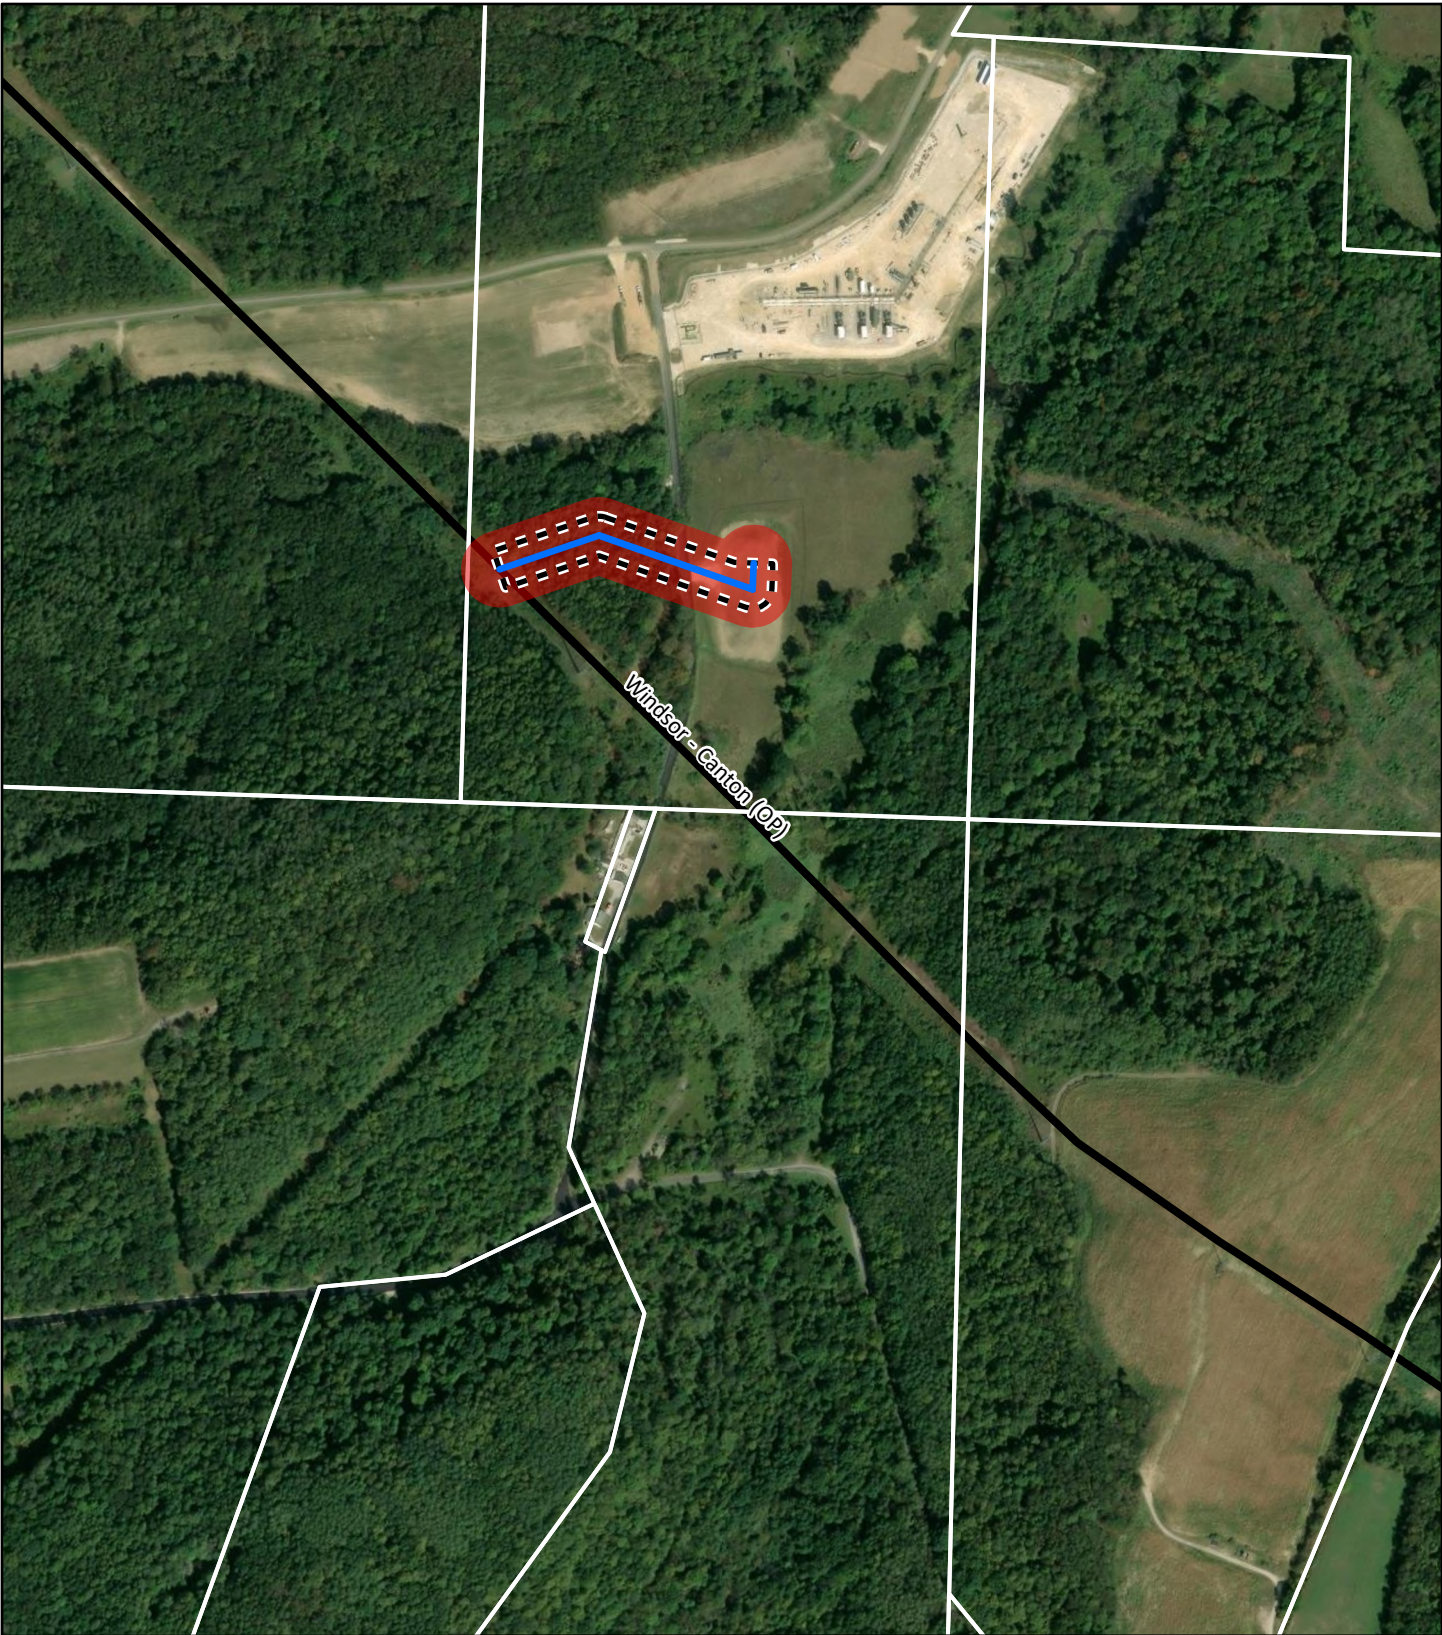
- Proposed Centerline
- Proposed 100 ft Right of Way
- Proposed Route
- Existing Transmission Line
- Parcel Boundary
