Figure 4-6: NHLs, NRHP-Listed, and Eligible Architectural Resources within 1.5 miles of the Project (West-half of alignment). Source: VCRIS

### 5. RESULTS OF FIELD RECONNAISSANCE

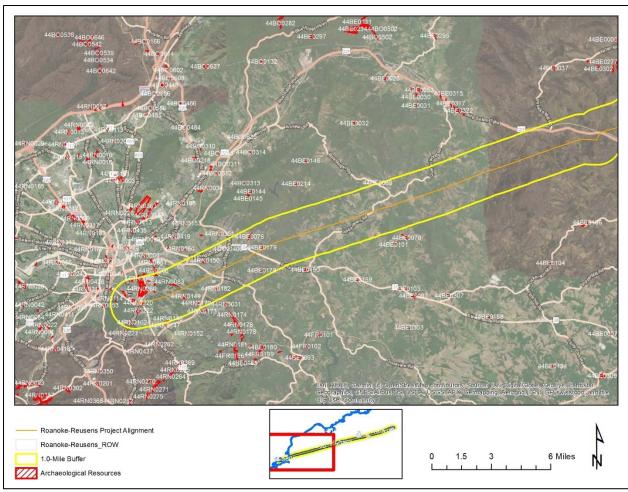
Figure 4-7: Previously Recorded Archaeological Resources Located within 1.0 mile of the Project (West-half of alignment). Source: VCRIS

**Table 4-3** lists all previously recorded archaeological resources located within 1.0 mile of the Project. **Figures 4-7 and 4-8** illustrates the locations of previously recorded sites within 1.0 mile of the Project and **Figure 4-9** illustrates the location of sites crossed by the Project ROW. The reported location of the Mountain View Church Cemetery is illustrated in **Figure 4-10**.

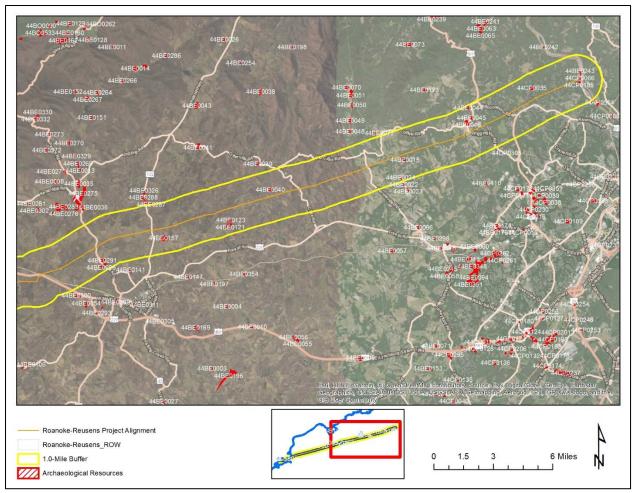
Figure 4-8: Previously Recorded Archaeological Resources Located within 1.0 mile of the Project (East-half of alignment). Source: VCRIS

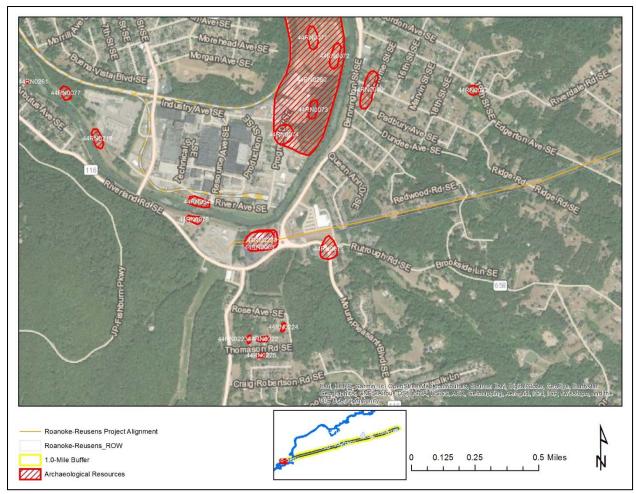
Figure 4-9: Detail of Previously Recorded Archaeological Resources Located within the Project ROW. Source: VCRIS

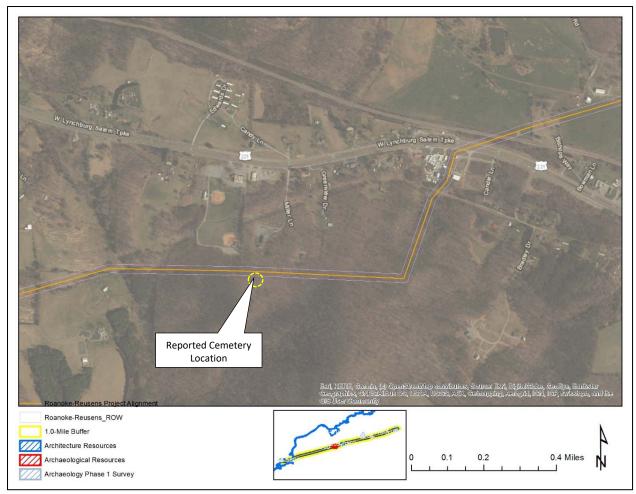
Figure 4-10: General location of the Mountain View Church Cemetery in relation to the Project ROW. Source: POWER

One additional site, the Mountain View Church Cemetery, has not been previously recorded or investigated, but was brought to attention by a local property owner and is located adjacent to the Project ROW.

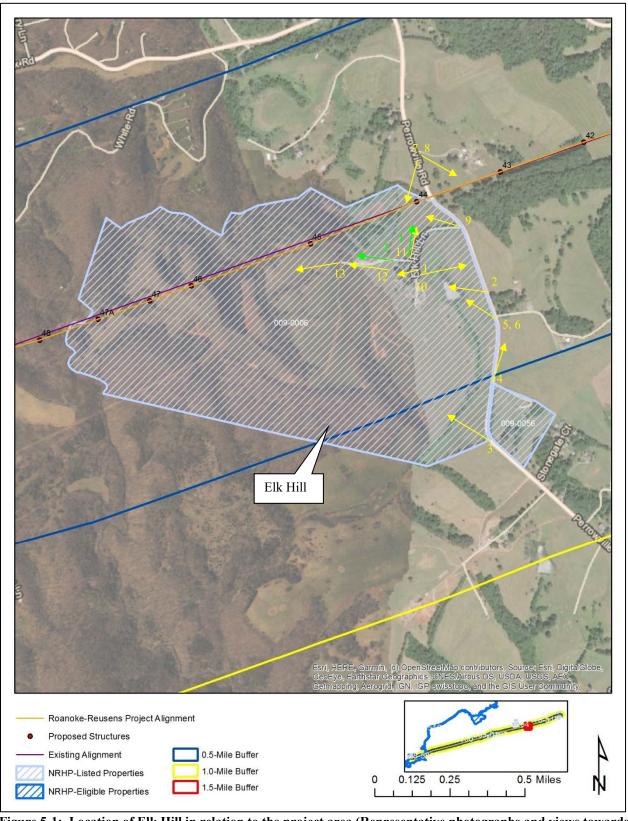
Figure 5-1: Location of Elk Hill in relation to the project area (Representative photographs and views towards the Project depicted in yellow, Photo Sims depicted in green).

**Figure 5-1** depicts the location of Elk Hill in relation to the Project and viewshed buffers, with the location and direction of all representative photographs. **Figures 5-2 through 5-14** are representative photographs of the property, as well as those taken from locations within and near the property towards the Project. **Figures 5-15 through 5-20** provide photo simulations of the Project from the property.

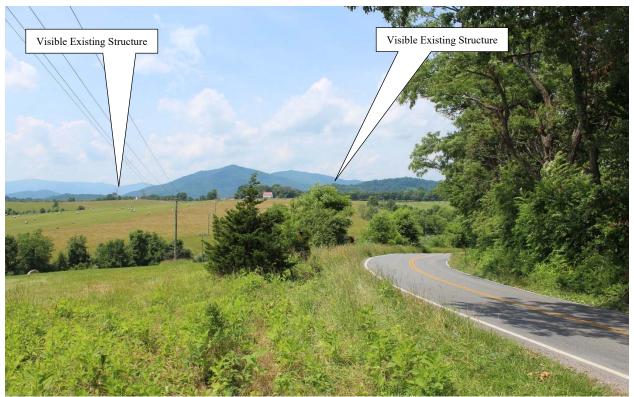
Figure 5-4: Photo location 3- View from Perrowville Road at south edge of Elk Hill property towards the property and Project (two existing structures seen above treeline), facing northwest.

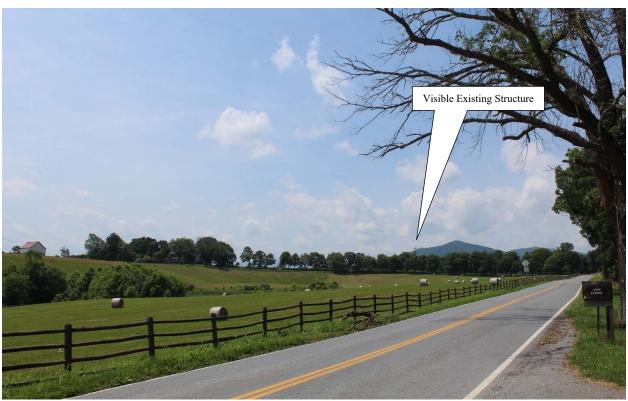
Figure 5-6: Photo location 5- View from Perrowville Road along front of Elk Hill towards the property and Project (one existing structure visible above treeline), facing northwest.

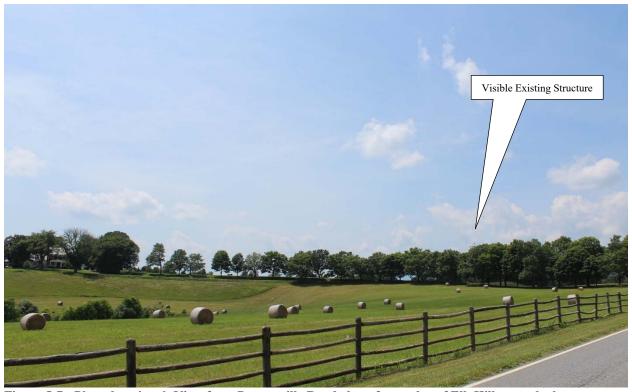
Figure 5-7: Photo location 6- View from Perrowville Road along front edge of Elk Hill towards the property and Project (one existing structure visible above treeline), facing northwest.

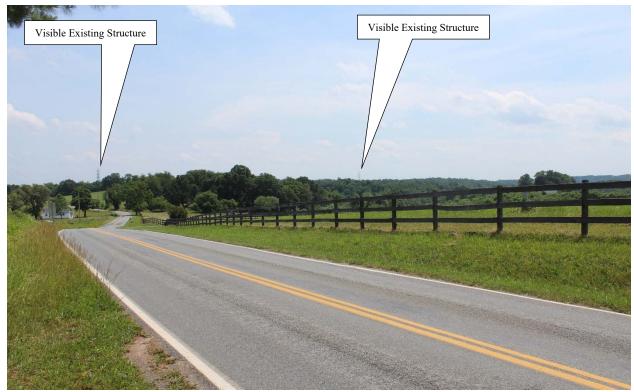
Figure 5-8: Photo location 7- View from Perrowville Road at north edge of Elk Hill property towards the Project (one existing structure visible through break in treeline and one visible above treeline), facing southwest.

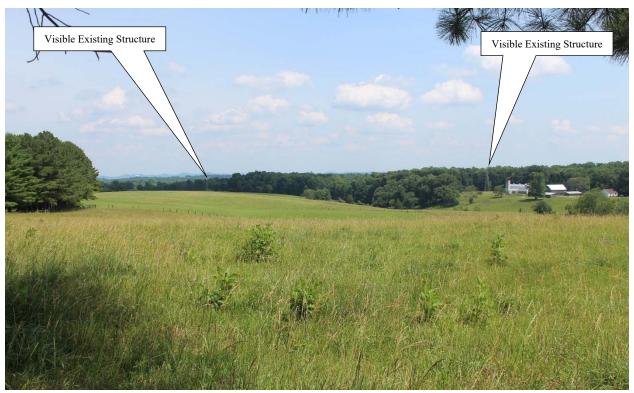
Figure 5-9: Photo location 8- View from Perrowville Road at north edge of Elk Hill property towards the Project across the road (two existing structures seen across open field), facing southeast.

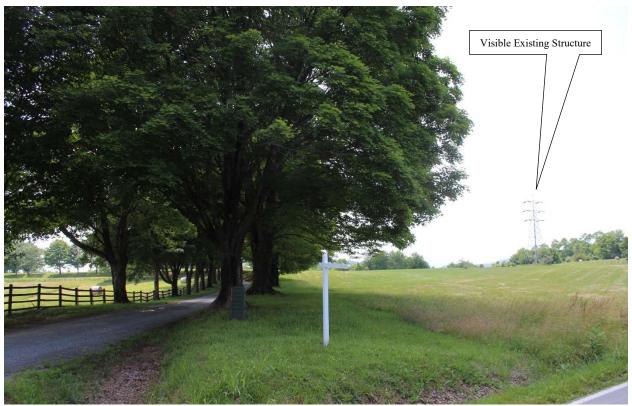
Figure 5-10: Photo location 9- View from Elk Hill driveway towards the Project (one existing structure seen in front field), facing west.

Hill property is located in the field immediately adjacent to the driveway and is thus highly visible when approaching the house, however, vegetation bordering the driveway and within the homesite inhibits views of additional structures on the property or beyond. Inspection from the homesite found that visibility of existing structures is generally more limited than from the road along the front of the property due to mature landscaping and vegetation around the homesite. From the front of the house, the structure bordering the driveway is screened by trees and structures across the road are screened by a thick wooded area. From the back of the house, the existing structures become slightly more visible from discrete vantage points, although is still limited to one or two structures, including the one in the field adjacent to the driveway and the next one back. The additional structures to the rear of the property and below the horizon due to the topography of the area, however, they become visible from a vantage point at the rear secondary dwelling. From here, an additional structure on the property is visible, as is a structure far in the distance that is set atop a ridgeline.

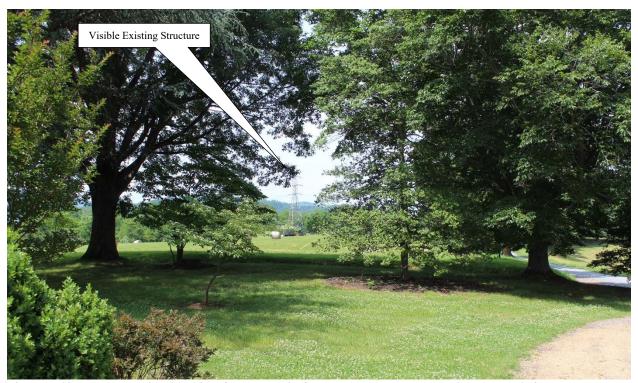
Figure 5-12: Photo location 11- View from Elk Hill front lawn towards the Project (one existing structure visible in front field), facing north.

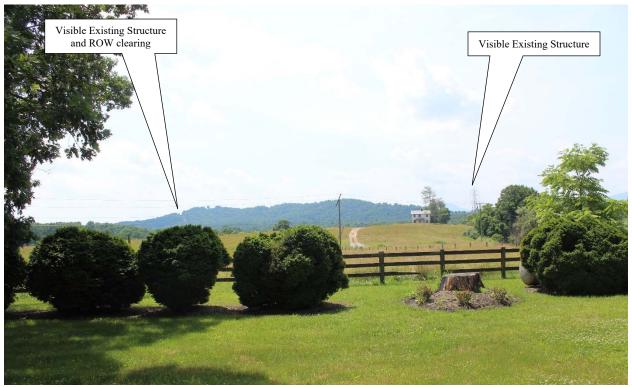
Figure 5-13: Photo location 12- View from Elk Hill rear lawn towards the Project (one existing structure on property visible across open field and one existing structure and ROW clearing visible in distance), facing west.

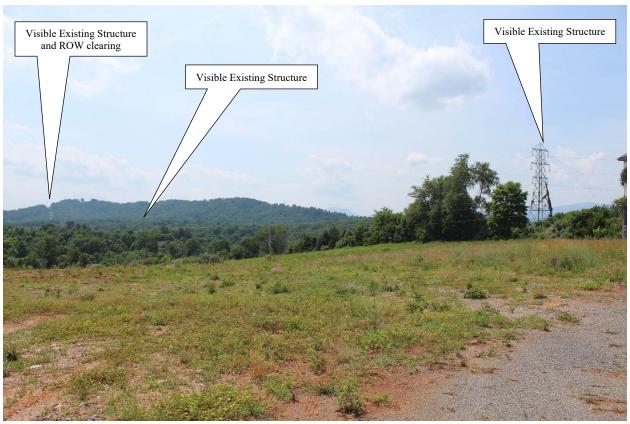
Figure 5-14: Photo location 13- View from Elk Hill secondary dwelling towards the Project (one existing structure on property visible across open field, one existing structure on property visible above treeline, and one existing structure and ROW clearing visible in distance), facing west.

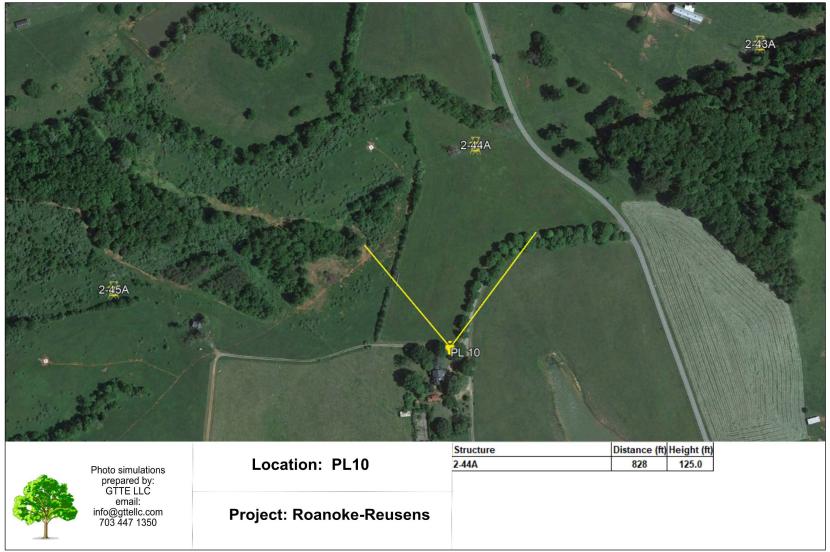
Figure 5-15: Elk Hill Simulation 1 - Simulation location, direction of view, and structures modeled to north side of the home. Source: GTTE, LLC

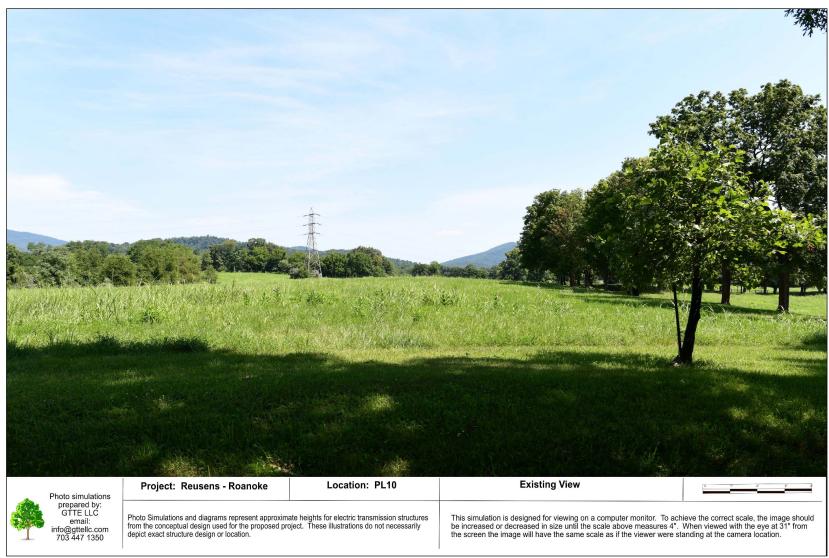
Figure 5-16: Elk Hill Simulation 1 – Existing view from north side of home. Source: GTTE, LLC

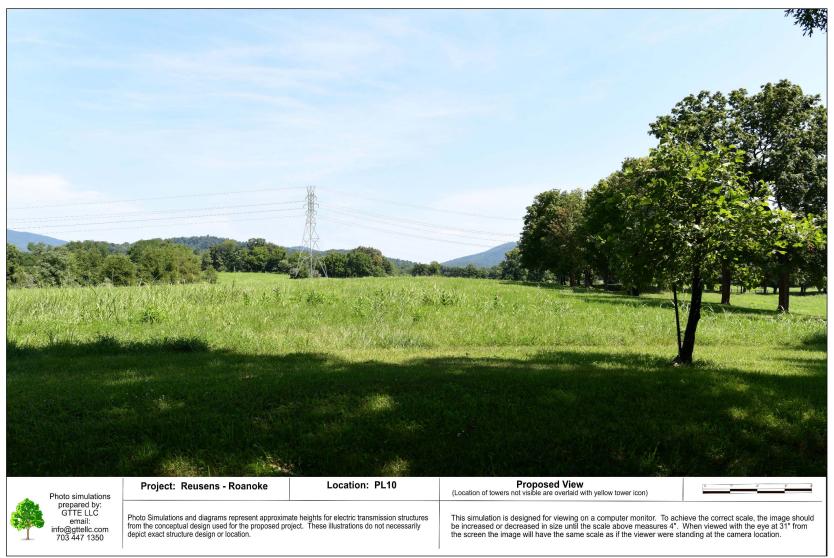
Figure 5-17: Elk Hill Simulation 1 - Proposed view from north side of home - (Visible structure shown as it would appear). Source: GTTE, LLC

The existing transmission line structures on the Elk Hill property are steel lattice and range from approximately 92- to 113-feet tall and the proposed replacement structures will remain lattice and range from approximately 110-feet to 140-feet tall. As such, there will be an increase in structure height, and while structures will generally be replaced on a one-to-one basis near existing structures, there be one additional structure built near the rear of the property to span Elk Creek. Project improvements will remain in the existing ROW at the front of the property, however, a slight realignment will take place near the rear of the property requiring additional ROW. Under these circumstances, it is anticipated that visibility of the replacement structures will be similar to the existing structures that are currently visible, albeit in a slightly taller and different configuration. It is expected that other structures that are currently screened by topography and vegetation will remain as such despite the increase. This was confirmed with photo simulation that shows the increase in structure height will be noticeable to the side and rear of the home, however, views will be limited to currently visible structures with no dramatic change. As such, the Project will introduce a slight change in visibility of the transmission line when looking towards or out from the property, however, it will not equate to a substantial change of viewshed or setting that already includes visibility of the existing transmission line and multiple structures. It is therefore D+A's opinion that the Project will have no more than a minimal impact on Elk Hill per VDHR's impact characterization.

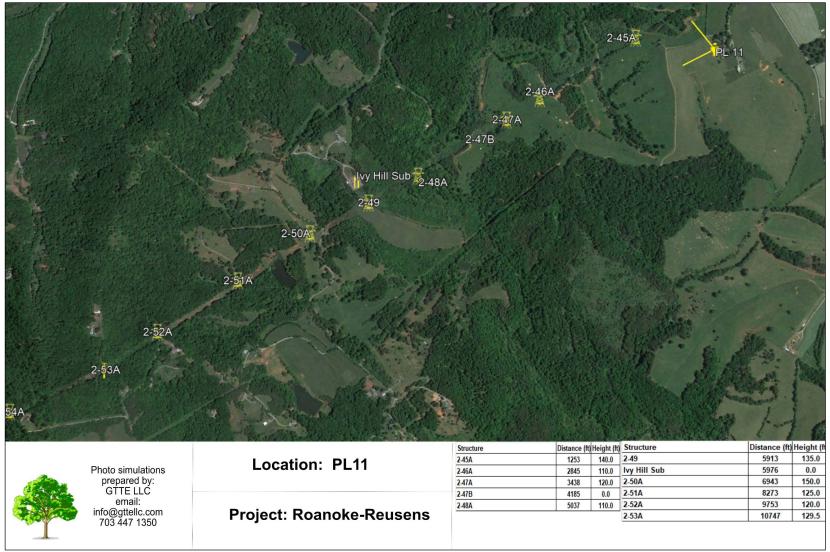
Figure 5-18: Elk Hill Simulation 2 - Simulation location, direction of view, and structures modeled to the rear of the property. Source: GTTE, LLC

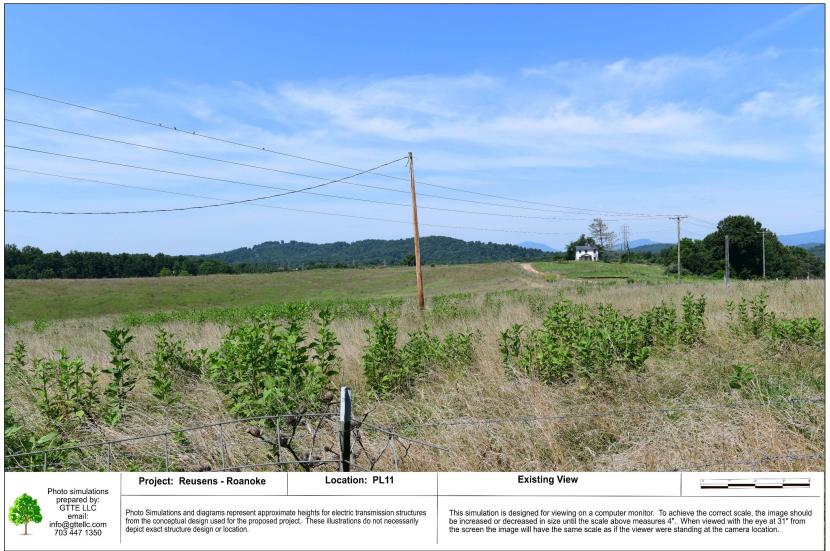
Figure 5-19: Elk Hill Simulation 2 – Existing view towards the rear of the property. Source: GTTE, LLC

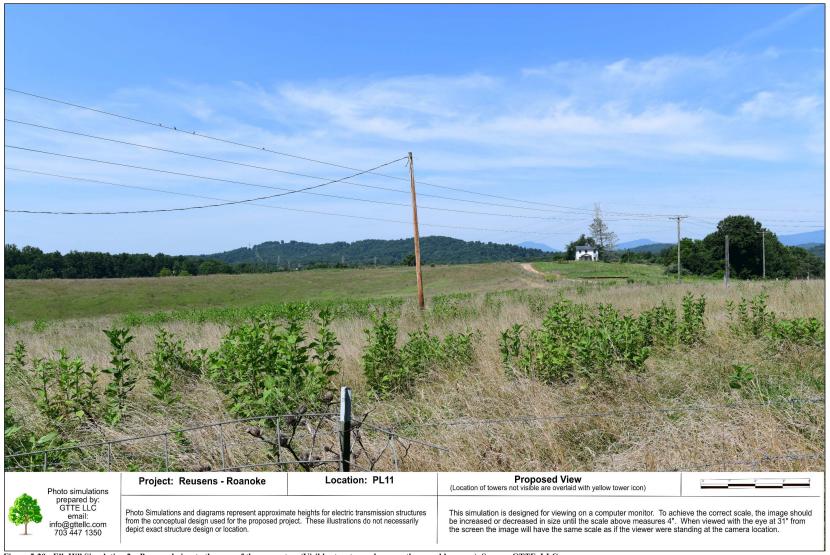
Figure 5-20: Elk Hill Simulation 2 - Proposed view to the rear of the property - (Visible structures shown as they would appear). Source: GTTE, LLC

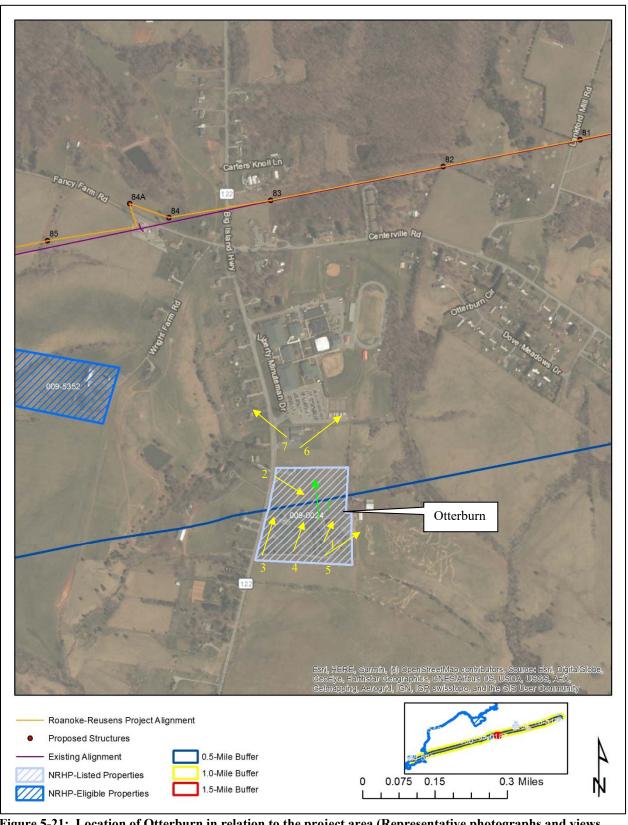
Figure 5-21: Location of Otterburn in relation to the project area (Representative photographs and views towards the project area depicted in yellow, photo sims depicted in green).

**Figure 5-21** depicts the location of Otterburn in relation to the Project and viewshed buffers, with the location and direction of all representative photographs. **Figures 5-22 through 5-28** are representative photographs of the property, as well as those taken from locations within and near the property towards the Project. **Figures 5-29 through 5-31** provide photo simulations of the Project from the property.

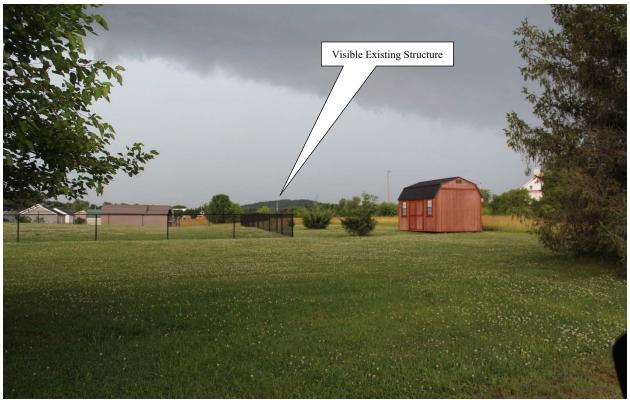
Figure 5-25: Photo location 4- View from Otterburn driveway towards the Project (one existing structure seen through break in development and vegetation), facing north.

Inspection from the road along the side of the Otterburg property found that the existing transmission line is completely screened by intervening topography, development, and vegetation. Inspection from the property revealed similarly screened views towards the existing transmission line from most vantage points, however, an existing structure may be seen from the driveway through a break in vegetation and development.

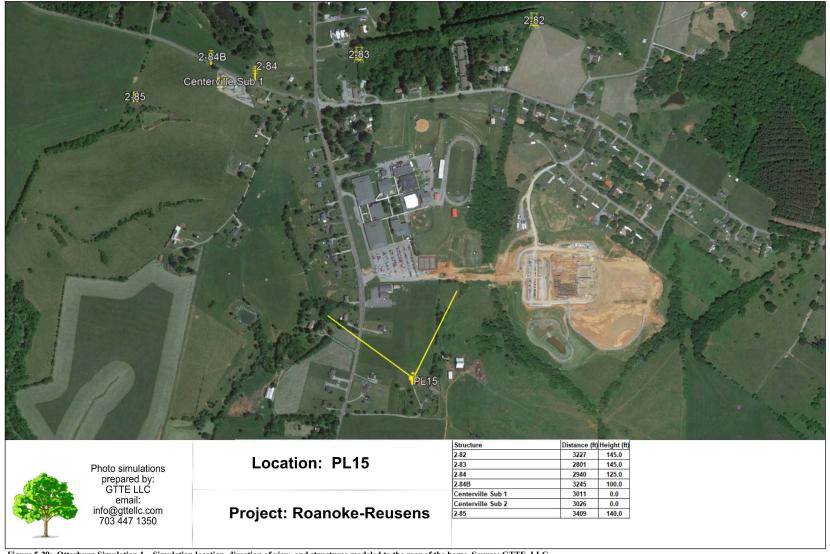
Figure 5-29: Otterburn Simulation 1 - Simulation location, direction of view, and structures modeled to the rear of the home. Source: GTTE, LLC

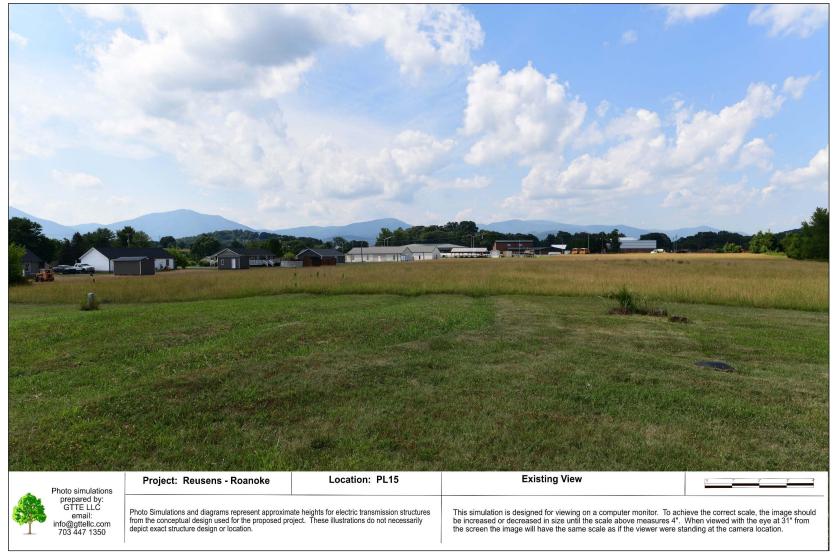
Figure 5-30: Otterburn Simulation 1 – Existing view from the rear of the home. Source: GTTE, LLC

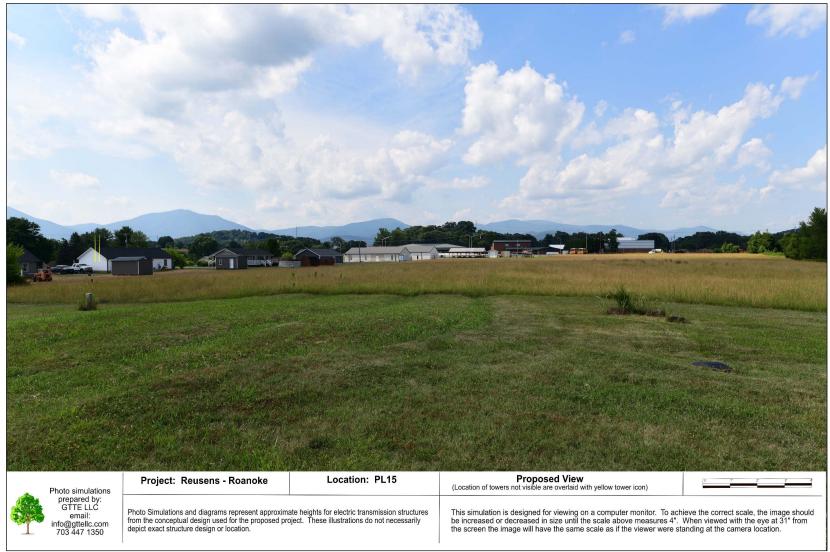
Figure 5-31: Otterburn Simulation 1 - Proposed view from the rear of the home - (Visible structures shown as the would appear. Screened structures sown in yellow). Source: GTTE, LLC

The existing transmission line structures within one-half mile of the property, including those within the Centerville substation, are steel lattice and range from approximately 64- to 115-feet tall and the proposed replacement structures will remain lattice and range from approximately 100-feet to 150-feet tall. As such, there will be an increase in structure height, and while structures will generally be replaced on a one-to-one basis near existing structures, there will be a slight shift in alignment around and to the west of the Centerville substation that will require an expansion of ROW. Still, it is anticipated that the replacement structures will remain mostly screened by the intervening topography, development, and vegetation. The one existing structure that is currently visible from discrete vantage points will likely remain visible, although taller and in a similar configuration, and there is a potential for one or two additional structures to become visible above or through breaks in vegetation. However, all visible structures would be seen in conjunction with and behind extensive modern development. This was confirmed with photo simulation that shows three structures will be visible from the rear of the house above the treeline and other modern development in the distance. As such, the Project may introduce a slight change and/or increase in visibility of the transmission line, however, it will not introduce any substantial change in setting or viewshed of or from the property that has already been compromised by modern development and infrastructure. It is therefore D+A's opinion that the Project will have no more than a minimal impact on Otterburn per VDHR's impact characterization.

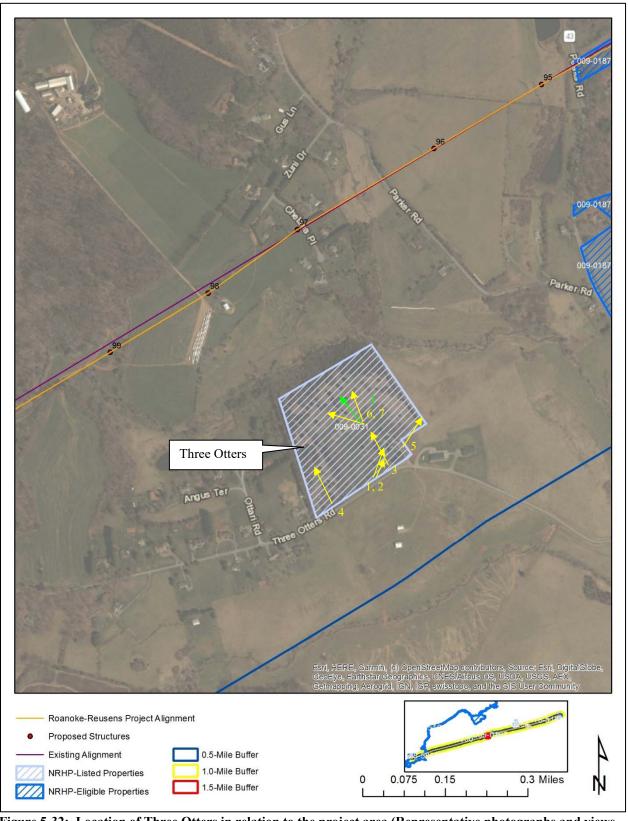
Figure 5-32: Location of Three Otters in relation to the project area (Representative photographs and views towards the project area depicted in yellow, photo sims depicted in green).

**Figure 5-32** depicts the location of Three Otters in relation to the Project and viewshed buffers, with the location and direction of all representative photographs. **Figures 5-33 through 5-39** are representative photographs of the property, as well as those taken from locations within and near the property towards the Project. **Figures 5-40 through 5-42** provide photo simulations of the Project from the property.

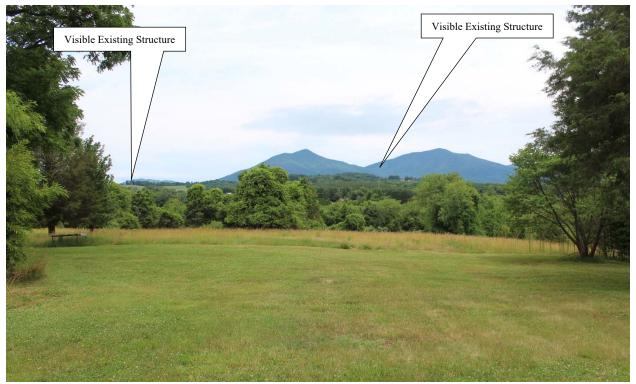
Figure 5-38: Photo location 6- View from rear of Three Otters property towards the Project (two existing structures visible above treeline), facing north.

The existing transmission line structures within one-half mile of the property are steel lattice and range from approximately 92- to 115-feet tall and the proposed replacement structures will remain lattice and range from approximately 110-feet to 155-feet tall. As such, there will be a substantial increase in structure height, and while structures will generally be replaced on a one-to-one basis near existing structures, there will be a slight shift in alignment that will require an expansion of ROW towards the property. Under these circumstances, it is anticipated that visibility of the line and structures may increase, with currently visible structures becoming taller and rising higher above the treeline, and the potential for additional structures currently screened by vegetation to become visible. This was confirmed with photo simulation from the rear of the home that shows several structures rising higher above the treeline, including a structure not currently visible. As such, the Project has the potential to introduce a noticeable increase in visibility of the transmission line, resulting in a change in setting and viewshed of and from the property. It is therefore D+A's opinion that the Project may have as much as a *moderate impact* on Three Otters per VDHR's impact characterization.

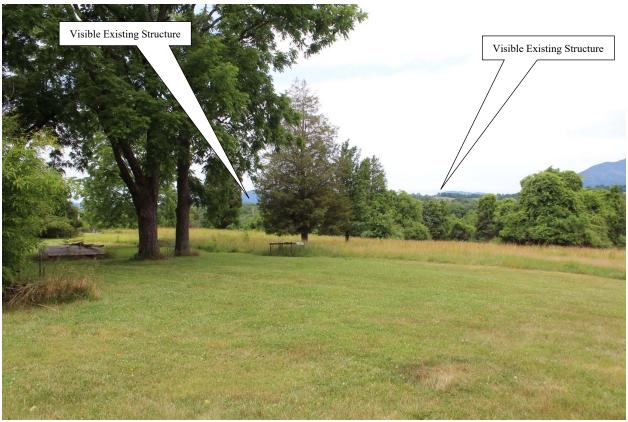
Figure 5-39: Photo location 7- View from rear of Three Otters property towards the Project (two existing structures visible above treeline and through gap in trees), facing northwest.

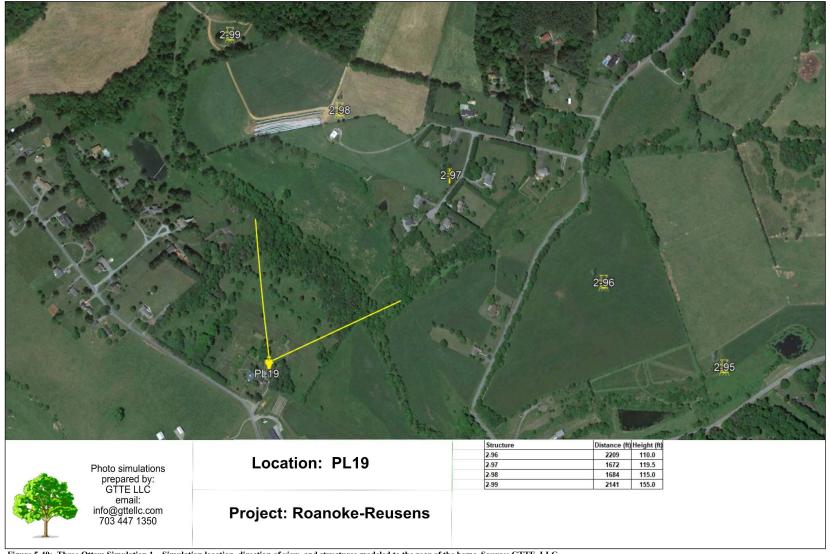
Figure 5-40: Three Otters Simulation 1 - Simulation location, direction of view, and structures modeled to the rear of the home. Source: GTTE, LLC

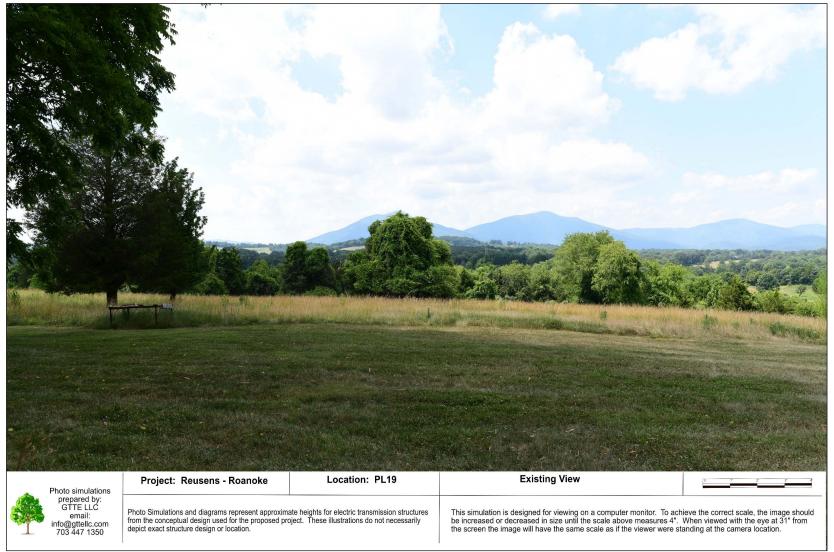
Figure 5-41: Three Otters Simulation 1 – Existing view to the rear of the home. Source: GTTE, LLC

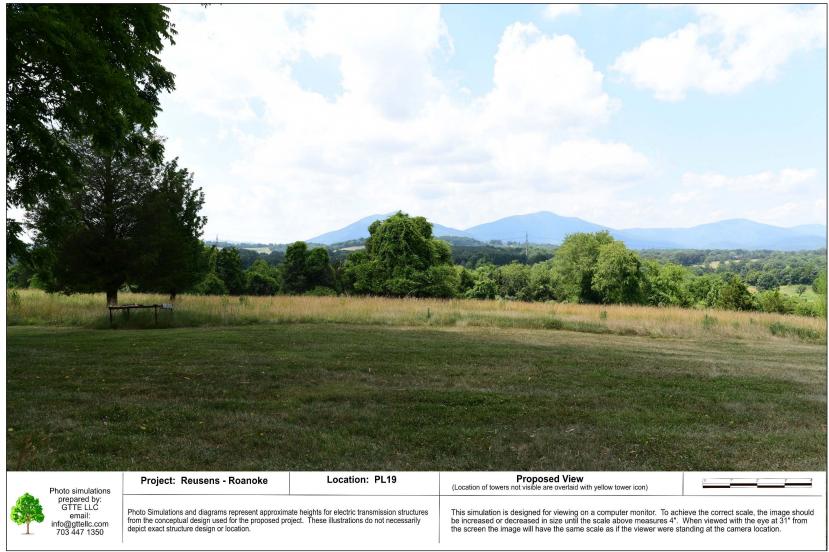
Figure 5-42: Three Otters Simulation 1 - Proposed view to the rear of the home - (Visible structures shown as they would appear). Source: GTTE, LLC

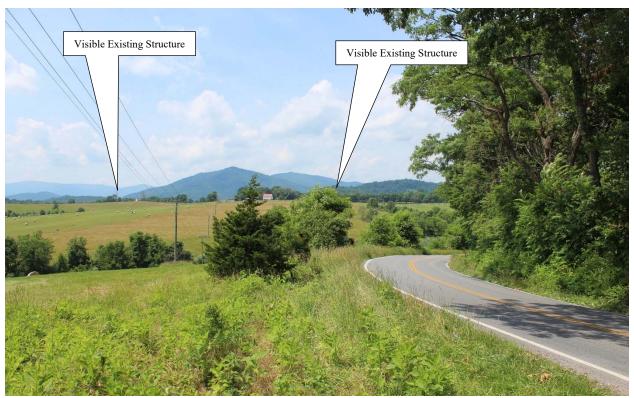
Figure 5-48: Photo location 5- View from front edge of Old Rectory property towards the Project (two existing structures visible above treeline in distance), facing northwest.

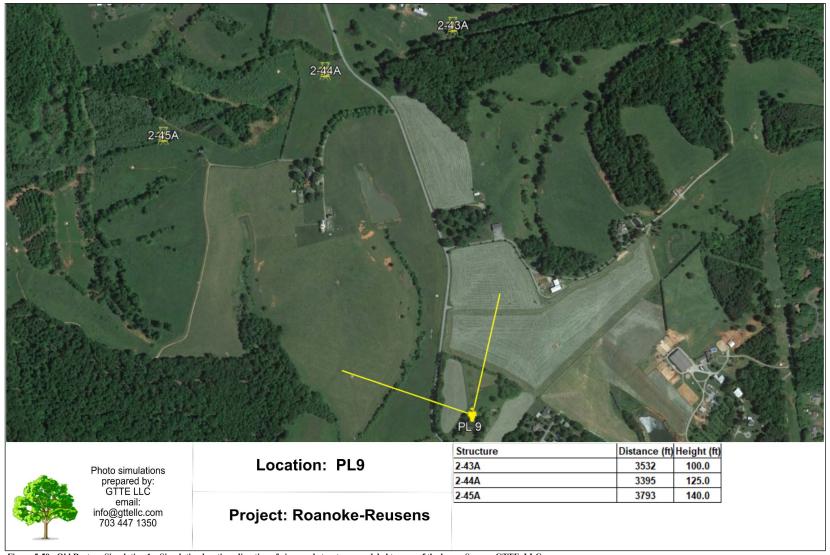
Figure 5-50: Old Rectory Simulation 1 - Simulation location, direction of view, and structures modeled to rear of the home. Source: GTTE, LLC

**Figure 5-43** depicts the location of the Old Rectory in relation to the Project and viewshed buffers, with the location and direction of all representative photographs. **Figures 5-44 through 5-49** are representative photographs of the property, as well as those taken from locations within and near the property towards the Project. **Figures 5-50 through 5-52** provide photo simulations of the Project from the property.

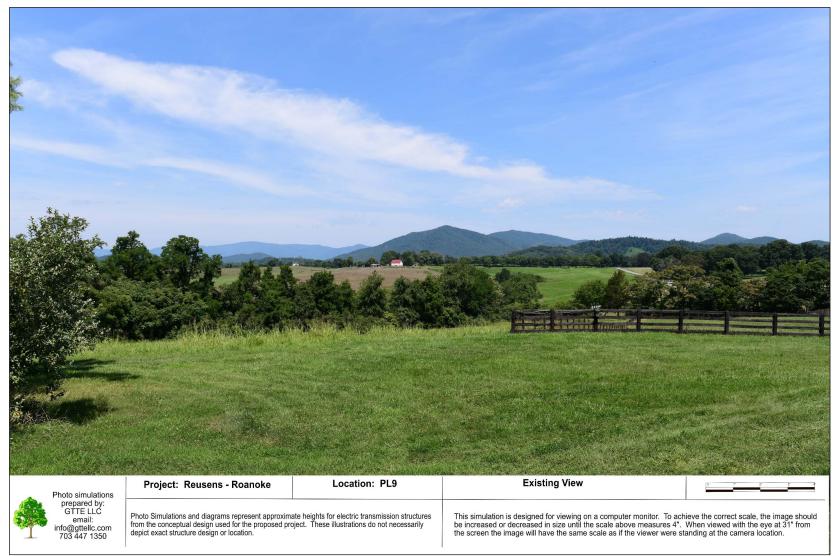
Figure 5-51: Old Rectory Simulation 1 – Existing view from rear of home. Source: GTTE, LLC

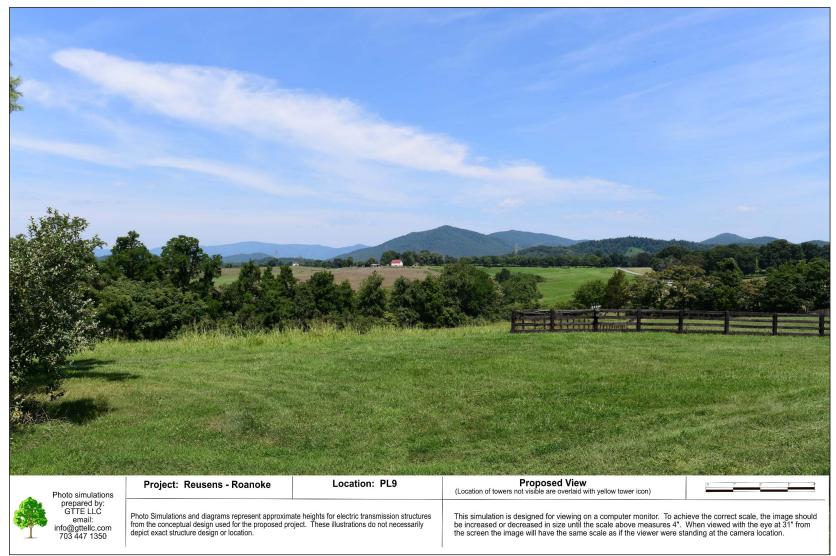
Figure 5-52: Old Rectory Simulation 1 - Proposed view from rear of home - (Visible structures shown as they would appear. Screened structures shown in yellow). Source: GTTE, LLC

The existing transmission line structures within one-half mile of the property are steel lattice and range from approximately 92- to 100-feet tall and the proposed replacement structures will remain lattice and range from approximately 100-feet to 160-feet tall. As such, there will be a substantial increase in structure height, although structures will generally be replaced on a one-to-one basis near existing structures. As such, it is anticipated that visibility of the line and structures may increase from the public road along the front of the property, with currently visible structures becoming taller and rising higher above the treeline. There is also the potential for additional structures currently screened by vegetation to become visible, particularly to the rear of the house. This was confirmed with photo simulation from the rear of the house that shows two structures rising substantially higher above the treeline, while one that is currently not visible will remain screened. As such, the Project has the potential to introduce a noticeable increase in visibility of the transmission line, resulting in a change in setting and viewshed of and from the property. It is therefore D+A's opinion that the Project may have as much as a *moderate impact* on the Old Rectory per VDHR's impact characterization.

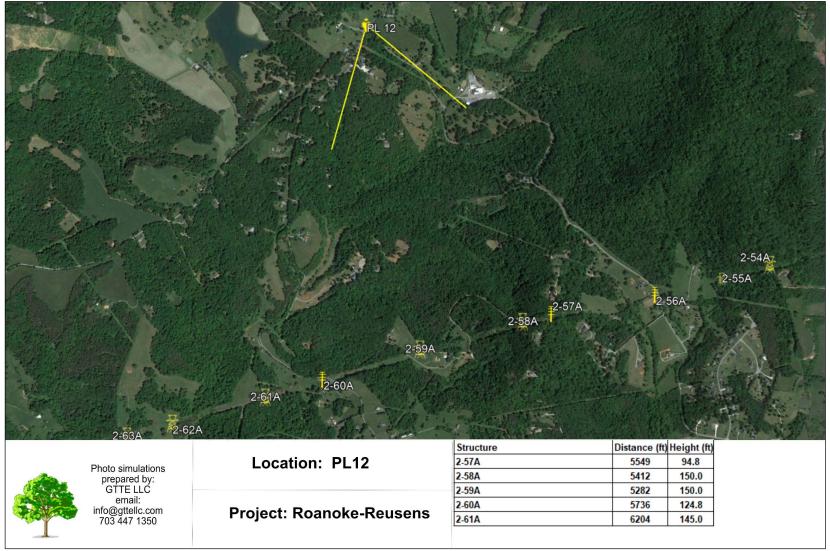
Figure 5-67: Cifax Rural Historic District Simulation 1 - Simulation location, direction of view, and structures modeled from intersection of Old Cifax Road and Otter Road. Source: GTTE, LLC

**Figure 5-53** depicts the location of the Cifax Rural Historic District in relation to the Project and viewshed buffers, with the location and direction of all representative photographs. **Figures 5-54 through 5-66** are representative photographs of the district, as well as those taken from locations within the district towards the Project. **Figures 5-67 through 5-75** provide photo simulations of the Project from representative locations in the district.

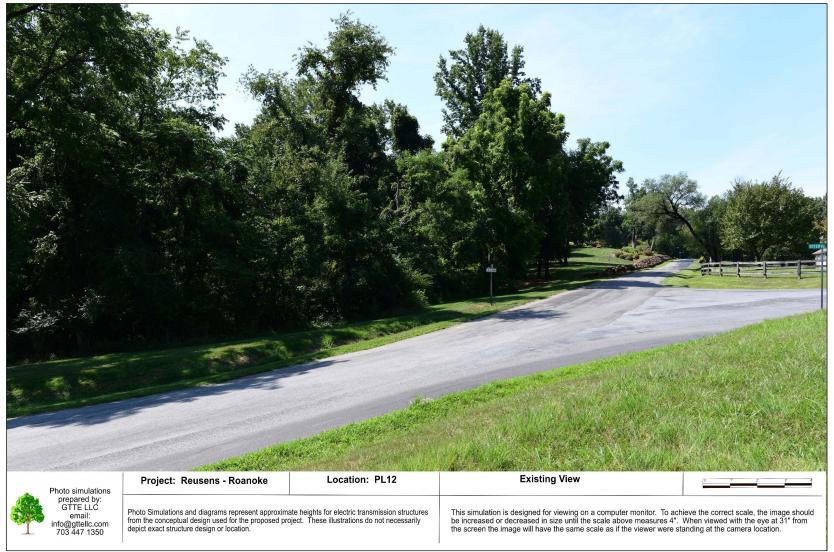
Figure 5-68: Cifax Rural Historic District Simulation 1 - Existing view from intersection of Old Cifax Road and Otter Road. Source: GTTE, LLC

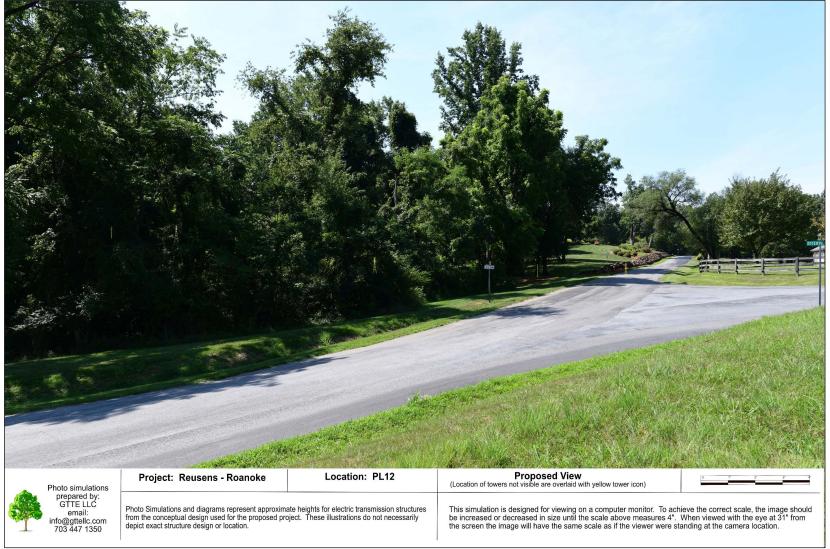
Figure 5-69: Cifax Rural Historic District Simulation 1 - Proposed view from intersection of Old Cifax Road and Otter Road - (Structures not visible shown in yellow). Source: GTTE, LLC

The existing transmission line structures within the vicinity of the district are steel lattice and range from approximately 93- to 114-feet tall and the proposed replacement structures will remain lattice and range from approximately 120-feet to 150-feet tall. As such, there will be a substantial increase in structure height, although structures will generally be replaced on a oneto-one basis near existing structures. Despite the increase in structure height, it is anticipated that visibility of the line and structures will remain screened from the vast majority of the district and contributing properties. As is the case currently, there may be limited visibility of a limited number of structures from discrete vantage points, however, views will be intermittent, at a great distance, and obscured by development and vegetation in the foreground. This was confirmed with photo simulation from multiple locations throughout the district that shows all structures will be screened from most locations, although one structure set atop a ridge in the distance will be increasingly visible through discrete breaks in vegetation in the portion of the district nearest to the Project. As such, the Project is not expected to introduce a noticeable change in setting and viewshed of and from the district or the contributing properties. It is therefore D+A's opinion that the Project will have no more than a *minimal impact* on the Cifax Rural Historic District per VDHR's impact characterization.

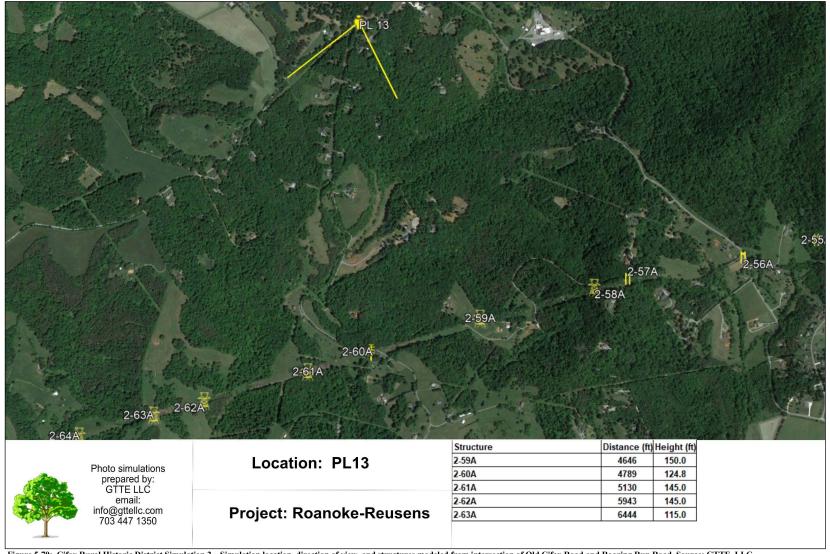
Figure 5-70: Cifax Rural Historic District Simulation 2 - Simulation location, direction of view, and structures modeled from intersection of Old Cifax Road and Roaring Run Road. Source: GTTE, LLC

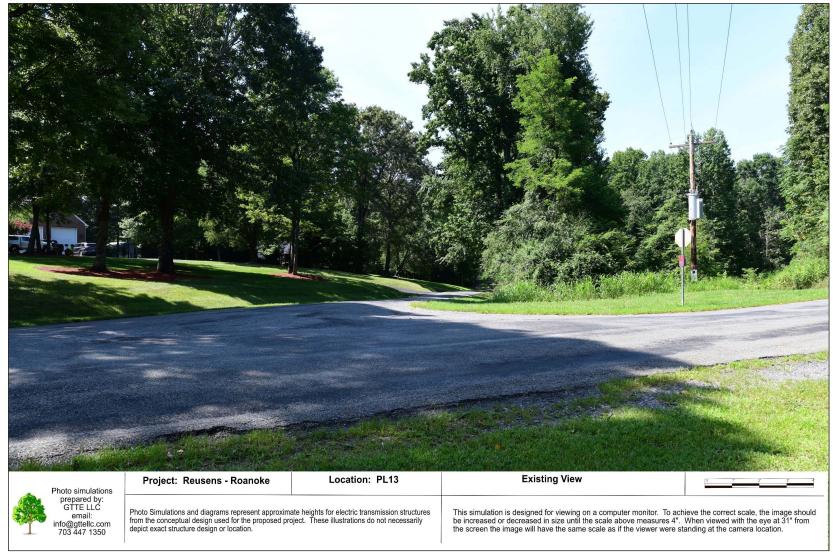
Figure 5-71: Cifax Rural Historic District Simulation 2 - Existing view from intersection of Old Cifax Road and Roaring Run Road. Source: GTTE, LLC

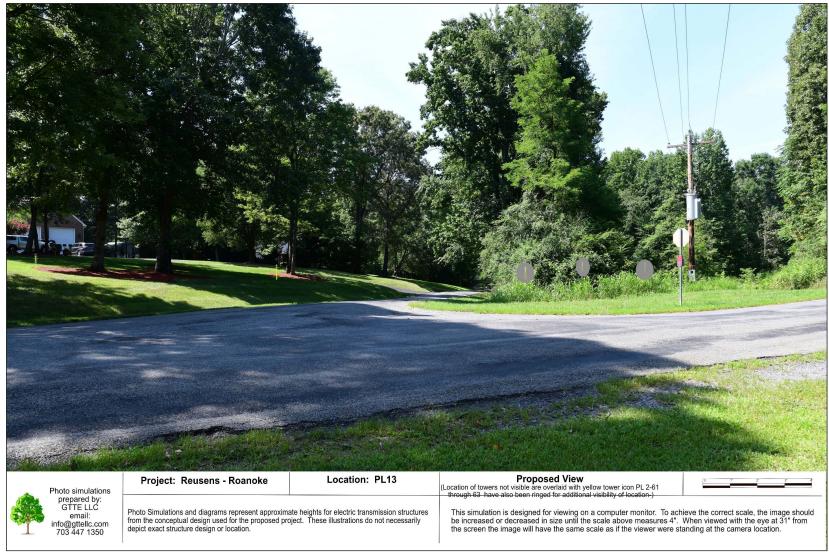
Figure 5-72: Cifax Rural Historic District Simulation 2 - Proposed view from intersection of Old Cifax Road and Roaring Run Road Road - (Structures not visible shown in yellow). Source: GTTE, LLC

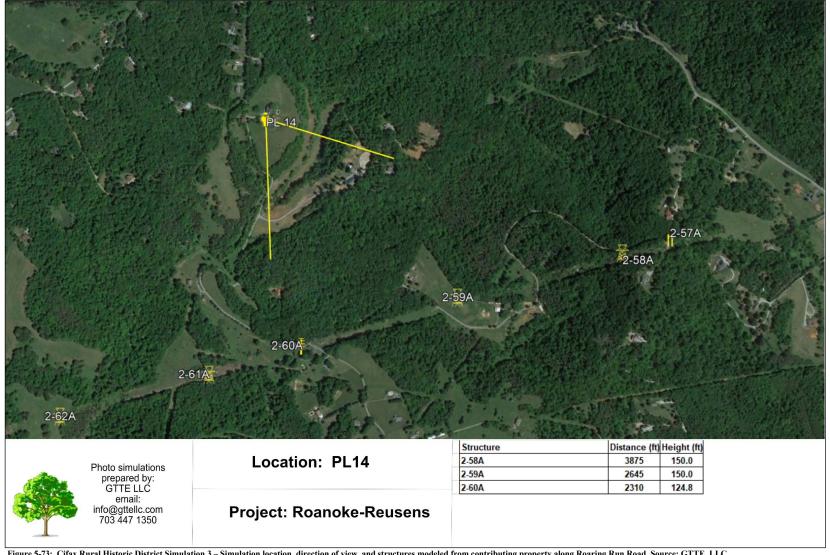
Figure 5-73: Cifax Rural Historic District Simulation 3 - Simulation location, direction of view, and structures modeled from contributing property along Roaring Run Road. Source: GTTE, LLC

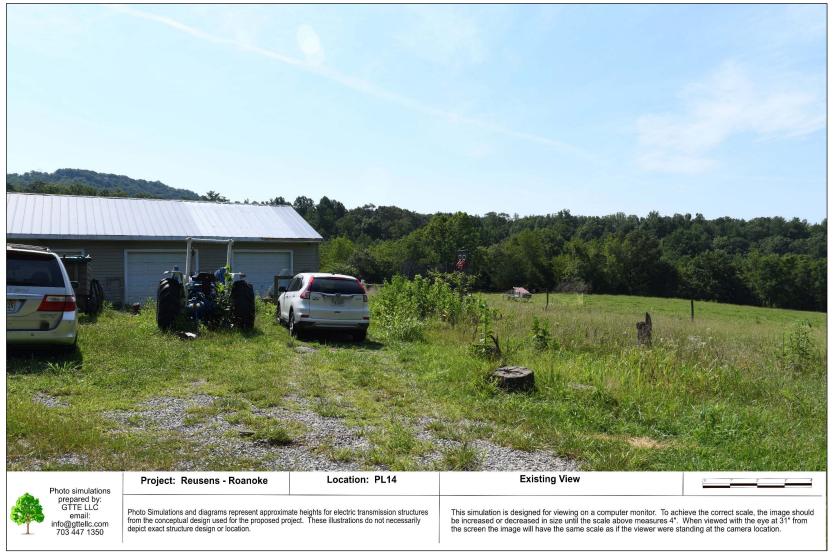
Figure 5-74: Cifax Rural Historic District Simulation 3 - Existing view from contributing property along Roaring Run Road. Source: GTTE, LLC
