Figure 4-6: NHLs, NRHP-Listed, and Eligible Architectural Resources within 1.5 miles of the Project (West-half of alignment). Source: VCRIS

### 5. RESULTS OF FIELD RECONNAISSANCE

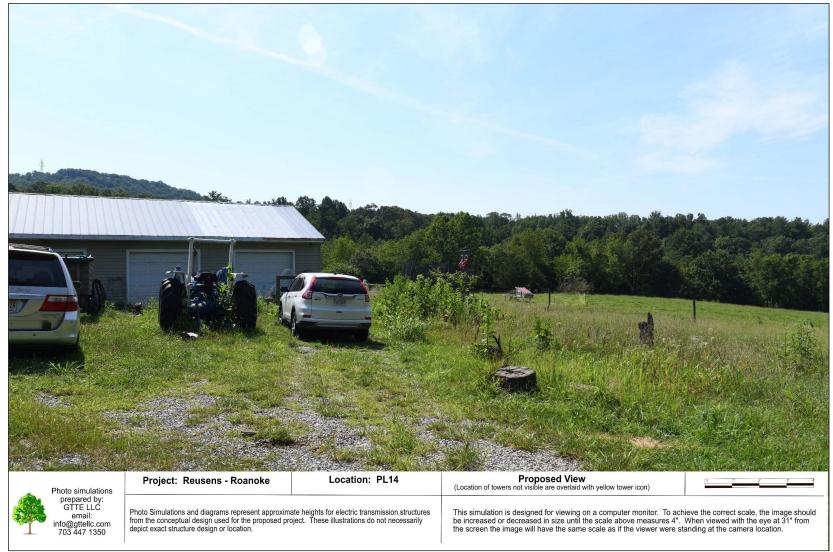
Figure 5-75: Cifax Rural Historic District Simulation 3 - Proposed view from contributing property along Roaring Run Road - (Structures not visible shown in yellow). Source: GTTE, LLC

The existing transmission line structures within the vicinity of the district are steel lattice and range from approximately 93- to 114-feet tall and the proposed replacement structures will remain lattice and range from approximately 120-feet to 150-feet tall. As such, there will be a substantial increase in structure height, although structures will generally be replaced on a oneto-one basis near existing structures. Despite the increase in structure height, it is anticipated that visibility of the line and structures will remain screened from the vast majority of the district and contributing properties. As is the case currently, there may be limited visibility of a limited number of structures from discrete vantage points, however, views will be intermittent, at a great distance, and obscured by development and vegetation in the foreground. This was confirmed with photo simulation from multiple locations throughout the district that shows all structures will be screened from most locations, although one structure set atop a ridge in the distance will be increasingly visible through discrete breaks in vegetation in the portion of the district nearest to the Project. As such, the Project is not expected to introduce a noticeable change in setting and viewshed of and from the district or the contributing properties. It is therefore D+A's opinion that the Project will have no more than a *minimal impact* on the Cifax Rural Historic District per VDHR's impact characterization.

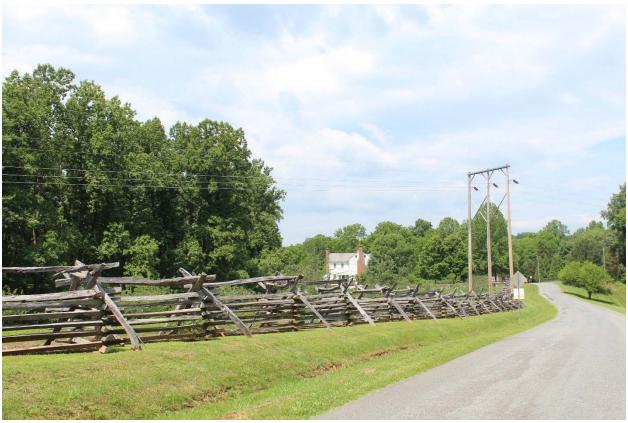
Figure 5-81: Photo location 5- View of Bowling Eldridge House setting depicting existing transmission line on property, facing west.

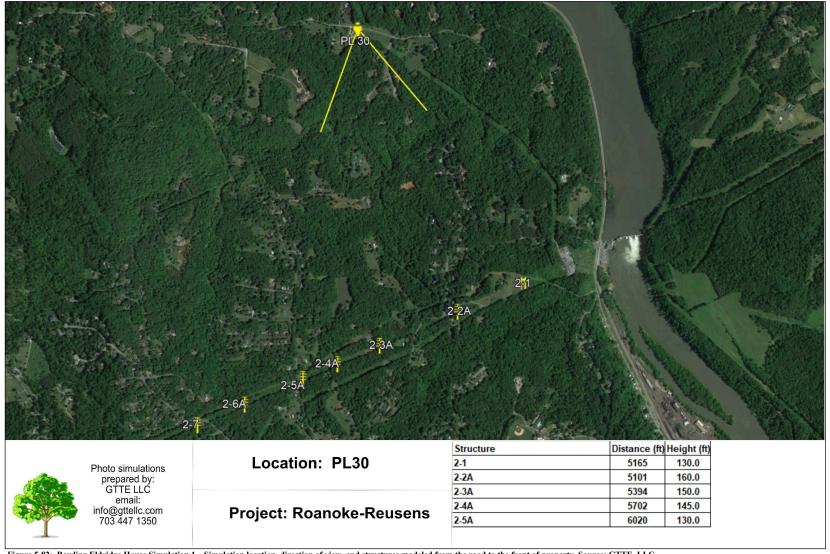
Figure 5-82: Bowling Eldridge House Simulation 1 - Simulation location, direction of view, and structures modeled from the road to the front of property. Source: GTTE, LLC

**Figure 5-76** depicts the location of the Bowling Eldridge House in relation to the Project and viewshed buffers, with the location and direction of all representative photographs. **Figures 5-77 through 5-81** are representative photographs of the property, as well as those taken from locations within and near the property towards the Project. **Figures 5-82 through 5-84** provide photo simulations of the Project from the property.

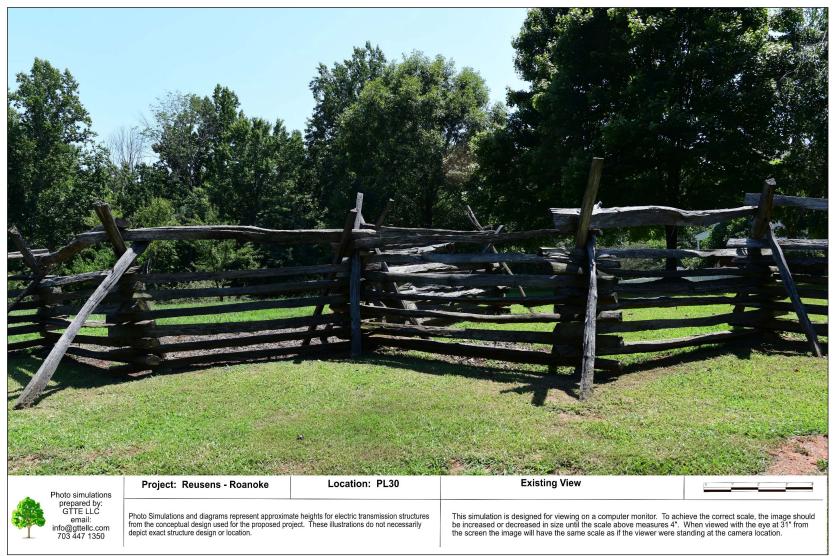
Figure 5-83: Bowling Eldridge House Simulation 1 – Existing view from road to the front of property. Source: GTTE, LLC

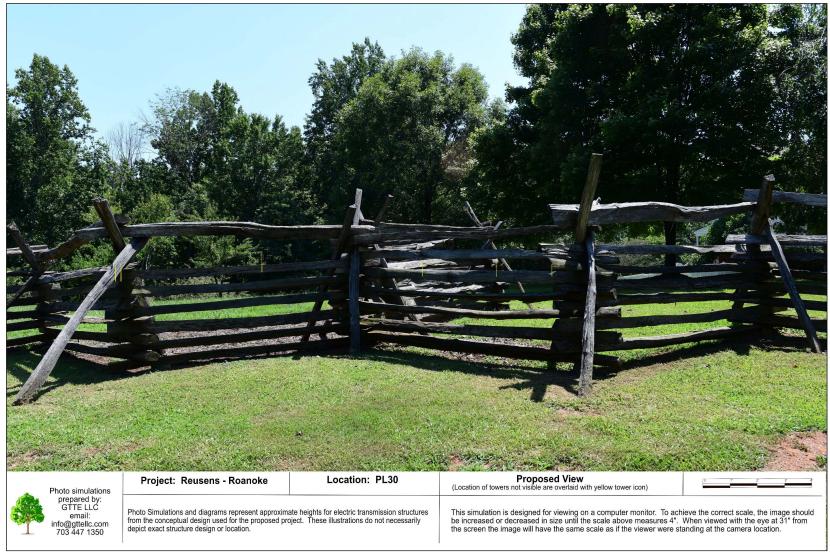
Figure 5-84: Bowling Eldridge House Simulation 1 - Proposed view from road in front of property - (Structures not visible shown in yellow). Source: GTTE, LLC

The existing transmission line structures range from approximately 95-feet to 116-feet tall and the proposed replacement structures will range from approximately 130-feet to 160-feet tall. As such, there will be a substantial increase in structure height, although structures will be replaced on a one-to-one basis in generally the same locations. Despite the increase in height, it is anticipated that there will continue to be no visibility of the transmission line following the rebuild. This was confirmed with photo simulation from the road in front of the house that shows all structures will remain completely screened by intervening vegetation. As such, the Project will not introduce any change of viewshed or setting for the property which is already compromised from relocation, and further compromised by an existing local distribution transmission line. It is

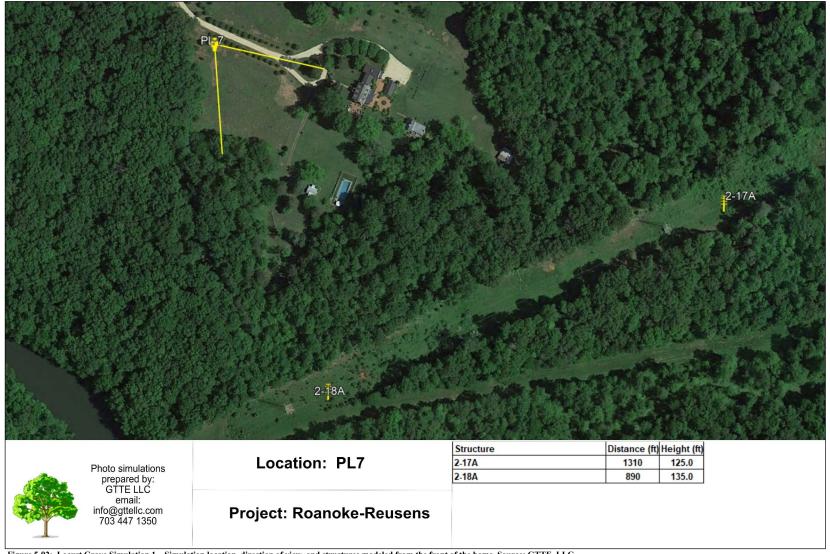
Figure 5-92: Locust Grove Simulation 1 - Simulation location, direction of view, and structures modeled from the front of the home. Source: GTTE, LLC

**Figure 5-85** depicts the location of the Locust Grove in relation to the Project and viewshed buffers, with the location and direction of all representative photographs. **Figures 5-86 through 5-91** are representative photographs of the property, as well as those taken from locations within and near the property towards the Project. **Figures 5-92 through 5-94** provide photo simulations of the Project from the property.

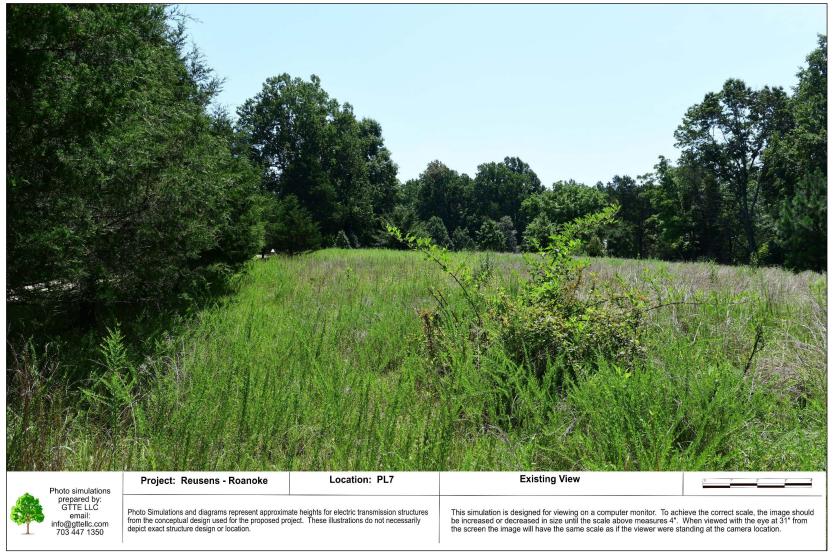
Figure 5-93: Locust Grove Simulation 1 – Existing view from the front of the home. Source: GTTE, LLC

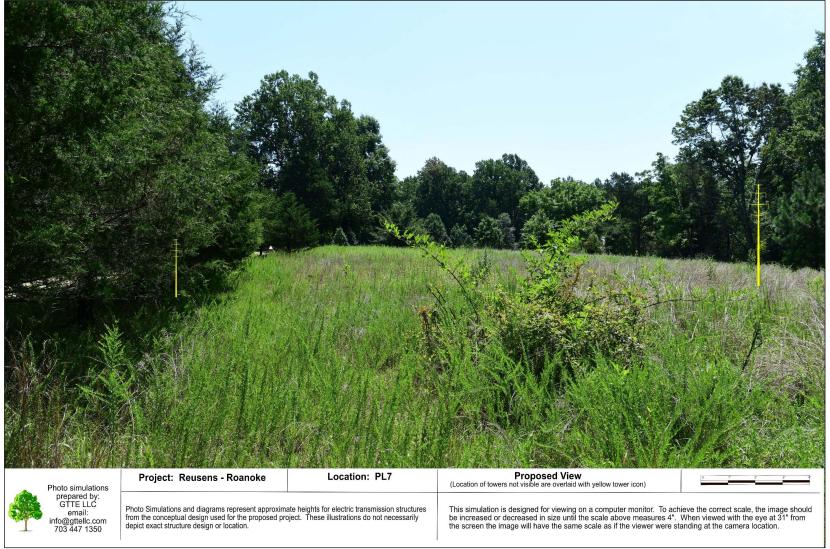
Figure 5-94: Locust Grove Simulation 1 - Proposed view from the front of the home - (Structures not visible shown in yellow). Source: GTTE, LLC

The existing transmission line structures on the property are 92- and 95-feet tall while those within one-half mile range from 93-feet to 140-feet tall and are a mix of lattice and monopole structures. The proposed replacement structures on the property will be 125- and 135- feet tall and those within one-half mile will range from 105-feet to 135-feet tall and all be monopoles. Structures will generally be replaced on a one-to-one basis near existing locations although there will be the need for one additional structure to the east of the property. Despite the increase in height, it is anticipated that the thick vegetation on the property and angle of view will continue to screen all visibility of structures on the property as well as those in the vicinity. This was confirmed with photo simulation from the front of the house that revealed structures will remain screened behind intervening vegetation on the property. As such, the Project is not anticipated to introduce any noticeable change to the existing setting or viewshed of or from the property, however will still directly cross the property. It is therefore D+A's opinion that the Project will have no more than a *minimal impact* on Locust Grove per VDHR's impact characterization.

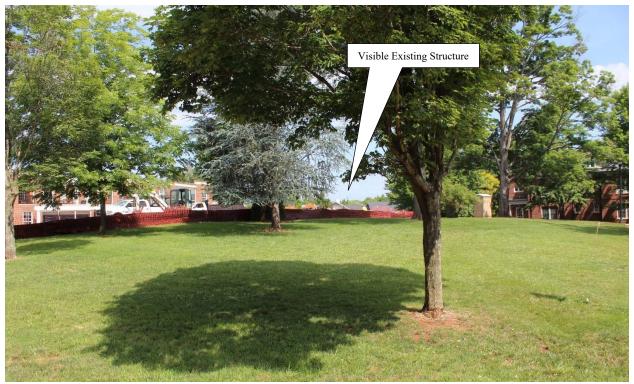
Figure 5-101: Photo location 6- View from VES campus towards the Project (one existing structure visible above treeline through break in foreground vegetation), facing northwest.

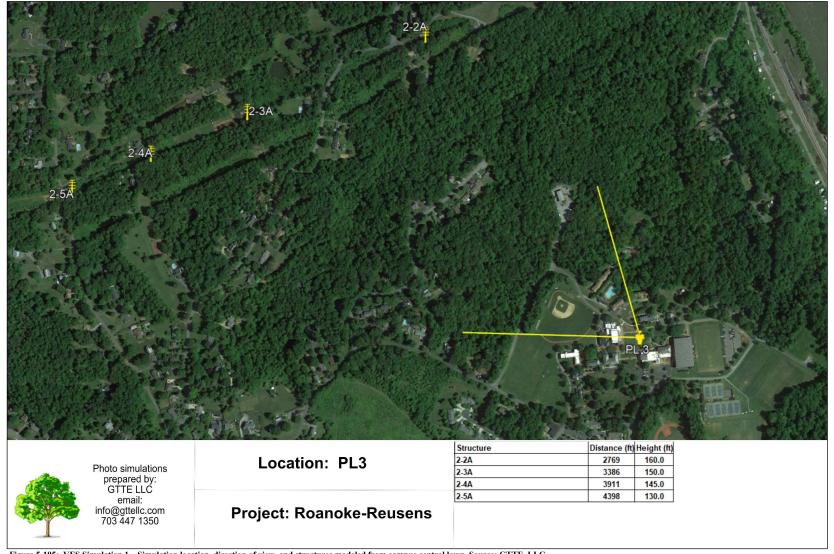
Figure 5-105: VES Simulation 1 - Simulation location, direction of view, and structures modeled from campus central lawn. Source: GTTE, LLC

**Figure 5-95** depicts the location of the Virginia Episcopal School in relation to the Project and viewshed buffers, with the location and direction of all representative photographs. **Figures 5-96 through 5-104** are representative photographs of the property, as well as those taken from locations within and near the property towards the Project. **Figures 5-105 through 5-110** provide photo simulations of the Project from the property.

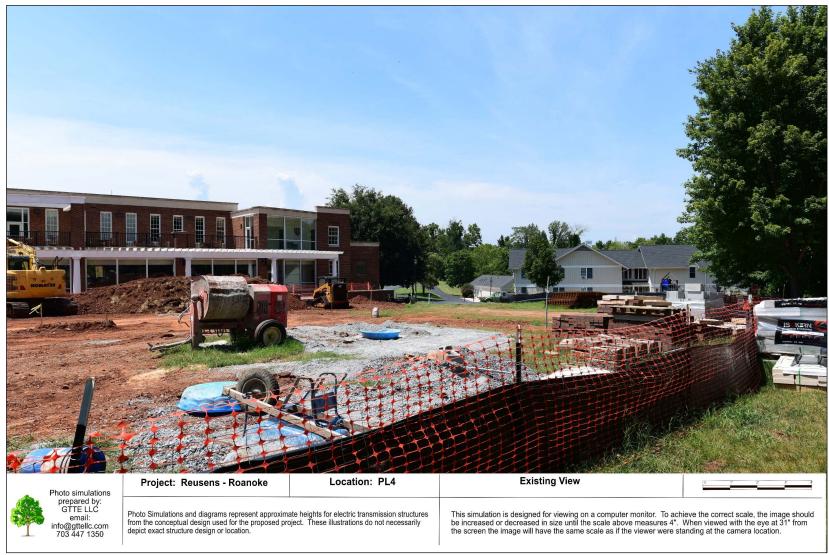
Figure 5-106: VES Simulation 1 – Existing view from campus central lawn. Source: GTTE, LLC

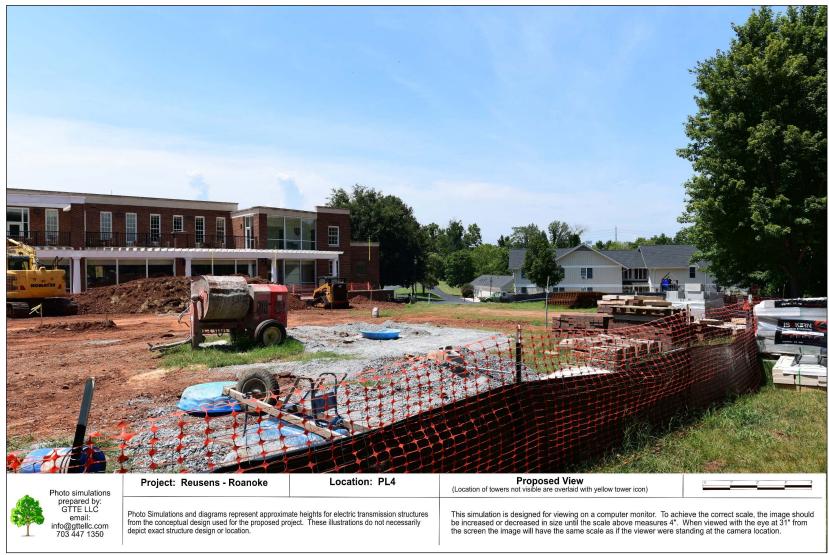
Figure 5-107: VES Simulation 1 - Proposed view from campus central lawn - (One visible structure shown as it would appear. Structures not visible shown as yellow). Source: GTTE, LLC

The existing transmission line structures in the vicinity of the property are steel lattice and range from approximately 80-feet to 116-feet tall and the proposed replacement structures will be monopoles that range from approximately 130-feet to 160-feet tall. Structures in the vicinity will be replaced on a one-to-one basis near the existing locations. As such, there will be a substantial increase in height, however, it is anticipated that development and vegetation within the property, as well as between it and the Project will continue to generally inhibit views of the transmission line following the rebuild. The exception is the one currently visible structure that may rise slightly higher above the treeline, although is expected to remain visible in isolation from only discrete vantage points. This was confirmed with photo simulation that shows one existing structure currently visible from the central green will rise higher above the treeline, however, no additional structures become visible from this vantage. As such, the Project is not anticipated to introduce any substantial change to the existing setting or viewshed of or from the property and it is therefore D+A's opinion that the Project will have no more than a *minimal impact* on the Virginia Episcopal School per VDHR's impact characterization.

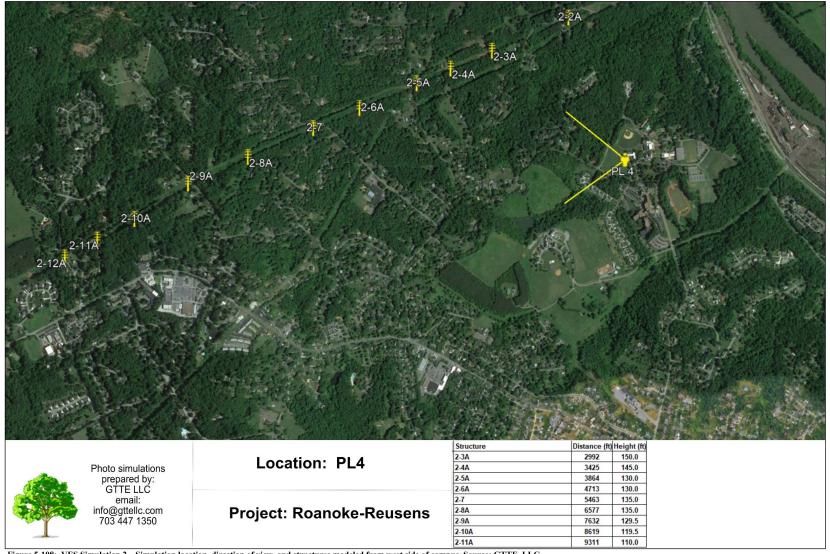
Figure 5-108: VES Simulation 2 - Simulation location, direction of view, and structures modeled from west side of campus. Source: GTTE, LLC

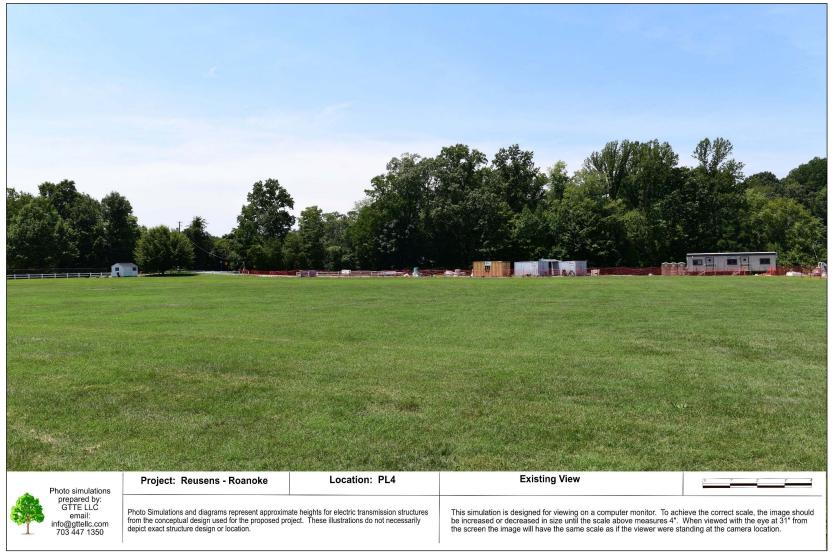
Figure 5-109: VES Simulation 2 – Existing view from west side of campus. Source: GTTE, LLC

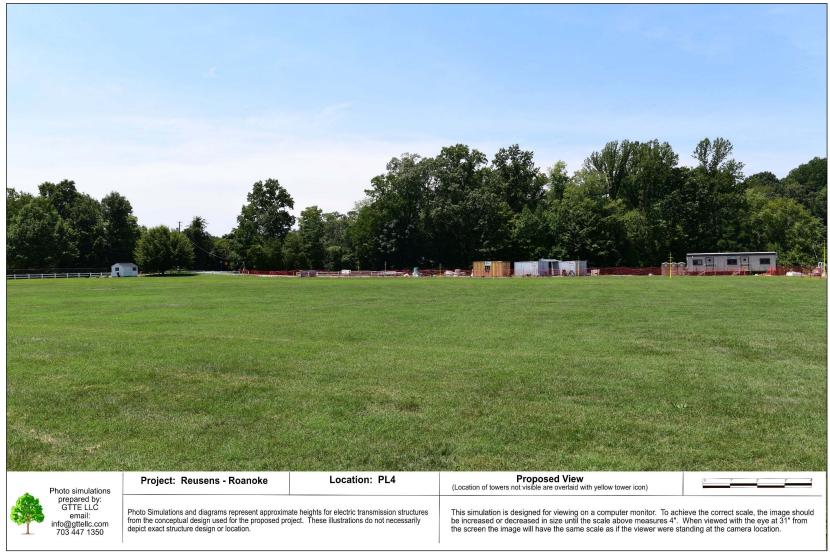
Figure 5-110: VES Simulation 2 - Proposed view from north side of home - (Structures not visible shown in yellow). Source: GTTE, LLC

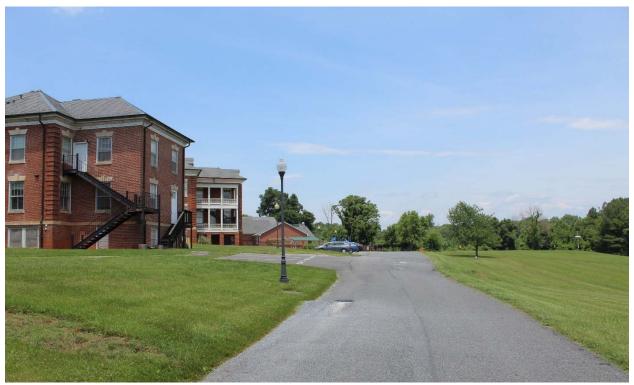
Figure 5-115: Photo location 4- View from rear driveway towards the Project (not visible – screened by vegetation), facing north.

**Figure 5-111** depicts the location of the Presbyterian Orphans Home in relation to the Project and viewshed buffers, with the location and direction of all representative photographs. **Figures 5-112 through 5-119** are representative photographs of the property, as well as those taken from locations within and near the property towards the Project. **Figures 5-120 through 5-125** provide photo simulations of the Project from the property.

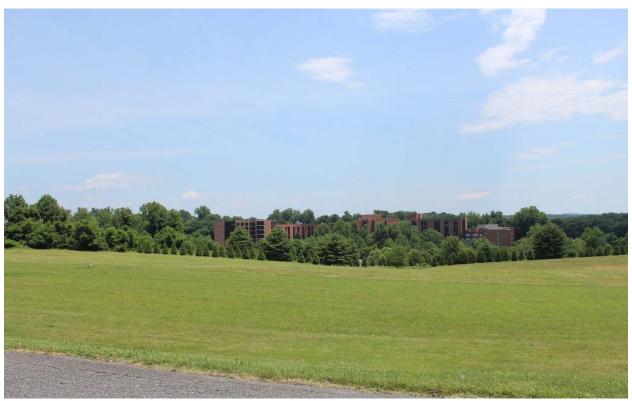
Figure 5-116: Photo location 5- View from rear driveway towards the Project (not visible – screened by vegetation and topography), facing northeast.

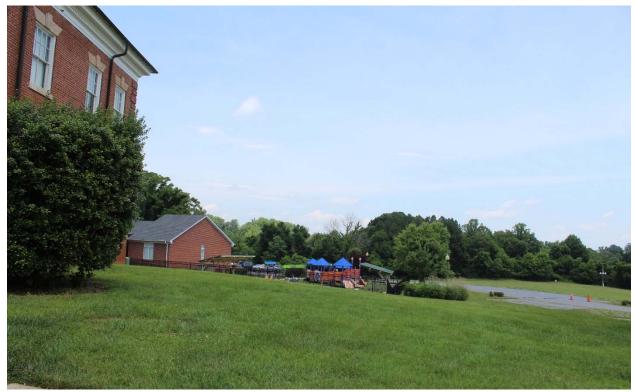
Figure 5-117: Photo location 6- View from campus loop towards the Project (not visible – screened by vegetation and topography), facing northeast.

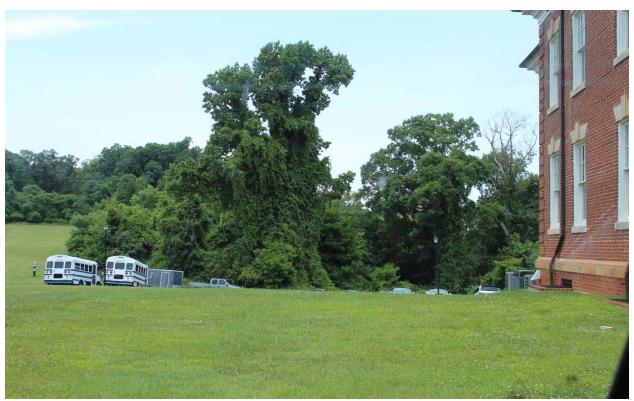
Figure 5-118: Photo location 7- View from campus loop towards the Project (not visible – screened by vegetation and topography), facing north.

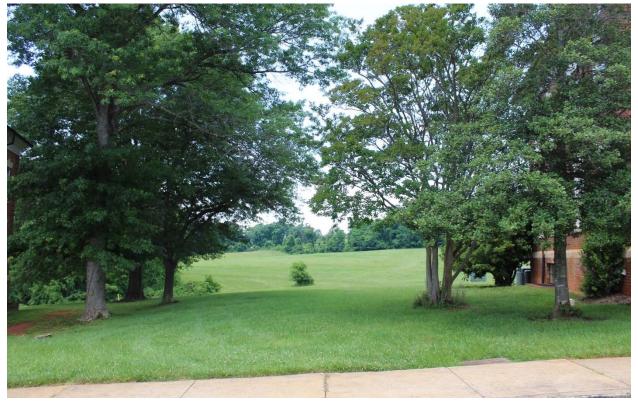
Figure 5-119: Photo location 8- View from campus loop towards the Project (not visible – screened by vegetation and topography), facing northwest.

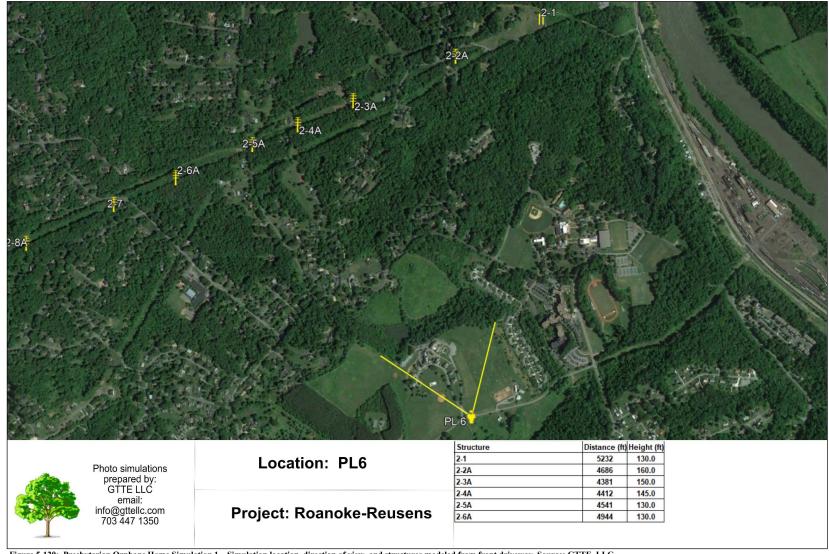
Figure 5-120: Presbyterian Orphans Home Simulation 1 - Simulation location, direction of view, and structures modeled from front driveway. Source: GTTE, LLC

The existing transmission line structures in the vicinity of the property are steel lattice that range from approximately 92-feet to 118-feet tall; and the proposed replacement structures will be steel monopoles that will range from approximately 130-feet to 160-feet tall. Structures in the vicinity will generally be replaced on a one-to-one basis near the existing locations. Despite the increase in height, it is anticipated that the intervening vegetation and development will continue to inhibit views of the transmission line following the rebuild. This was confirmed with photo simulation from the primary driveway into the campus, as well as the western edge of the central

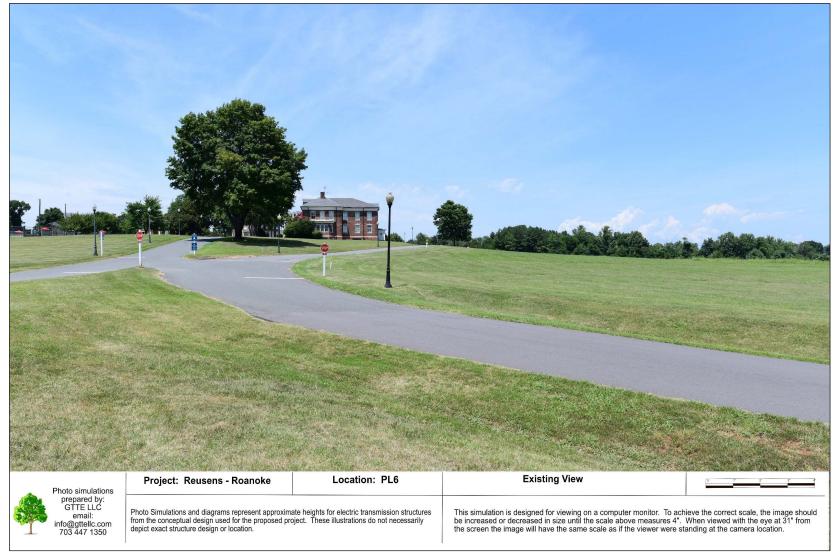
Figure 5-121: Presbyterian Orphans Home Simulation 1 - Existing view from front driveway. Source: GTTE, LLC

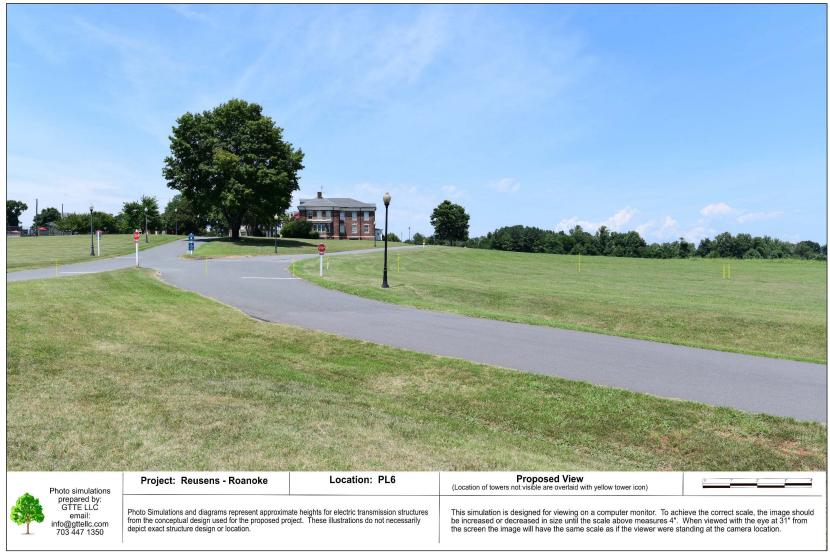
Figure 5-122: Presbyterian Orphans Home Simulation 1 - Proposed view from front driveway - (Structures not visible shown in yellow). Source: GTTE, LLC

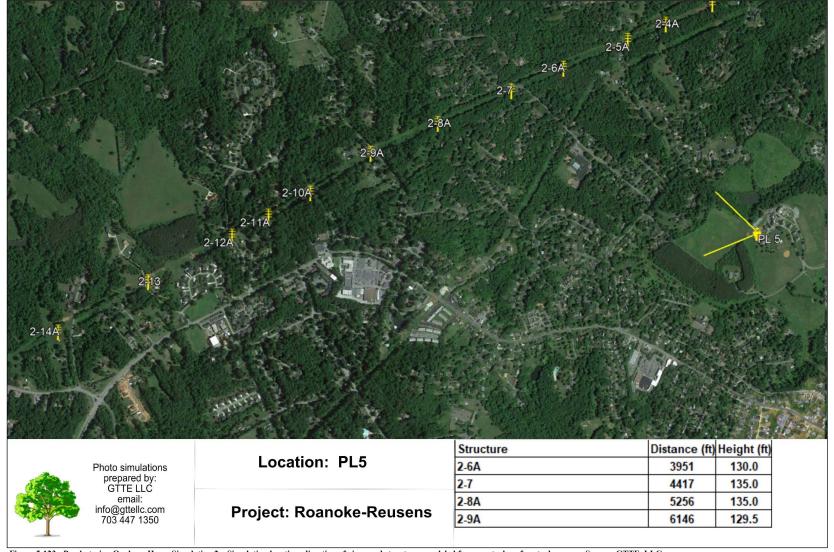
Figure 5-123: Presbyterian Orphans Home Simulation 2 - Simulation location, direction of view, and structures modeled from west edge of central campus. Source: GTTE, LLC

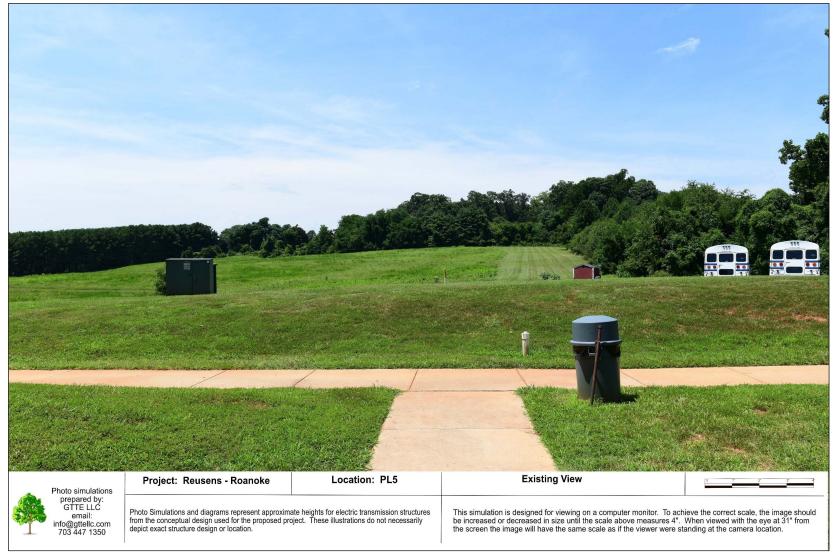
Figure 5-124: Presbyterian Orphans Home Simulation 2 - Existing view from west edge of central campus. Source: GTTE, LLC

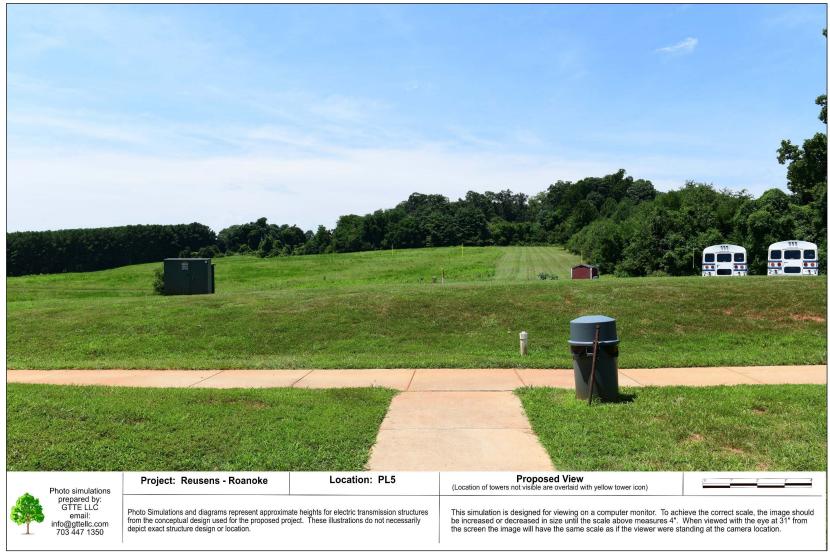
Figure 5-125: Presbyterian Orphans Home Simulation 2 - Proposed view from west edge of central campus - (Structures not visible shown in yellow). Source: GTTE, LLC

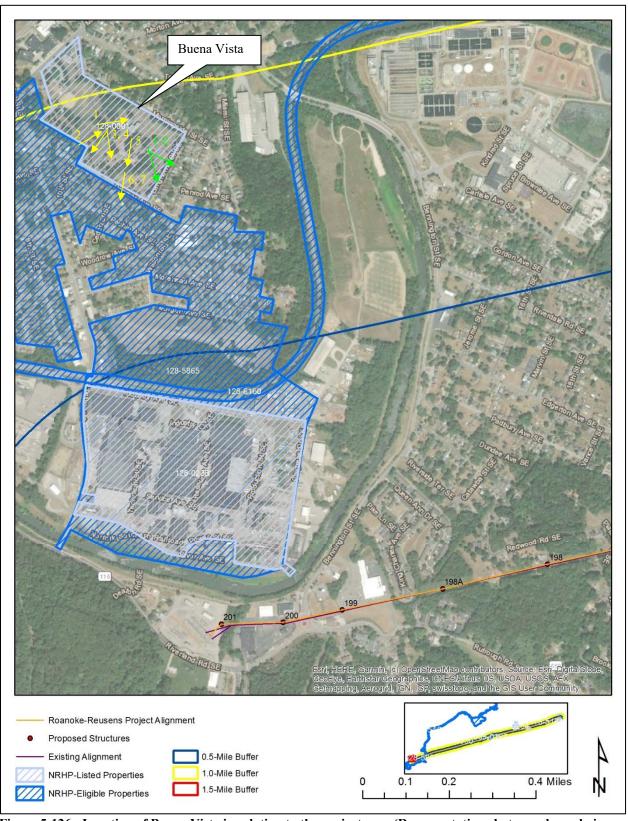
Figure 5-126: Location of Buena Vista in relation to the project area (Representative photographs and views towards the project area depicted in yellow, photo sims depicted in green).

**Figure 5-126** depicts the location of Buena Vista in relation to the Project and viewshed buffers, with the location and direction of all representative photographs. **Figures 5-127 through 5-133** are representative photographs of the property, as well as those taken from locations within and near the property towards the Project. **Figures 5-134 through 5-137** provide photo simulations of the Project from the property.

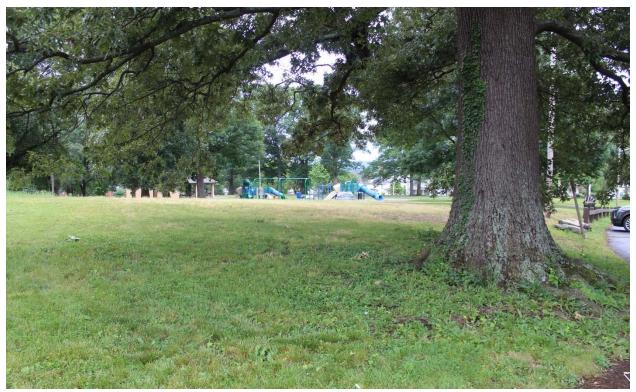
Figure 5-129: Photo location 3- View from Buena Vista parking area towards the Project (not visible – screened by development and topography), facing southeast.

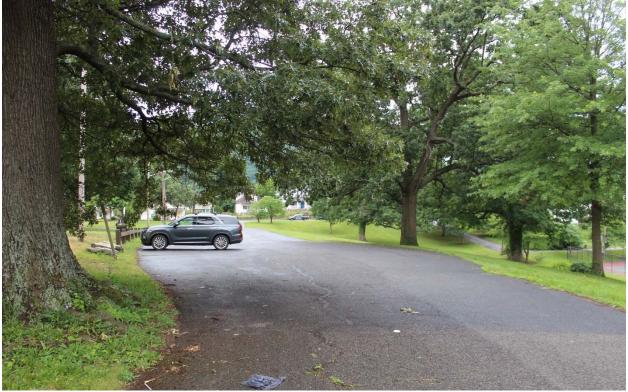
Figure 5-130: Photo location 4- View from Buena Vista parking area towards the Project (not visible – screened by development and vegetation), facing south.

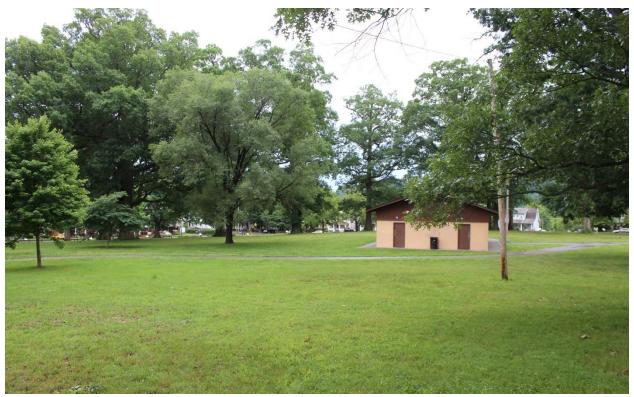
Figure 5-131: Photo location 5- View from rear of Buena Vista house towards the Project (not visible – screened by development and vegetation), facing south.

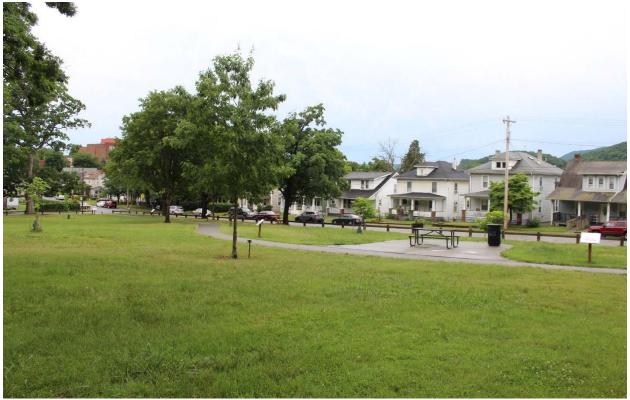
Figure 5-132: Photo location 6- View from Buena Vista park area towards the Project (not visible – screened by development and vegetation), facing southeast.

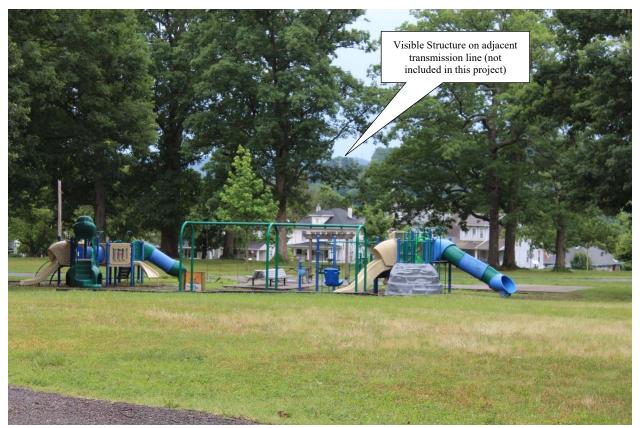
Figure 5-133: Photo location 7- View from Buena Vista park area towards the Project (not visible – screened by development and vegetation. One existing structure on an adjacent transmission line not included in this project is visible through a gap in the treeline), facing south.

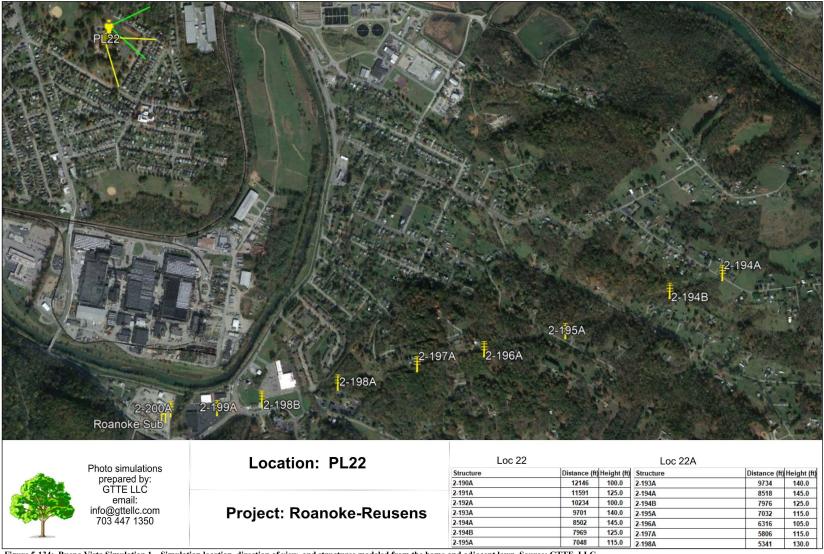
Figure 5-134: Buena Vista Simulation 1 - Simulation location, direction of view, and structures modeled from the home and adjacent lawn. Source: GTTE, LLC

The existing transmission line structures in the vicinity of the property are steel lattice and range from approximately 95- to 113-feet tall and the proposed replacement structures will be steel monopoles that range from approximately 115-feet to 130-feet tall. As such, there will be an increase in structure height, and structures will generally be replaced on a one-to-one basis near existing structures. Despite the increase in height, it is anticipated that the replacement structures will remain below the line of sight from the property and screened by the intervening development and vegetation. This was confirmed with photo simulation from the home and adjacent lawn that shows all structures will remain screened by vegetation and the intervening topography. As such, the Project will not introduce any change in setting or viewshed of or from the property that has already been compromised by its incorporation into a park and the flanking residential development. It is therefore D+A's opinion that the Project will have *no impact* on Buena Vista per VDHR's impact characterization.

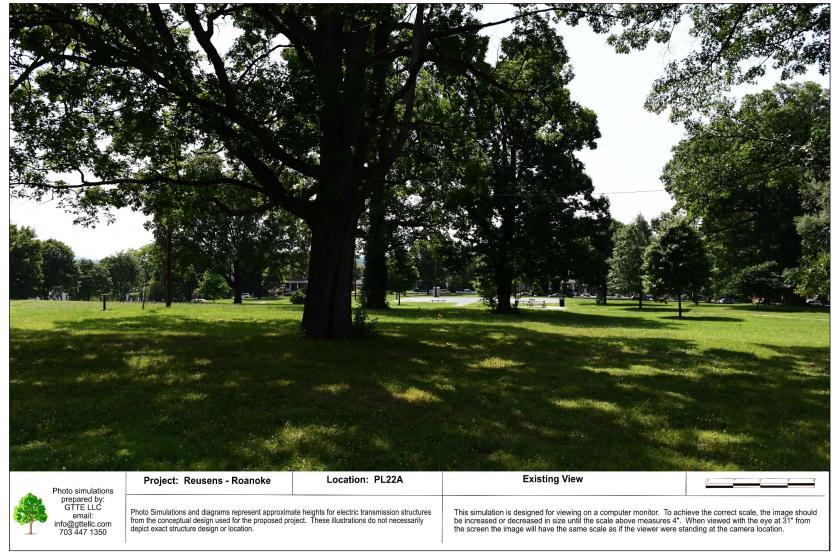
Figure 5-135: Buena Vista Simulation 1 – Existing view from the home. Source: GTTE, LLC

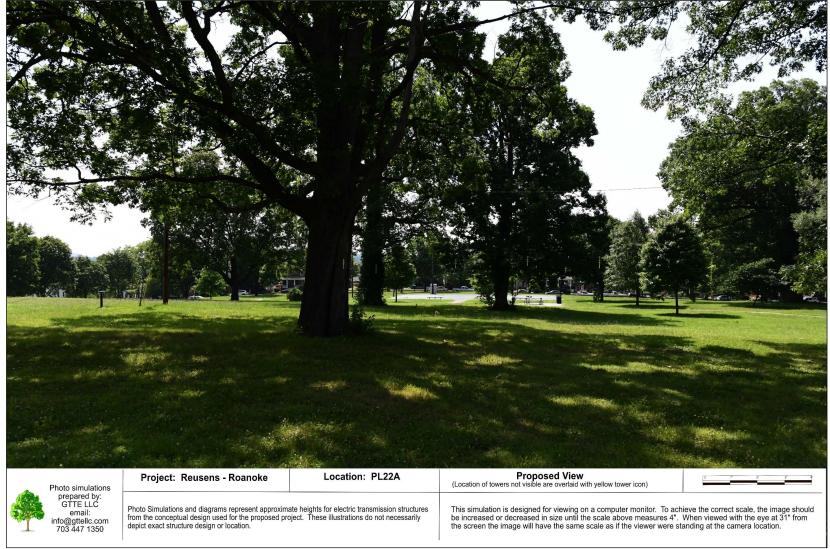
Figure 5-136: Buena Vista Simulation 1 - Proposed view from the home - (Structures not visible shown in yellow). Source: GTTE, LLC
