Construction Notice for Beatty Road Station Drainage Improvements

PUCO Case No. 16-0549-EL-BNR

Appendix B Project Structure Design Drawings September 30, 2016

JACKSON TOWNSHIP, FRANKLIN COUNTY, OHIO AEP BEATTY ROAD STATION SECURITY FENCE AND ACCESS DRIVE IMROVENTS 2016

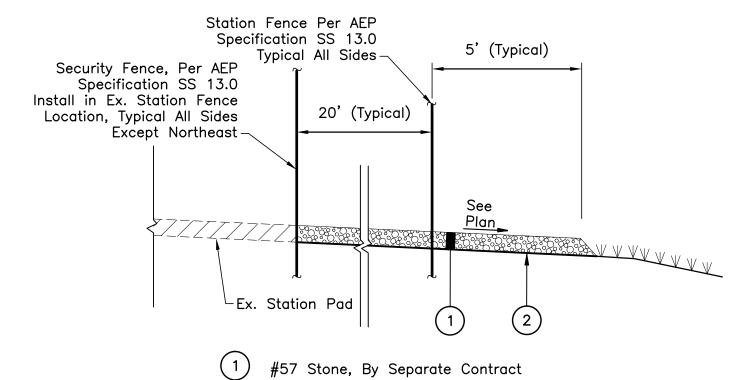
ADDITION TO STATION PAD TYPICAL SECTION

(2) AEP Item 4.6 Compacted Subgrade

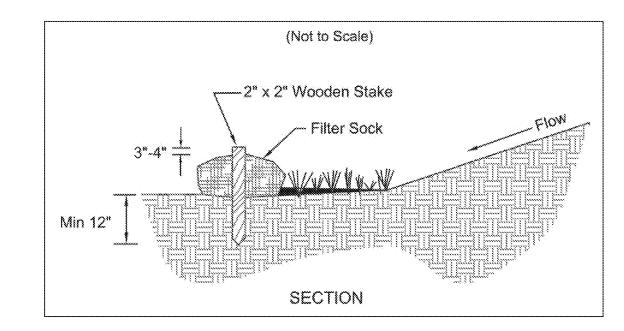
- 1. Materials Compost used for filter socks shall be weed, 5. Filter Socks are not to be used in concentrated flow pathogen and insect free and free of any refuse, contamisituations or in runoff channels. nants or other materials toxic to plant growth. They shall be derived from a well-decomposed source of organic
- matter and consist of a particles ranging from 3/8" to 2". 2. Filter Socks shall be 3 or 5 mil continuous, tubular, HDPE 3/8" knitted mesh netting material, filled with compost passing the above specifications for compost products.
- 3. Filter socks will be placed on a level line across slopes, generally parallel to the base of the slope or other affected area. On slopes approaching 2:1, additional

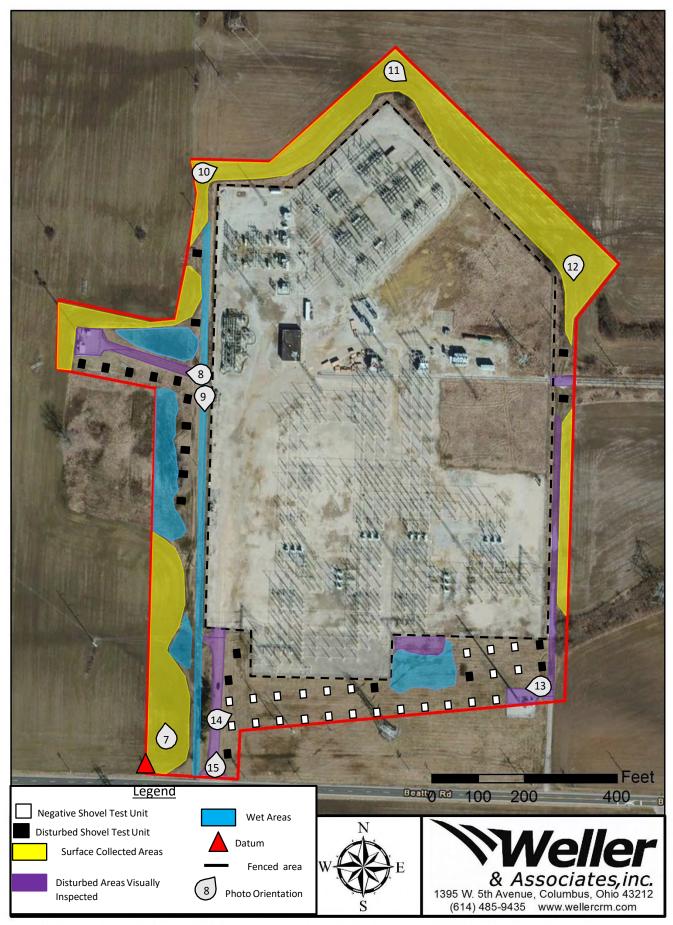
Figure 6. Fieldwork map showing results of testing and photo orientations.

The field investigations for this project were conducted on March 17, 2016 (Figures 6-19). The weather was amiable for the completion of the fieldwork. The project area is approximately a 9-acre parcel that is the proposed location of the Beatty Rd. Substation. Two factors inhibiting sampling during the investigation include inundated conditions and significant disturbance in portions of the project area.

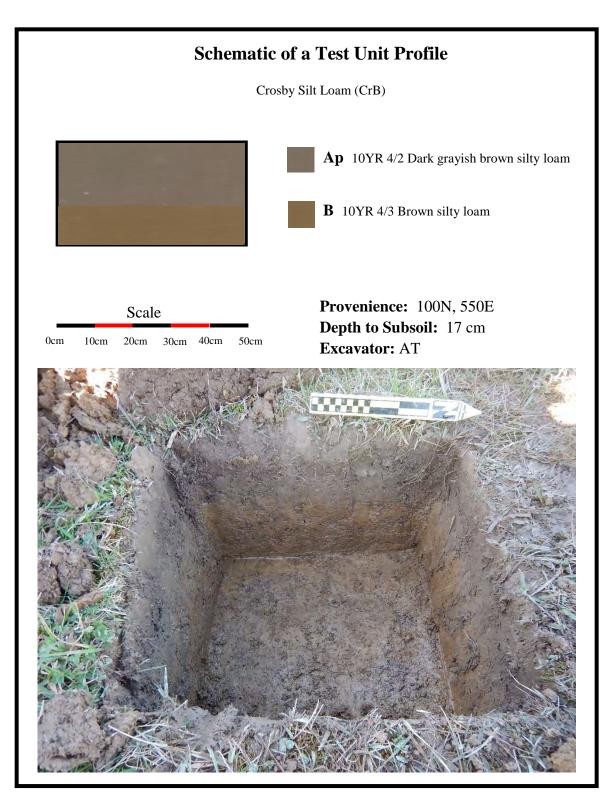
Figure 19. A typical shovel test unit excavated within the project.
